## 6. South-West Heritage Sites - Case Studies

### 6.1. Identification of heritage sites currently or potentially at risk

## **CHerISH PROJECT CASE STUDIES – COASTAL CHANGE ISSUES AND HERITAGE INTERESTS**

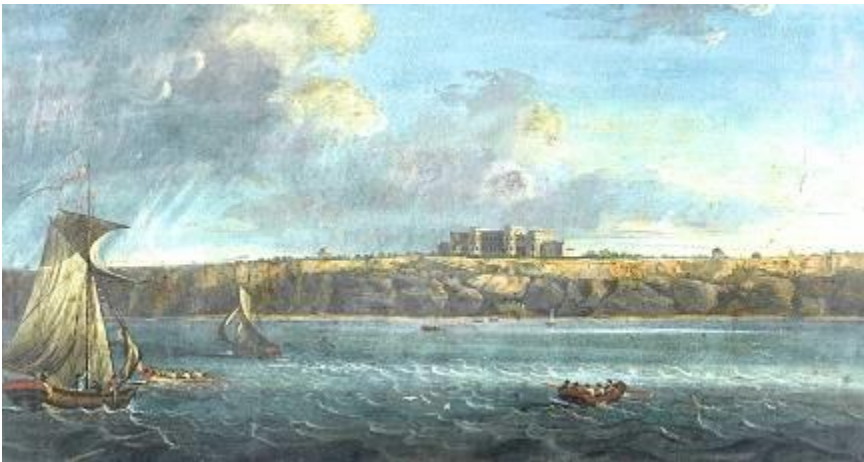
**Figure 1.1:** *'High Cliff from the Sea'* by Adam Callader. Oil on Canvas. 1783. This view shows the proximity of the mansion to the unstable cliffline. By 1813 the property had to be demolished.

Figures 1.1 and 1.2 overleaf show views of the old house from the sea and from the east, whilst Figure 1.3 shows the grand north façade. A pair of elegant circular temples and a gazebo adorned the cliff edge. (See Figures 1.4 and 1.5). The unstable nature of the cliff can be observed in Figure 1.5 and rapid coastal erosion led to the loss of the temples and necessitated the demolition of the property from 1813.

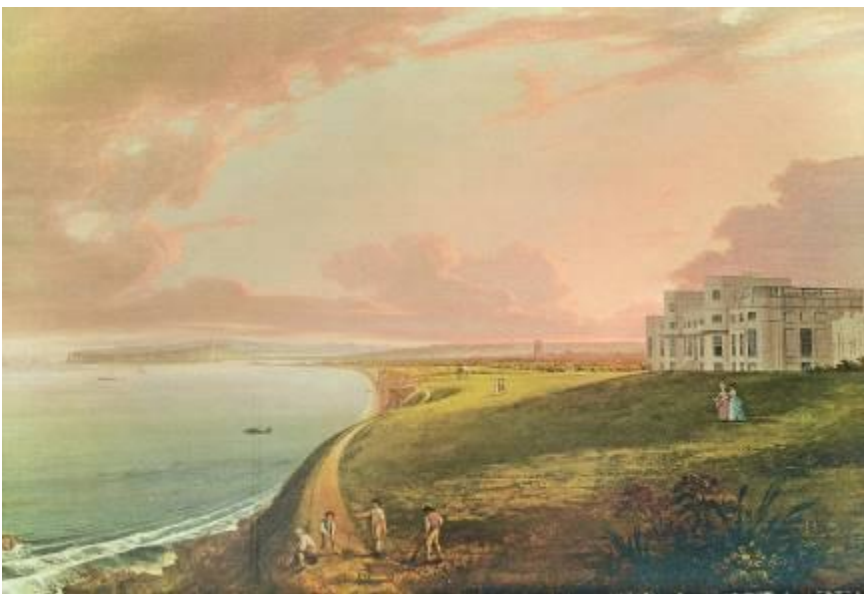
**Figure 1.2:** *'High Cliff from the East'* by Charles Stewart. Oil on Canvas. 1783. The view shows the relationship between the house and the cliff. Christchurch Priory and Hengistbury Head can be seen in the distance.

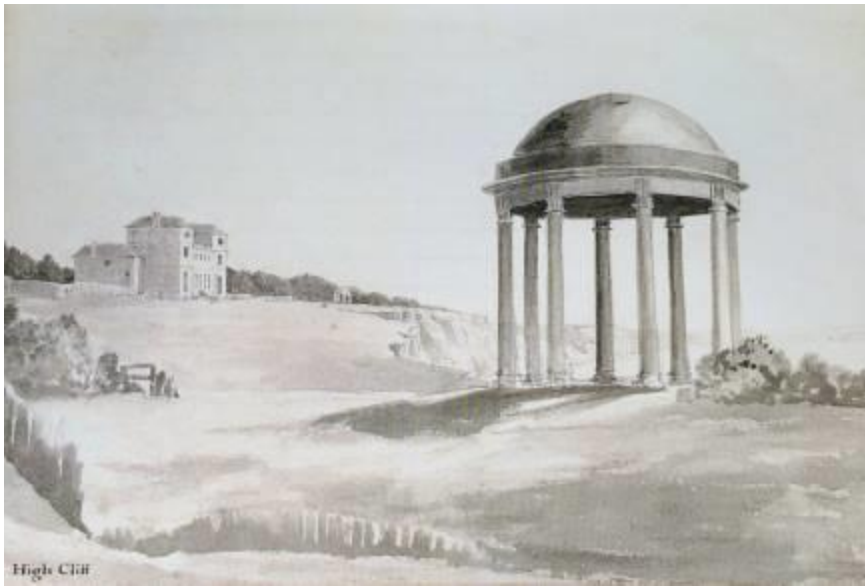
**Figure 1.4:** *'High Cliff Mansion'* after its wings had been removed to make the residence a more manageable size. Brown wash watercolour by Elizabeth Fanshawe. 1811. The pair of temples or gazebos may have been lost as a result of coastal erosion and instability.

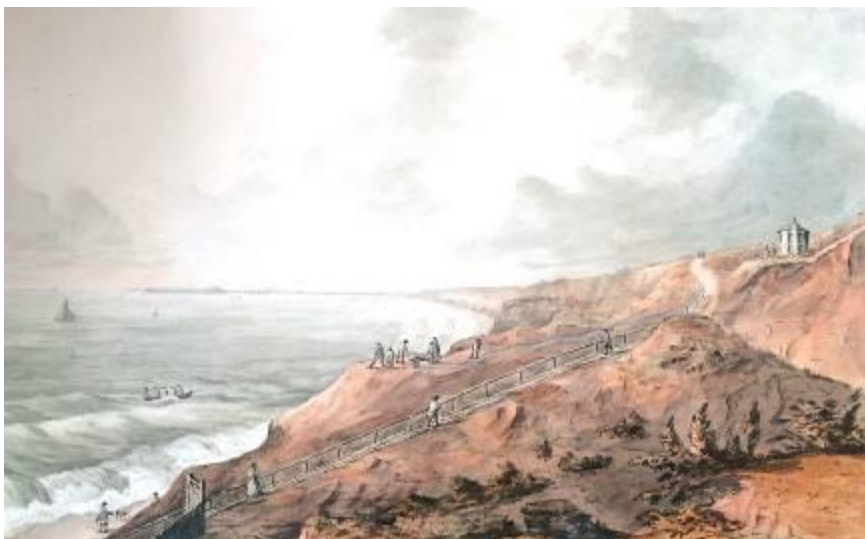
**Figure 1.5:** *'Capability' Brown's early Beach Hut* on the cliffs below High Cliff Mansion. Workers can be seen repairing the slope and path down the obviously unstable cliff.

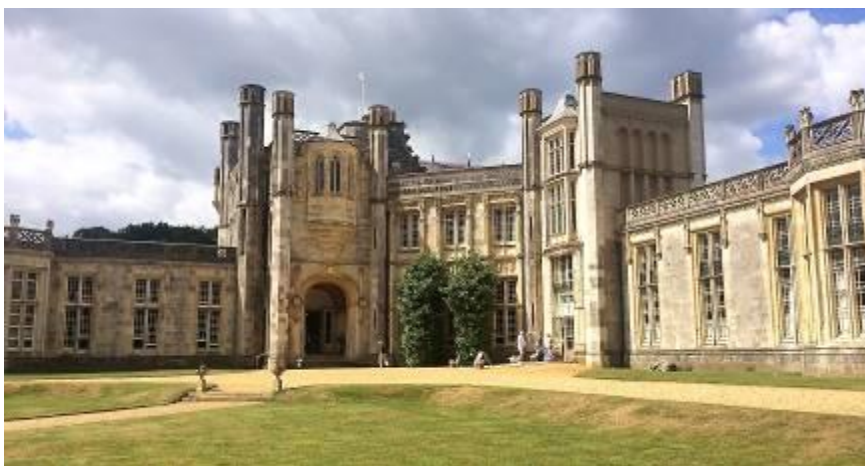
**Figure 1.6:** *'Highcliffe Castle'* today. The Grade I Listed Building is set well back from the cliff. The Castle represents an early example of adaptation to a rapidly changing coastline.

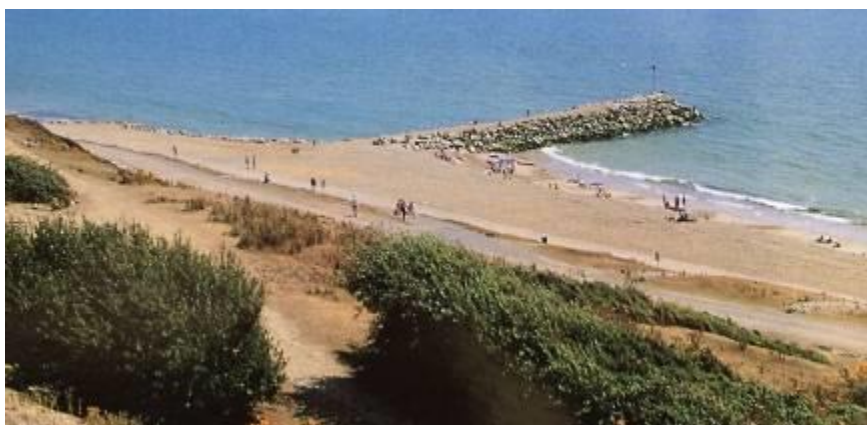
**Figure 1.8:** Highcliffe beach today. The rock breakwaters, beach replenishment and cliff works help to protect the frontage. The frontage has a 'Hold the Line' coastal protection policy for the next Century.

The frontage is now protected through cliff drainage works, together with rock groynes and beach replenishment (Figure 1.8).

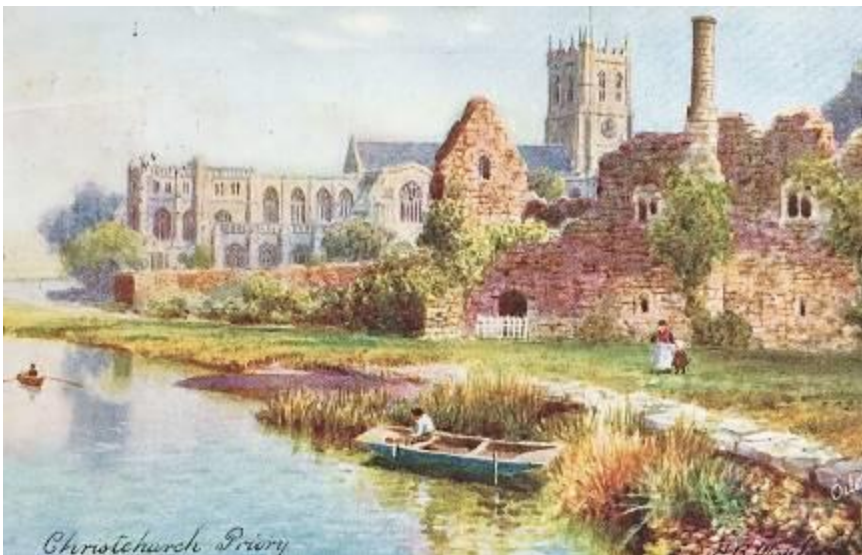
**Figure 1.13:** 'Christchurch Priory' by Henry B. Wimbush (c.1910) who was a postcard and book illustrator who worked for Raphael Tuck (postcards) and A. & C. Black (publishers). The condition of the Priory buildings and their proximity to the water's edge is shown very clearly.

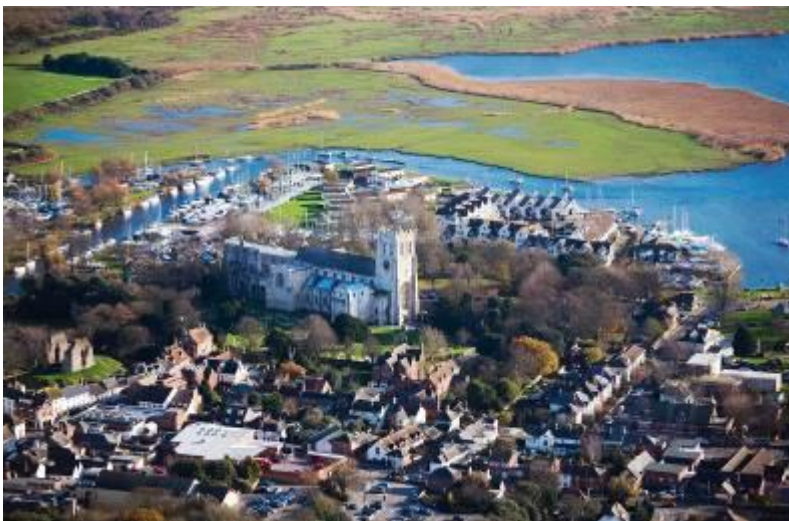
**Figure 1.17:** A view of Christchurch Priory showing the waterside location. Consideration is being given to upgrading flood defences in the vicinity.

This study site clearly illustrates risks to heritage from erosional processes as witnessed by the cliff retreat at Highcliffe, and highlights an apparent vulnerability to flooding at Christchurch Priory (see Figure 1.17). It emphasises the vital role played by coast protection structures and flood defence measures in terms of protecting such coastal heritage assets. Likewise, at Hengistbury Head, the site is protected by significant coastal defences supported by a substantial beach accretion. Whilst artworks can support understanding of past conditions at Highcliffe and Christchurch Quay the heritage interest at Hengistbury Head will be illustrated most effectively through aerial photography.

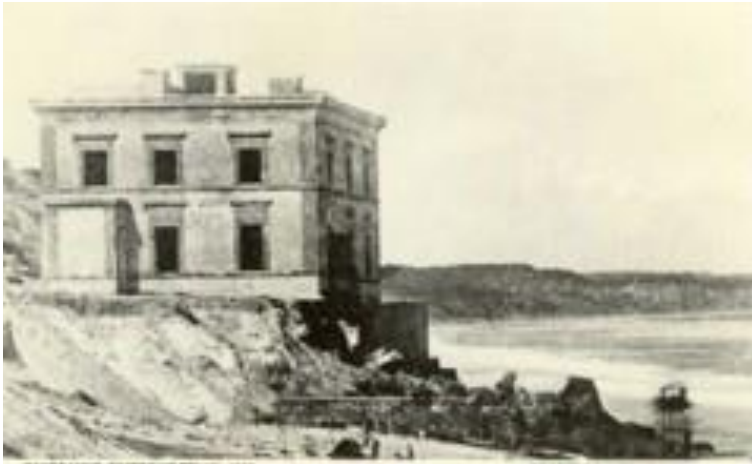
**Figure 2.1 (left):** *'Simpson's Folly'* was built at the foot of Canford Cliffs near Bournemouth in 1878. Insufficient consideration was given to coastal erosion and the property had to be demolished soon after its occupation.

Along the Canford Cliffs frontage two examples of the impacts of coastal erosion and cliff instability on heritage are illustrated. In 1874, a landowner, Captain John Hawkins Simpson, decided to build a row of seaside villas on the shore at Canford Cliffs between Flaghead Chine and Shore Road. Having obtained the permission of the landowner, and of the local authority the first of these houses was built (see Figure 2.1). The square flat-roof structure took four years to build and was completed in 1878 with a large seawall protecting it. However, the house had been built on a foundation of clay and sand and the sea quickly washed under the defences, making it unstable. The foundations were undermined and Captain Simpson was forced by the local authorities to abandon the property within weeks of its occupation. The property stood empty and the sea continued to undermine the property (Figure 2.2). By 1889 the whole property was collapsing. Poole Corporation ordered the demolition of the building for safety reasons and in 1890 the local authority blew up the remains of the property with gun powder. A high pile of concrete blocks and rubble was left in this location for many years until, in 1957, Poole Corporation was given the foreshore, and between 1960 and 1961 they constructed a promenade between the Shore Road promenade and the one at St Anne's, incorporating much of the rubble in the foundations of the new promenade, which was completed in 1962.

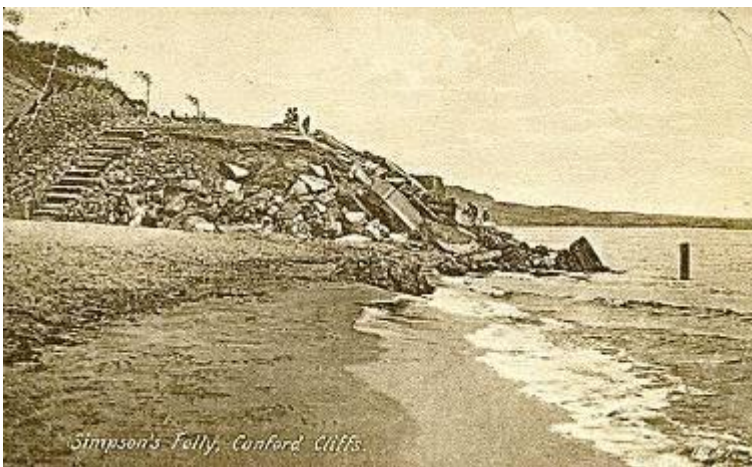
**Figure 2.2 (left):** The remains of *'Simpson's Folly'* remained on the shore for many years until it was incorporated within a new promenade.

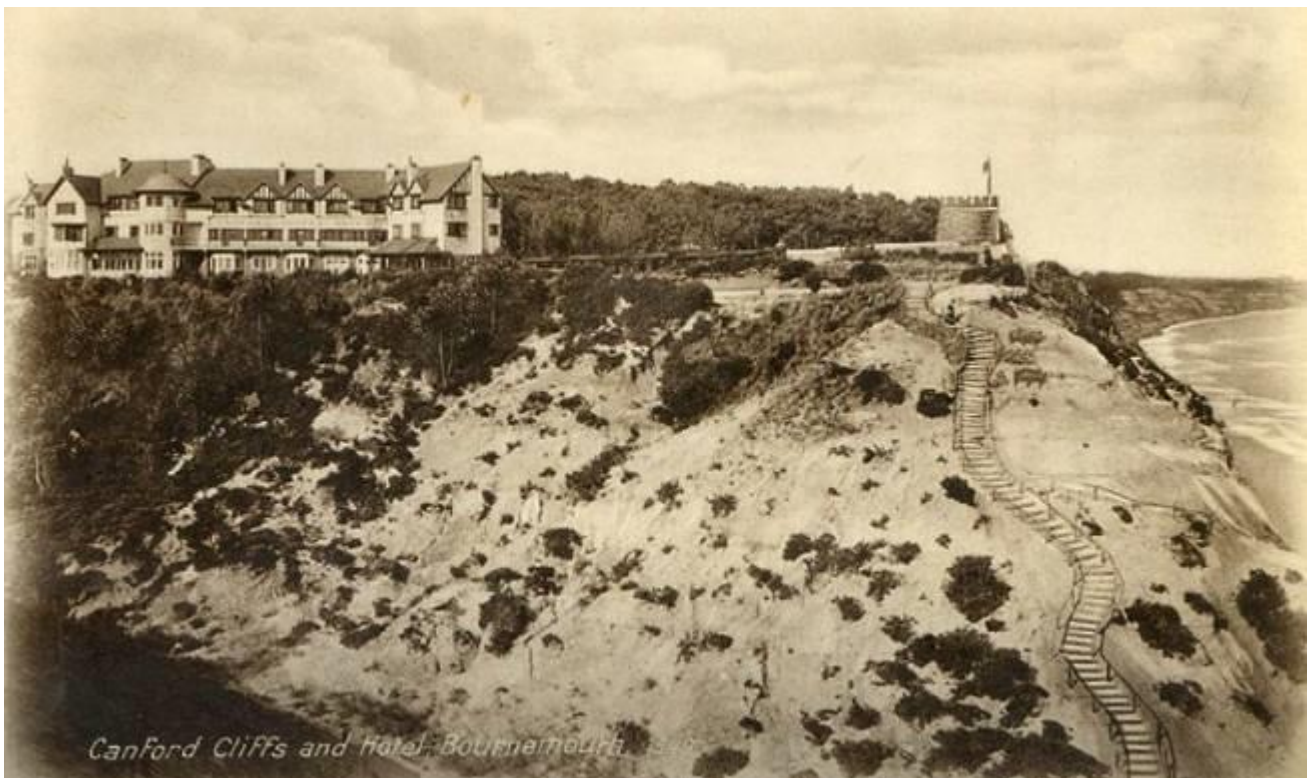
**Figure 2.3 (below):** The tower on the cliffs, which succumbed to coastal erosion despite having been located further from the coast.

A structure known as a 'Martello tower' was situated on the eastern side of Canford Cliffs Chine; the stone for its construction is reputed to have been imported from Beaulieu Abbey. In fact, this structure was not a defensive Martello tower but was actually a gazebo/folly built in 1857 for Sir Charles Packe of Branksome Park. It was used as a smoking room for the owners of the Canford Cliffs Hotel in the 1930s, before serving as staff quarters for a time. It gave its name to a magnificent Edwardian house, Martello Towers, which was subsequently demolished to make way for the present block of flats. Although the old tower had been moved back previously from the retreating cliffs, eventually it succumbed following a cliff fall. These case study sites illustrate the vulnerability of properties constructed too close to eroding or unstable cliff lines. Although the tower had been relocated, this was insufficient to save it from further retreat of the sea cliff (Figure 2.3).

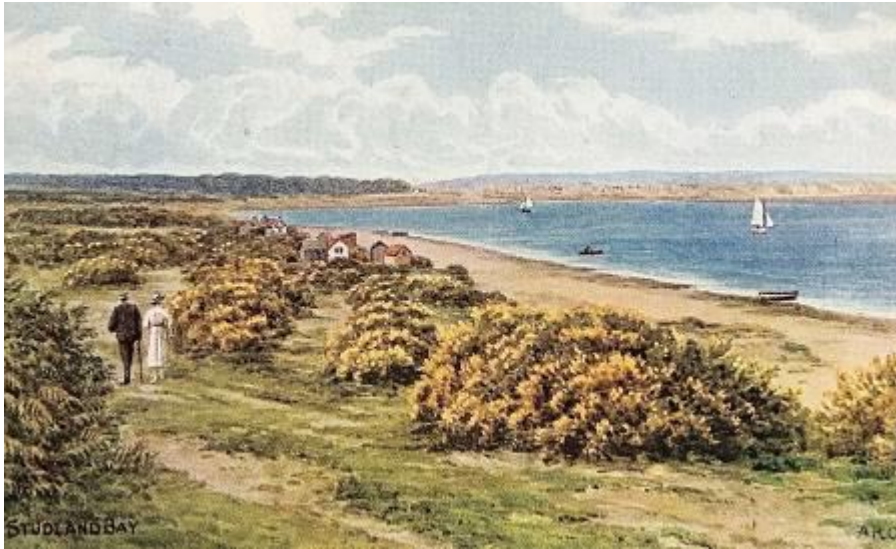
**Figures 2.11 and 2.12:** The watercolour by Alfred Robert Quinton (left) was painted c.1920 and looks north along Studland Beach. Here the beach has been accreting towards Poole Harbour entrance. The present day view is shown below.

The Studland Bay frontage (Figures 2.11-2.14) has been included in this case study because, although there are no heritage assets in the immediate vicinity, the principles being established through the National Trust's approach at Swanage are likely to become more widely applied, in line with current government guidance, which is aimed at managing coastal change through taking a long-term perspective and working with natural processes (National Trust, 2014<sup>4</sup>; Environment Agency, 2014<sup>3B</sup>). This policy has heritage implications elsewhere across the CHERISH case study sites such as Mullion Harbour in Cornwall.

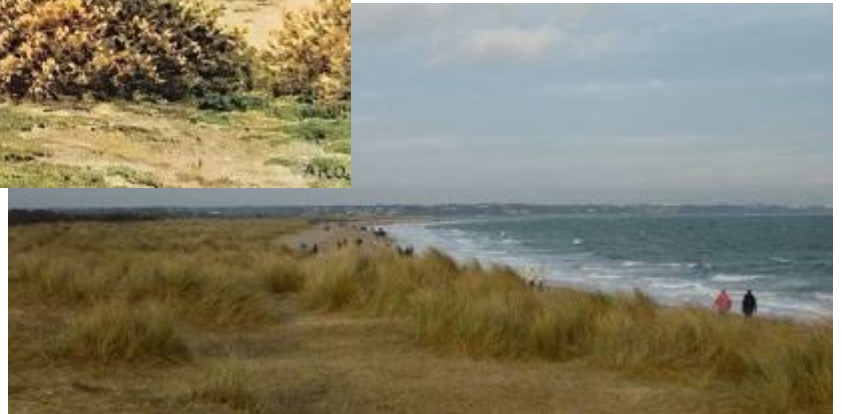
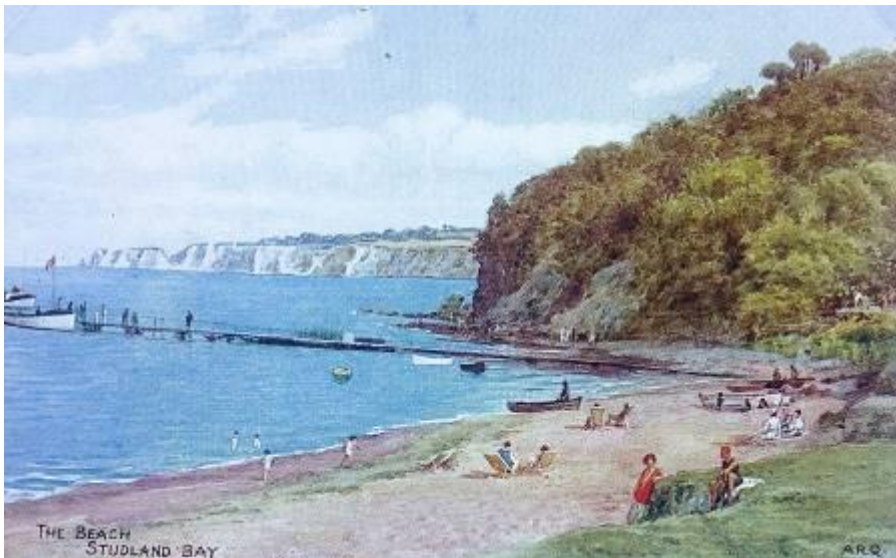
**Figures 2.13 (left):** In this view looking south along Studland Beach by Quinton Handfast Point can be seen in the distance. The beach here has been subject to significant coastal erosion and has necessitated changes in future management by its owner, the National Trust. **Figure 2.14 (below)** shows the view in the 1950s.

At Studland Bay the beautiful beach has been particularly popular with tourists for decades. As sea levels rise and weather patterns become increasingly unpredictable, it is unlikely that sufficient funds will be available to maintain locations such as Studland. Therefore, the National Trust has developed a national plan for coastal change, and a more locally focused adaptation strategy for the future management of the coast at Studland, which involves 'no active intervention'. Comparison of the watercolour drawings dating from the late nineteenth and early twentieth centuries with the present day photographs show how Studland's beach has continued to grow at its northern end near the entrance to Poole Harbour, whilst at the southern end coastal erosion is particularly active (Figure 2.11-2.14). This erosion process will continue and may increase, and inevitably result in the loss of space currently occupied by tourism facilities, such as the National Trust's current visitor at Studland. It has been recognised that the maintenance of such assets is not always practical in the longer term, hence the adoption of the 'no active intervention' strategy.

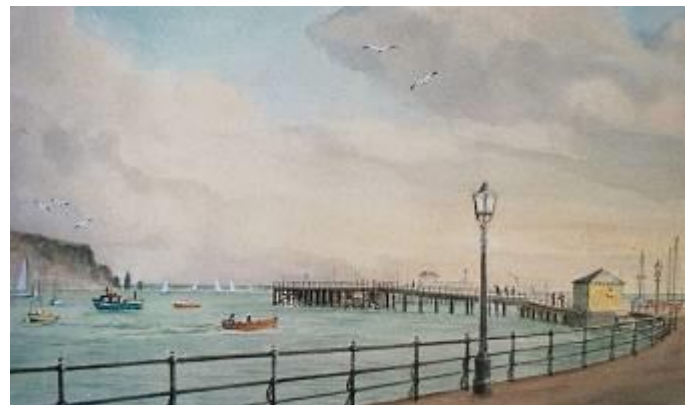
**Figure 3.4:** *'Swanage Pier'* painted in watercolour by David Addey in 1990. Now the award-winning, restored pier (Listed Grade II) forms a focus for water-based recreation.

In Swanage, the present pier, which replaced an earlier structure, required significant investment to maintain its integrity and this was completed recently as an award-winning scheme. Along the coastline to the south of Swanage, between Durlston Head and Anvil Point, two pairs of towers mark the extent of a '*nautical measured mile*'. These towers enabled various ships to be timed over that distance.

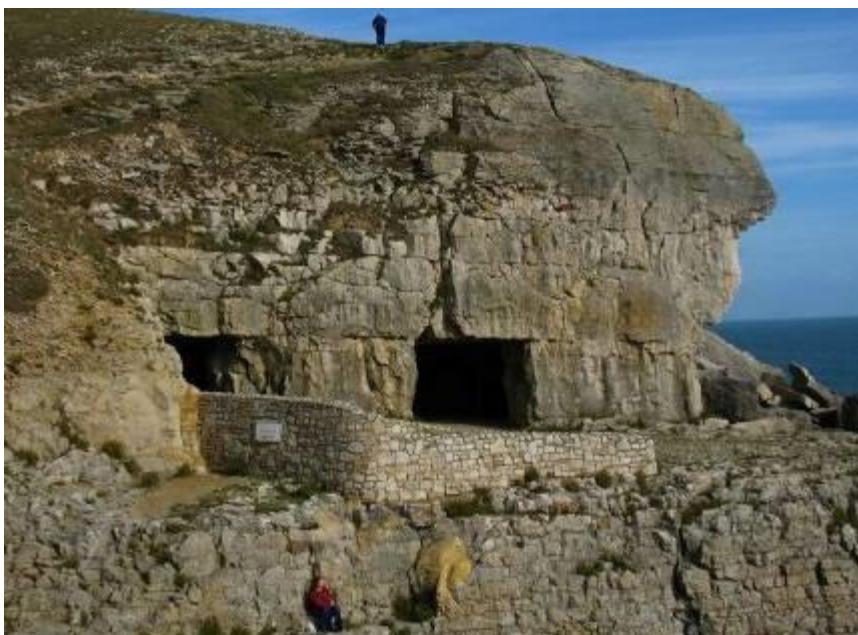
**Figure 3.10:** This present day view of Tilly Whim Caves compares very closely with Quinton's watercolour (above), including details of the jointing in the limestone.

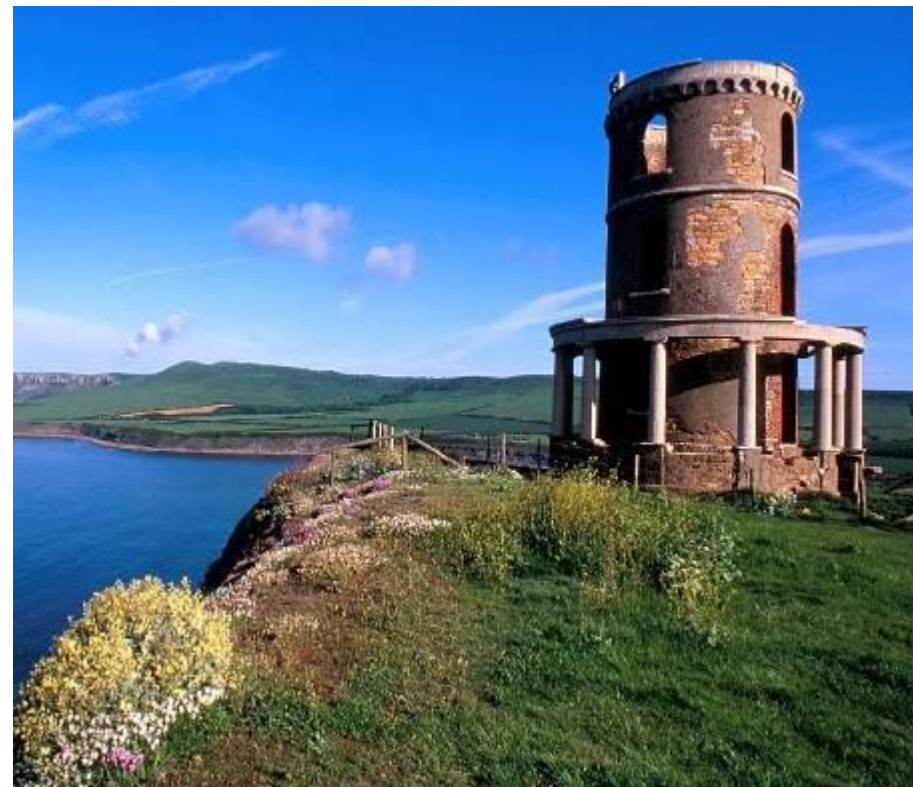
**Figure 5:** Clavell Tower prior to the commencement of its relocation twenty-five metres inland.

Clavell Tower (listed Grade II) was constructed as an observatory and coastal landmark by the Reverend J. Richards in 1830/31 (Figure 4.3). The frontage formed part of the Smedmore estate, which had been owned by the Clavell family since the 1420s. At the end of the nineteenth century, until about 1914, the Tower served as a lookout post for coastguards and was vacated as the structure started to deteriorate (Figure 4.4). Coastal erosion posed an increasing risk to the Tower and, in 2002, with the support and advice from the owner, the Landmark Trust commenced investigations into the possibility of relocating the tower further back from the coastline (Stanford, 2008<sup>3</sup>).

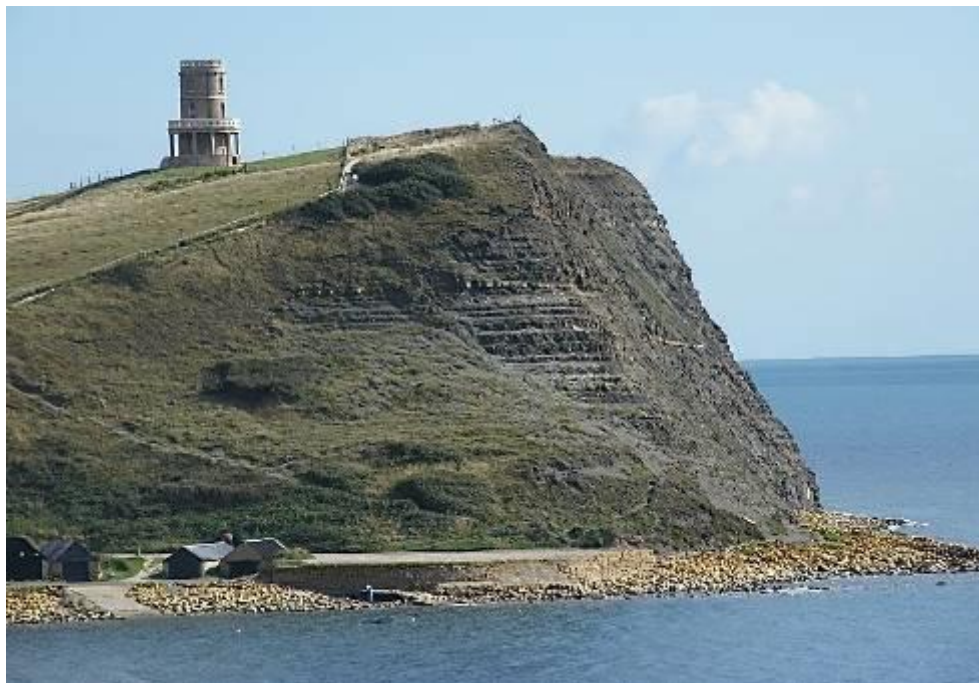
**Figure 4.7:** Clavell Tower following completion of the scheme by The Landmark Trust.

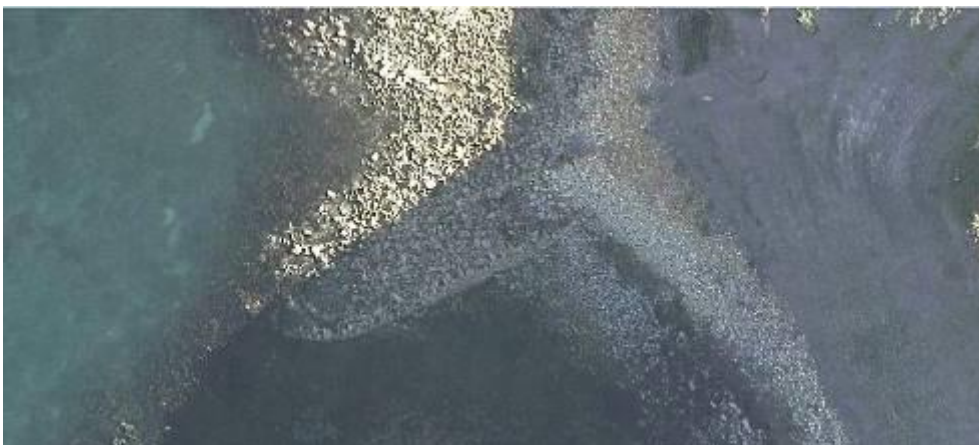
**Figure 4.8:** The remains of the former Quay at Kimmeridge Bay can be seen in this aerial photograph.

which were exposed in the cliff. These industries flourished in the seventeenth century. However, the venture did not prove successful financially, and the location did not lend itself to easy transportation of materials from the site, and these industries ceased (Cornwall County Council, 2014<sup>1</sup>). A small pier was constructed in 1858 to support extraction of bituminous shale for various uses, including fertilisers and oil production, but, again, this did not prove particularly successful. The remains of the quay can be seen in the aerial photograph (Figure 4.8). These features will be gradually lost as a result of sea level rise, erosion and undermining.

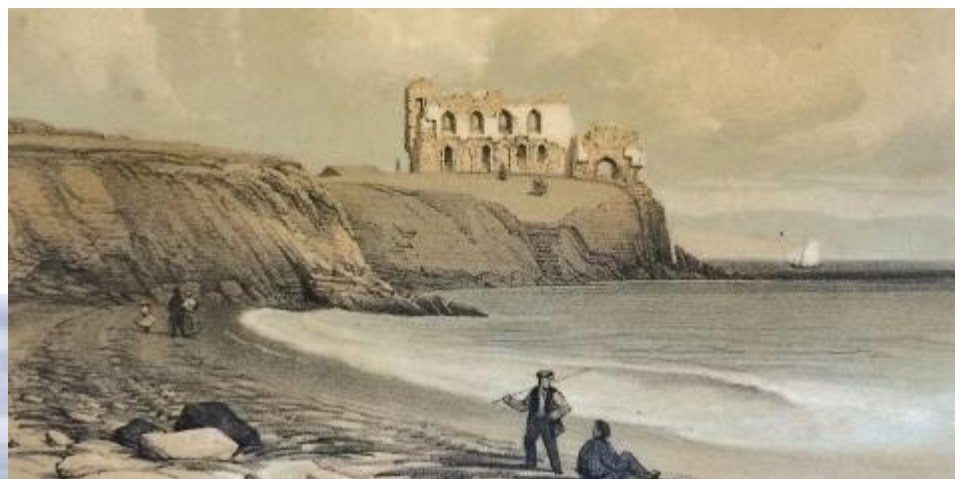
**Figure 6.1 (right):** A view of Sandsfoot Castle, Weymouth, in the 1840s. Lithograph. The seaward face of the Castle can be seen collapsing into the sea as a result of coastal erosion.

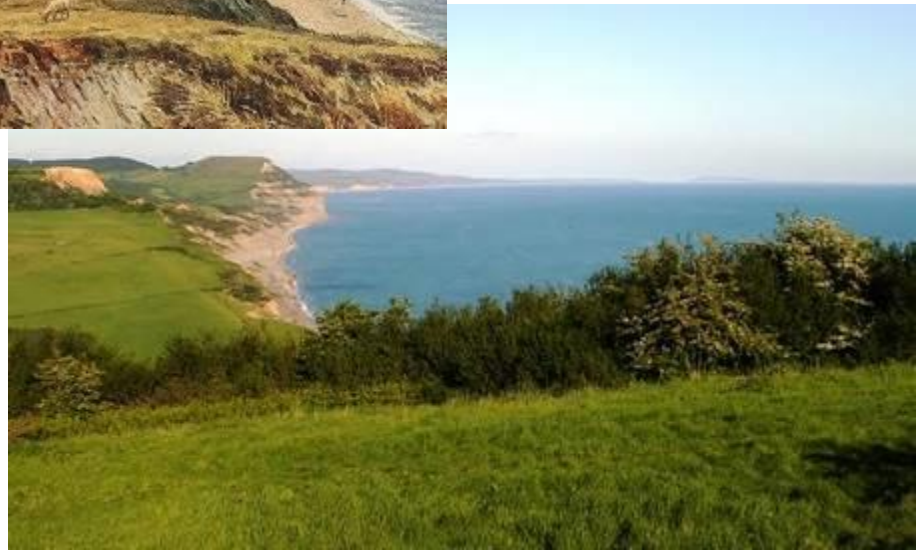
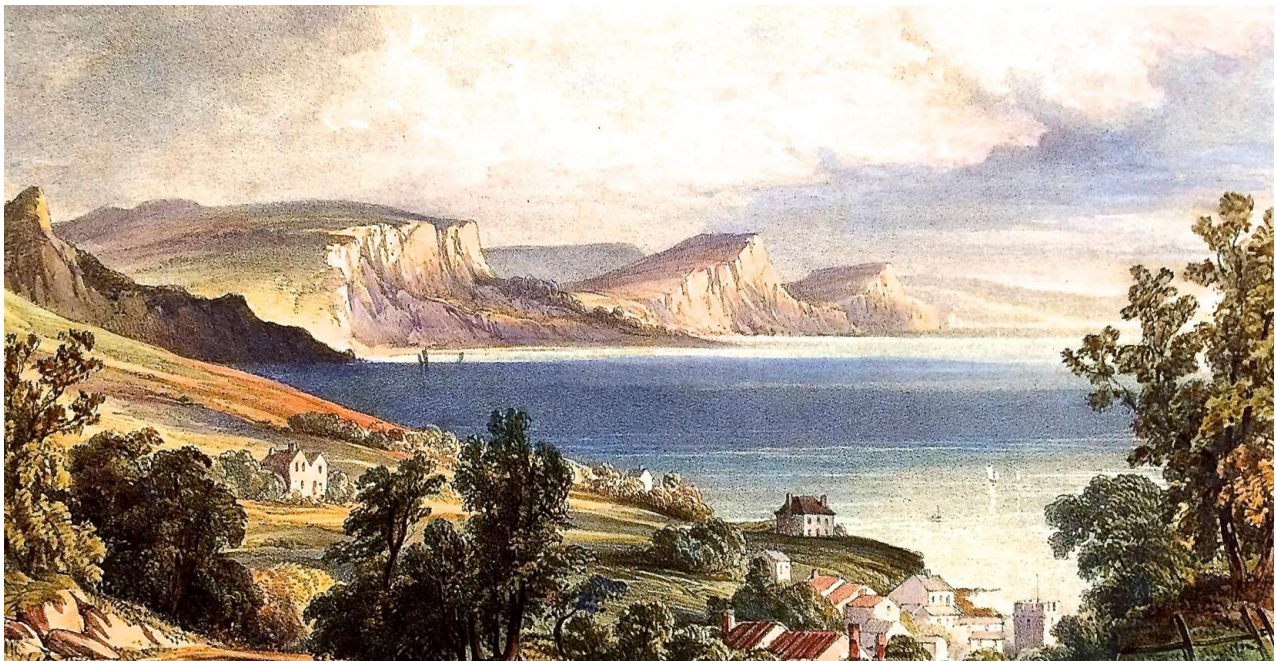
**Figures 7.5 (left) and 7.6 (below):** An extensive view along the cliff top from Charmouth looking eastwards by Alfred Robert Quinton, c.1920. The cliff tops contain numerous buried heritage sites, which are exposed through rapid coastal erosion and landsliding (e.g. Dog House Hill, Chideock MDO7655).

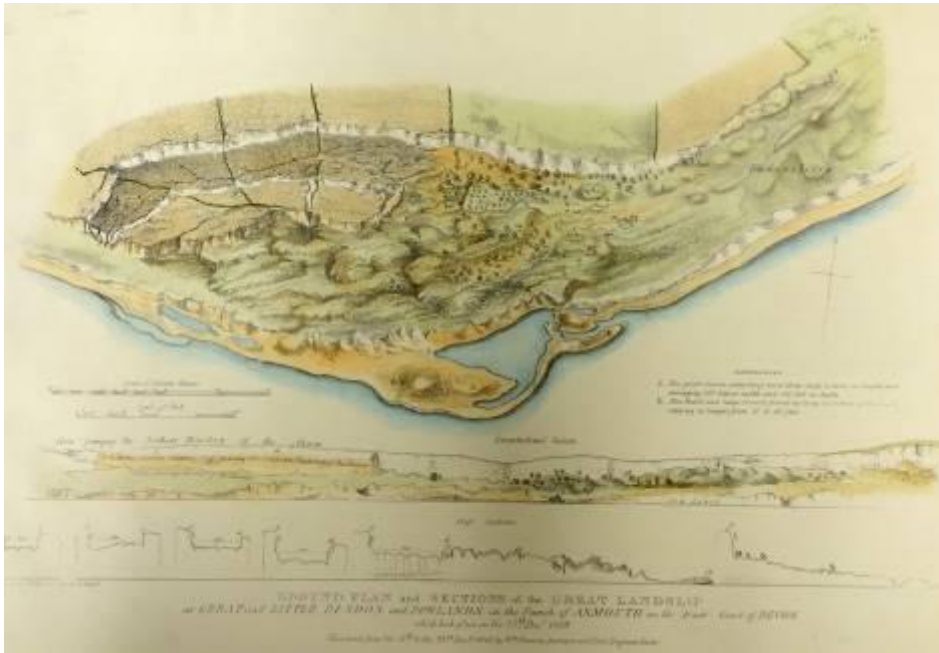
**Figure 7.8:** The coastal geology and geomorphology was mapped and described by the Rev. W. Conybeare and William Dawson in 1840. They provided detailed maps of the landslips, as well as finely lithographed views of the major landslide events.

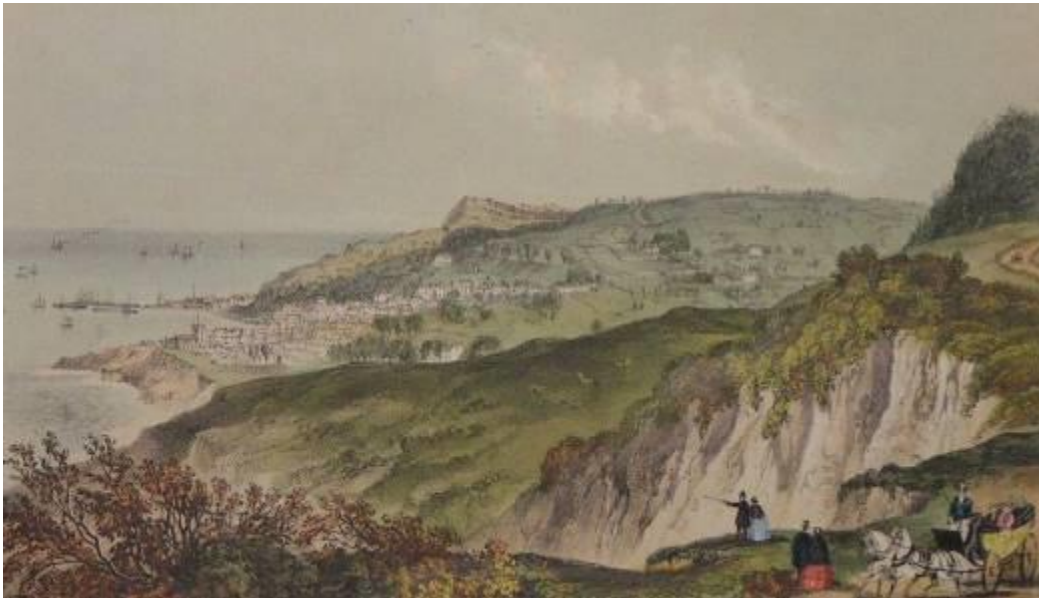
**Figure 7.12:** A mid-nineteenth century view looking over the developing town of Lyme Regis from the east side close to Black Ven. The unstable nature of the coastal cliffs can be seen in the foreground.

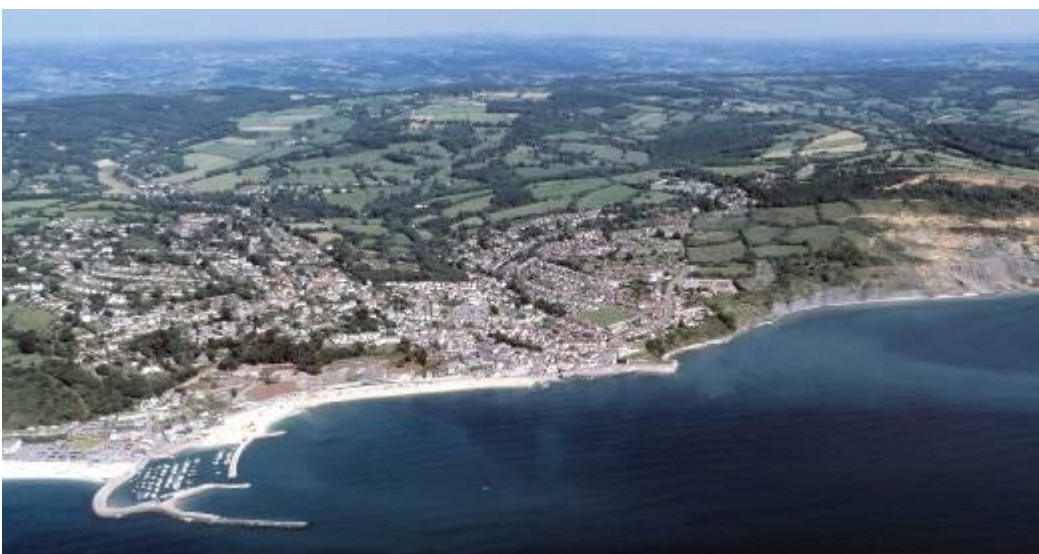
**Figure 7.13:** Lyme Regis has been protected progressively over the last twenty-five years with several phases of major coast protection and landslide stabilisation works. These have included the addition of rock armour at the end of The Cobb and, more recently, further works at the eastern end of the seafront below The Spittles.

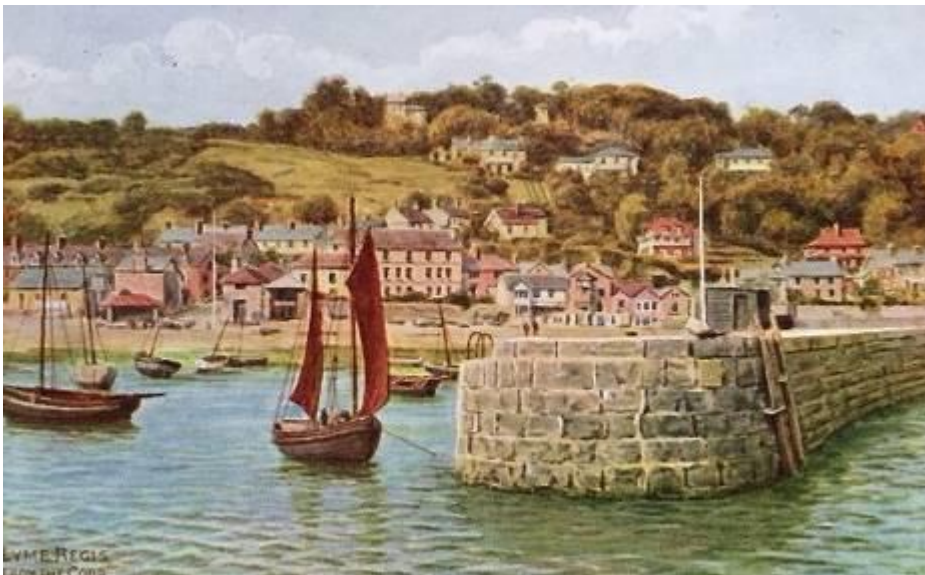
**Figure 7.14:** *'The Cobb, Lyme Regis'*, c.1890 by Charles Robertson RWS. This was one of at least two watercolours that he painted of Lyme. Robertson was a follower of the Pre-Raphaelites and, as a result, his watercolour drawings are both detailed and accurate.

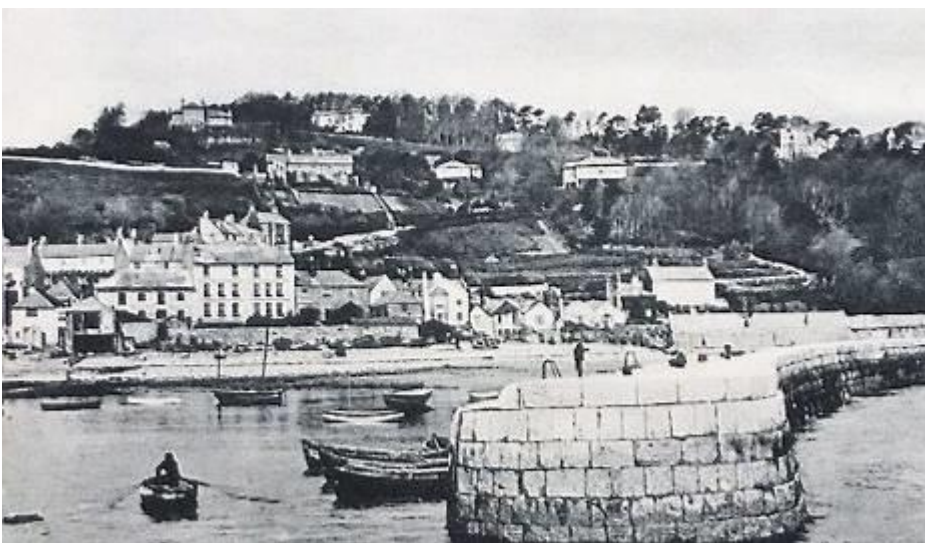
**Figure 7.15:** *'The Cobb, Lyme Regis'* by Alfred Robert Quinton, who painted numerous watercolours of the town and seafront in the 1920s. The quality and detail of Quinton's work is obvious and compares favourably with the black and white photographic postcard published at about the same time (**Figure 7.16 below**).

The advantages of images in colour in terms of describing the coastal architecture and the construction of The Cobb can be readily appreciated.

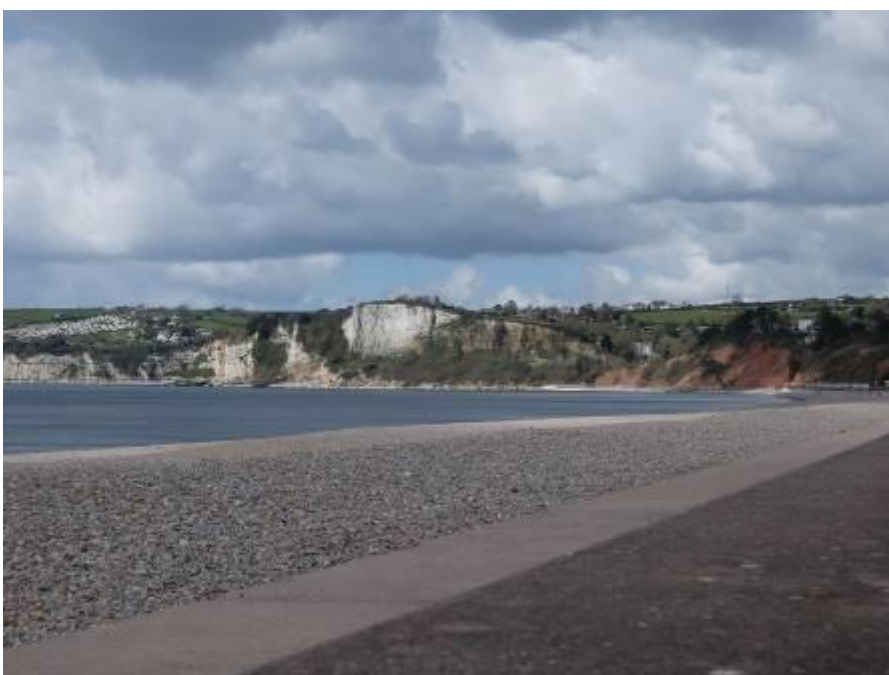
**Figure 8.4:** This photograph shows the headland on the left of Cooke's painting. The cliff tops contain heritage sites which are being lost progressively as a result of coastal erosion.

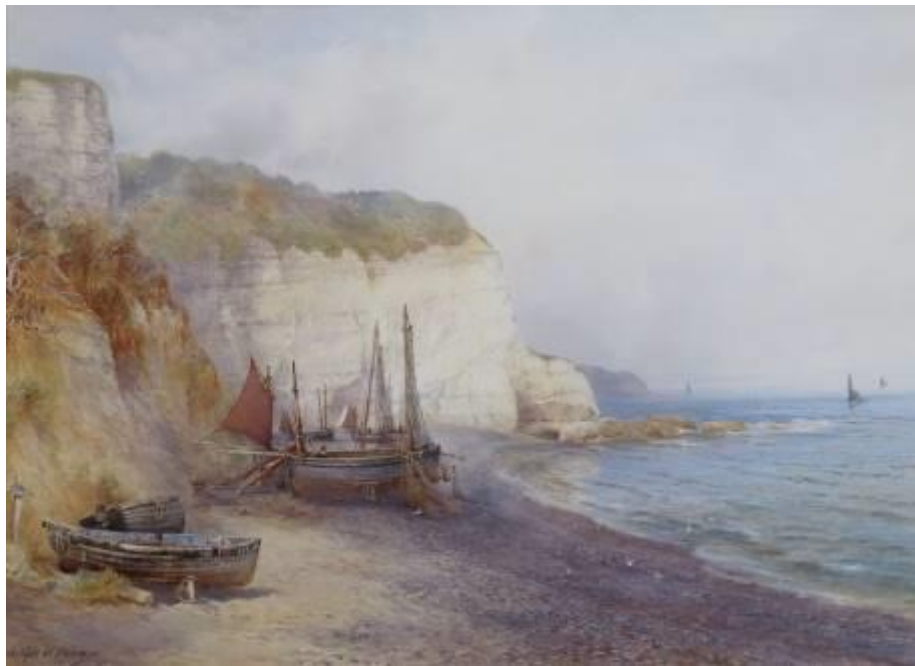
**Figure 8.5:** In this photograph the striking red and white strata, obvious in Cooke's oil painting, can be seen in the centre.

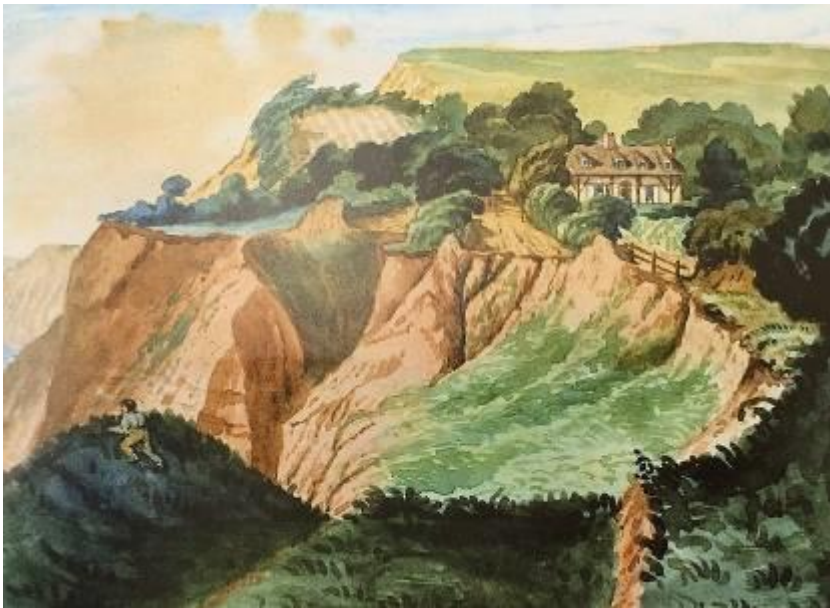
**Figure 9.8:** A failure of the cliff near Peak Cottage, Peak Hill, Sidmouth, on 31<sup>st</sup> August 1847. A watercolour painted on the spot by P. O. Hutchinson.

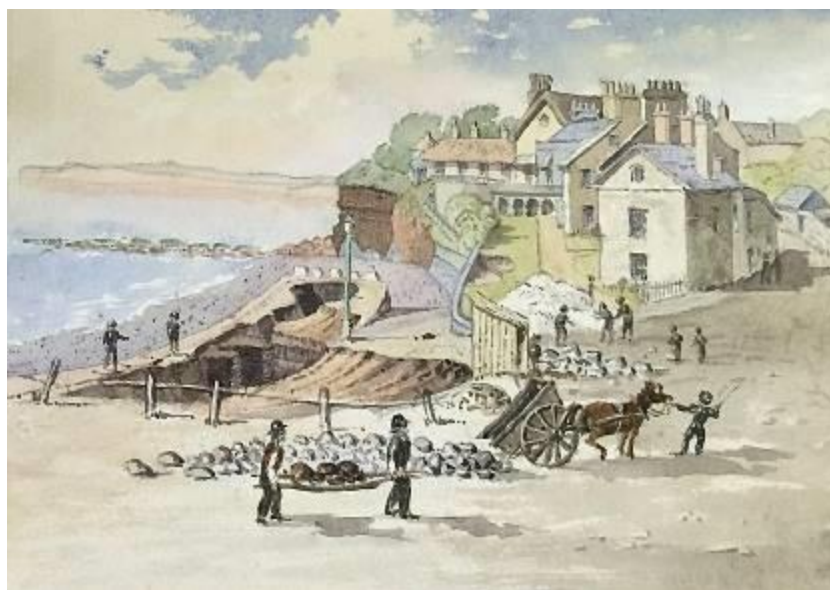
**Figure 9.10:** Sketch by P. O. Hutchinson showing repairing storm damage to the Esplanade near the bottom of Peak Hill, Sidmouth, in January 1873.

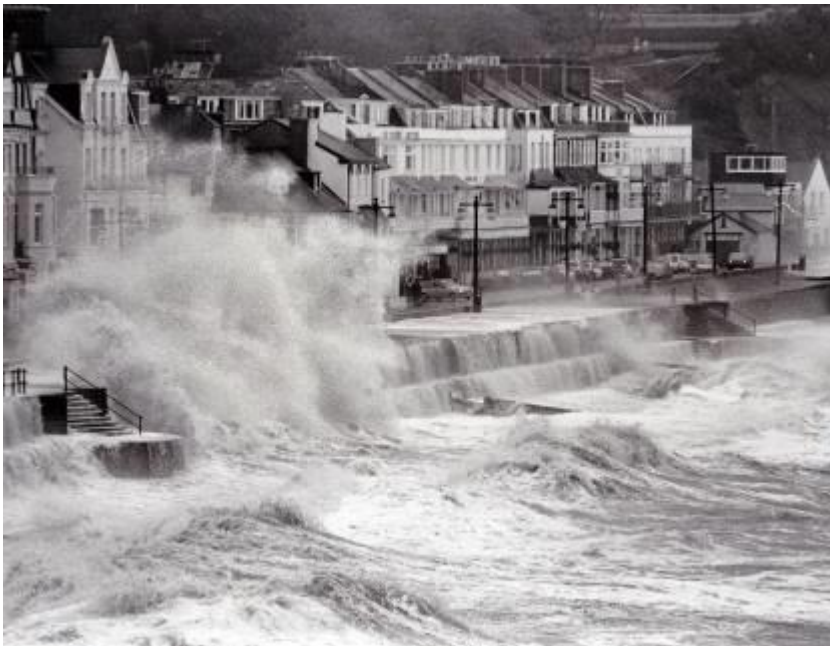
**Figure 9.12:** The exposed position of Sidmouth, facing the Atlantic's south-westerly storm waves, has led to frequent flooding events. Coastal defences have been improved since the 1990s and further upgrading is under consideration.

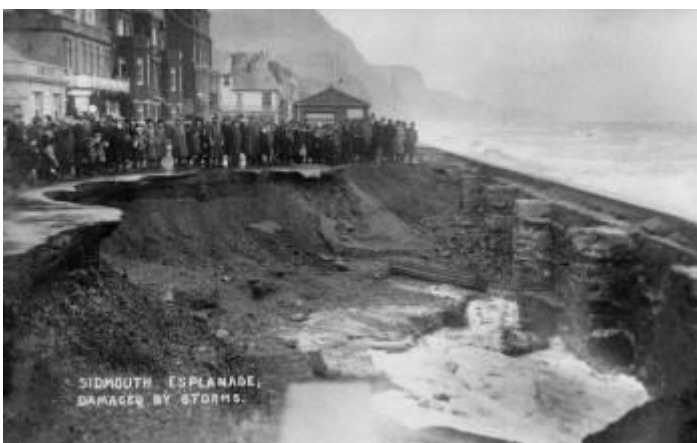
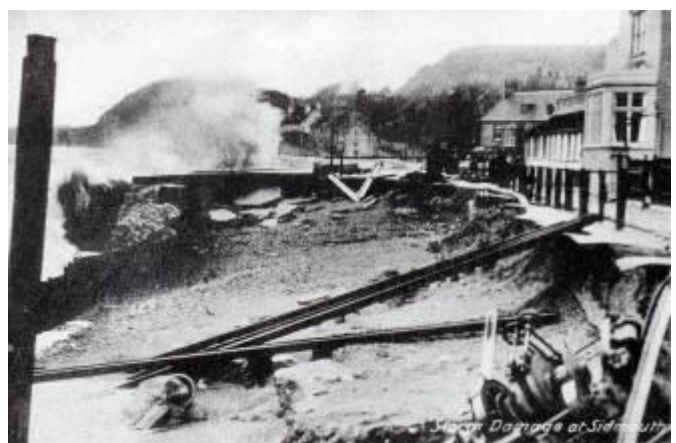
**Figures 9.13 and 9.14 (below):** show the devastation to the Esplanade after a severe storm.

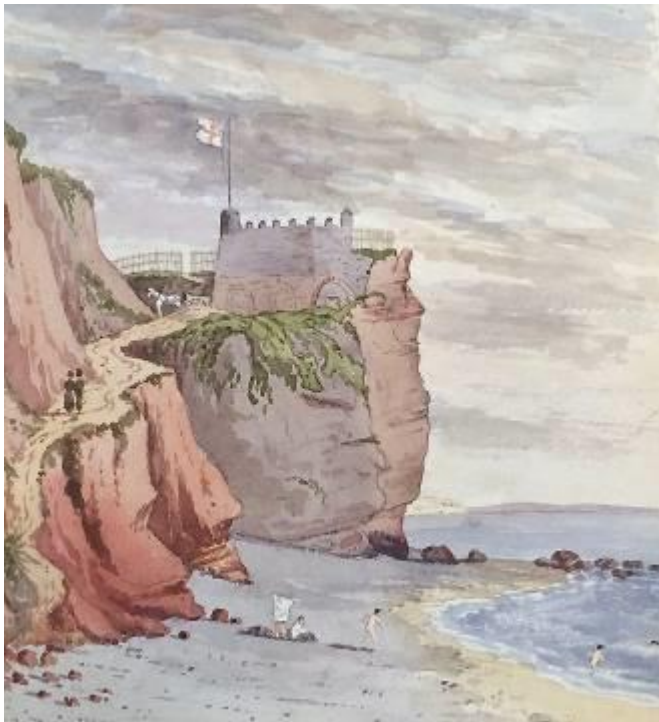
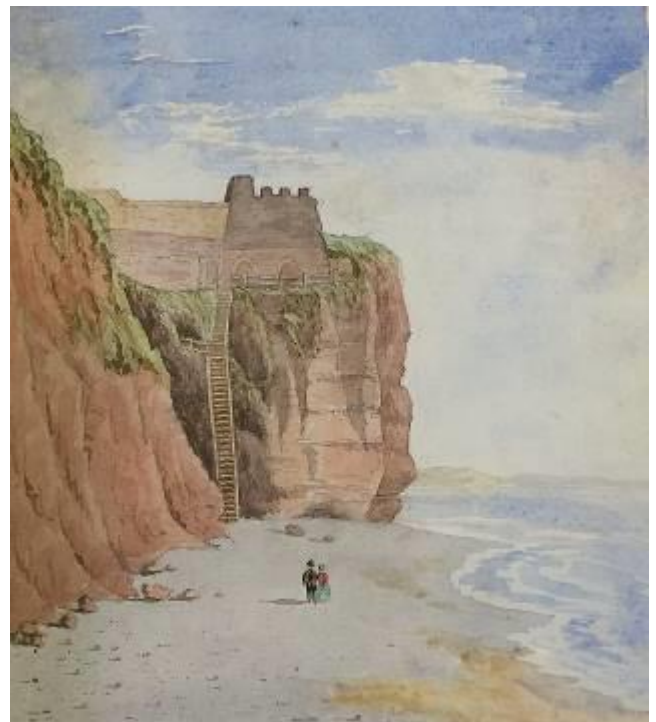
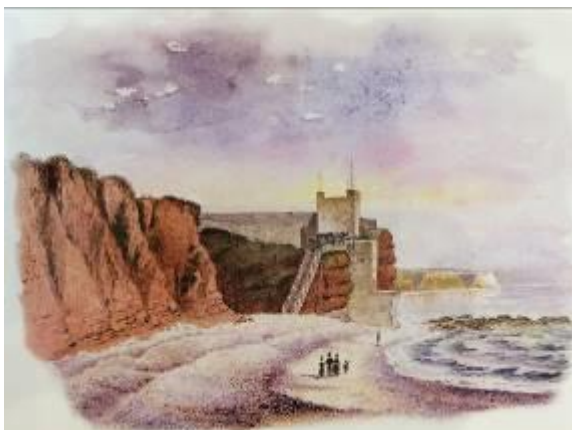
**Figures 9.15, 9.16 and 9.17:** These three views by Hutchinson depict the remains of the old lime kilns near the Chit Rocks at Sidmouth. The earliest view (top left) was painted on 4<sup>th</sup> December 1871 with a ladder providing access to the shore (top right). The view (left) was painted in May 1888 and, by now, the base of the cliff has been protected.
