## 6. South-West Heritage Sites - Case Studies

### 6.1. Identification of heritage sites currently or potentially at risk

## **CHerISH PROJECT CASE STUDIES – COASTAL CHANGE ISSUES AND HERITAGE INTERESTS**

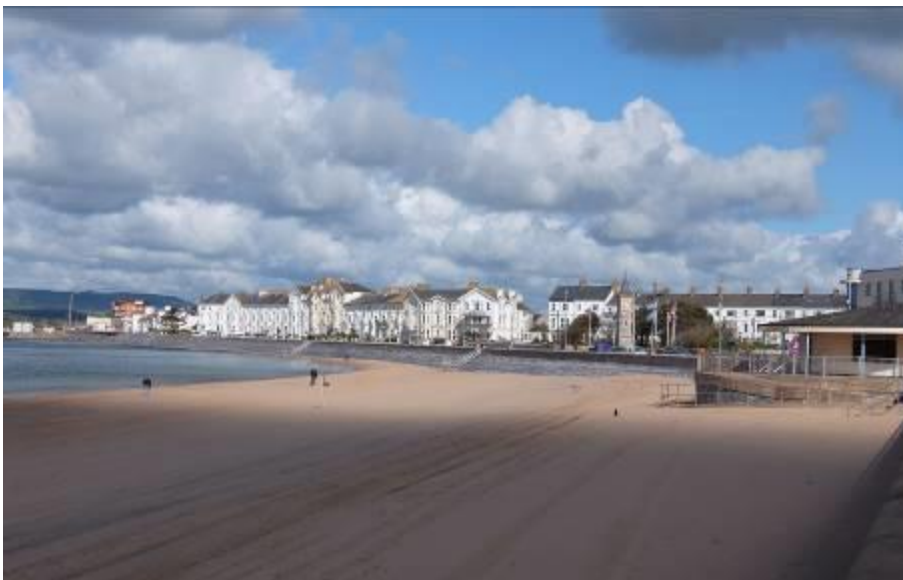
Coastal and flood defences help to protect the town frontage from erosion and flooding (**Figure 10.7 left**). However, the requirements are being reassessed through an erosion and flood risk management strategy. Damage caused during the severe storms of December 2013/January 2014 have highlighted the need for possible further improvements.

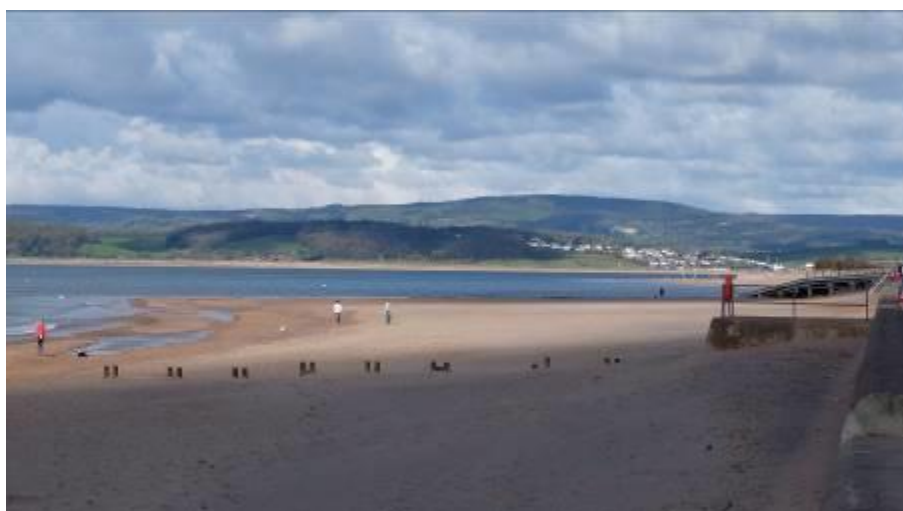
**Figure 10.8:** A view across the estuary mouth showing the extensive beach and Dawlish Warren beyond.

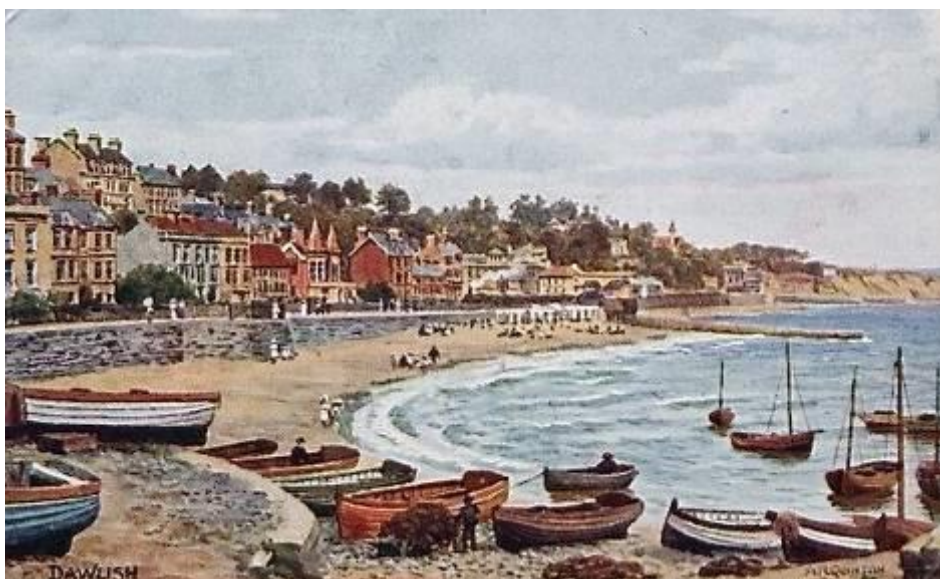
**Figure 11.9:** The seafront at Dawlish by A. R. Quinton painted in about 1920. By this time the railway line and the coastal properties are protected by a stone-faced seawall.

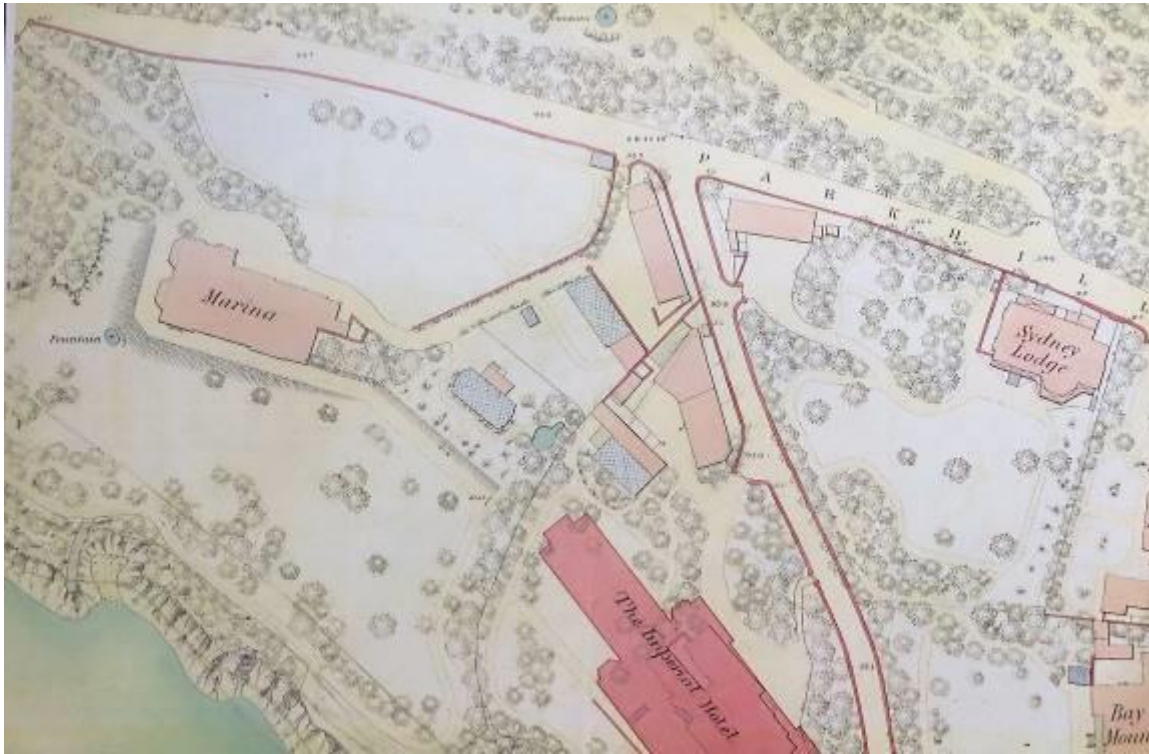
**Figure 12.2 (above):** The Ordnance Survey Map (1860-61) shows the expansion of the Imperial Hotel adjacent to 'The Marine Villa' or 'Marina' which is shown in Daniell's view (Figure 12.1).

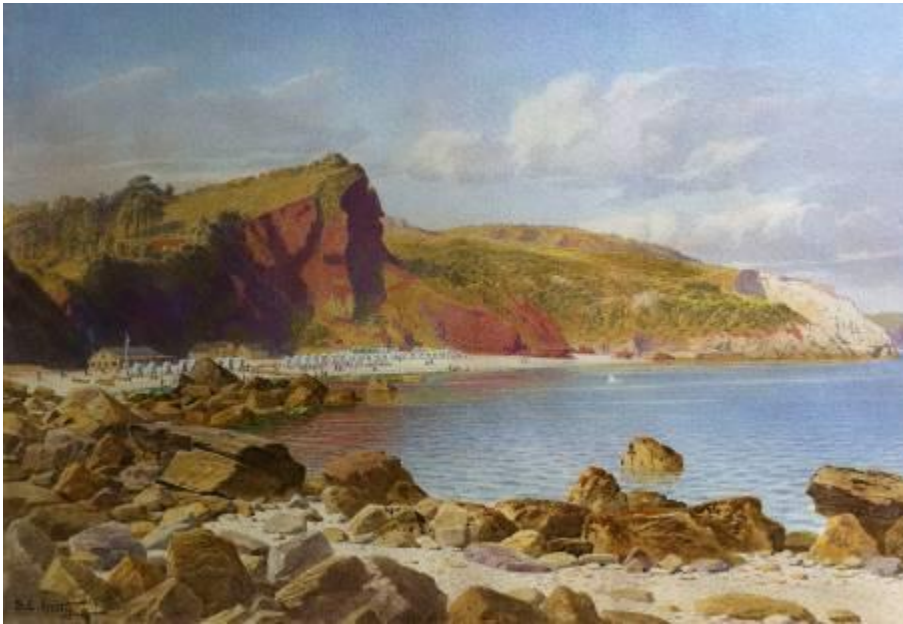
**Figure 12.18:** This detailed watercolour of 'Oddicombe Beach' by Samuel Edward Kelly, c.1910, shows development beneath the precarious red sandstone cliffs. Debris from previous cliff falls litters the shore in the foreground.

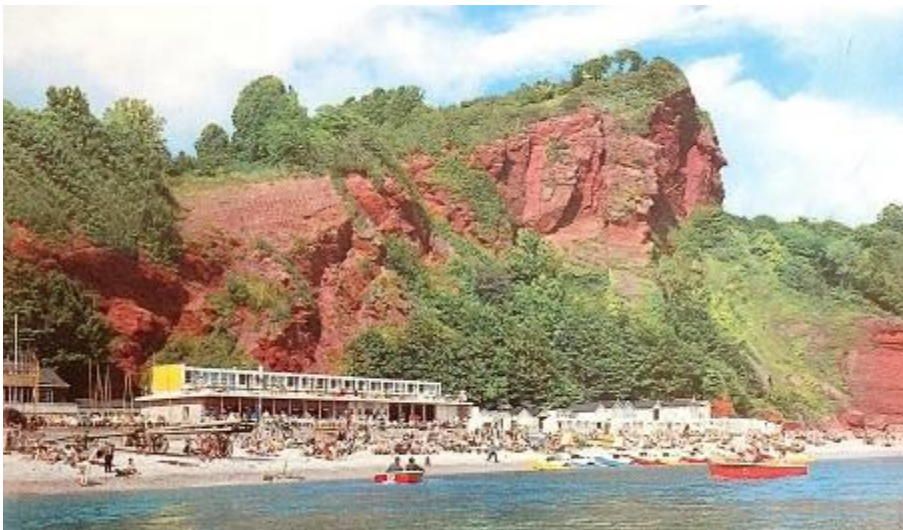
**Figure 12.19:** This postcard shows the beach and the cliff in about 1970. The jointing in the sandstone cliffs is clearly visible and suggests the potential for further cliff falls.

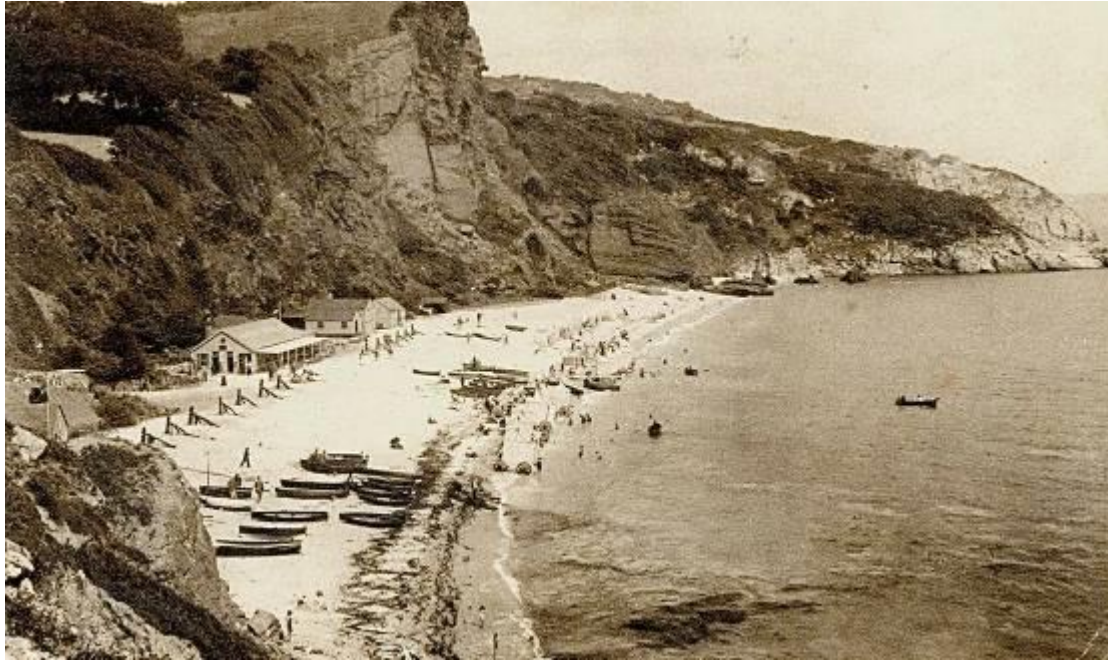
**Figure 12.21:** A photograph of Oddicombe Beach c.1900 looking eastwards. A cliff fall has occurred from the face of the bluff in the centre of the view.

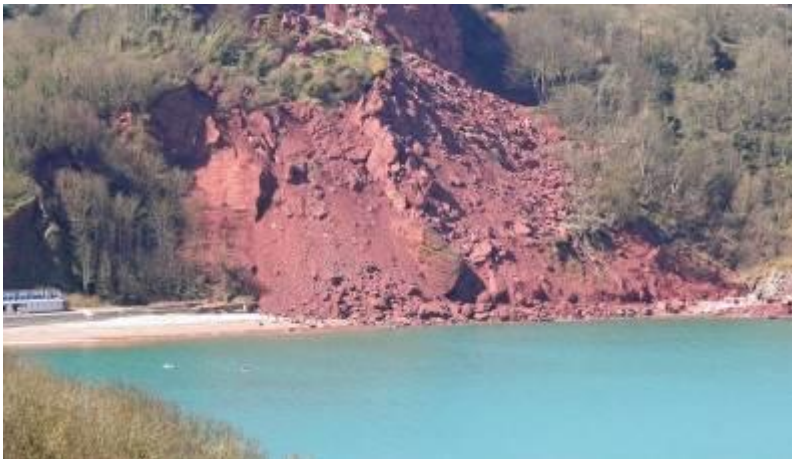
**Figure 12.22:** The massive cliff fall onto Oddicombe Beach on 3<sup>rd</sup> April 2013 at Ridgemont House.

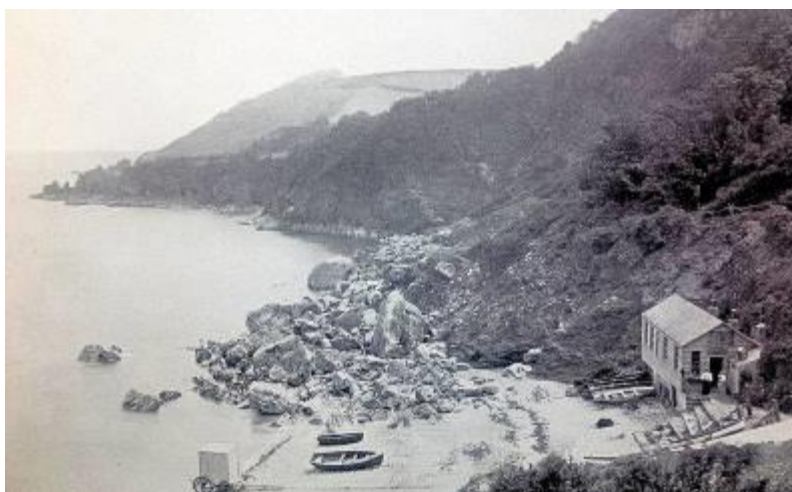
**Figure 12.23:** Another massive rockfall at nearby Anstey's Cove is recorded in this photograph c.1900.

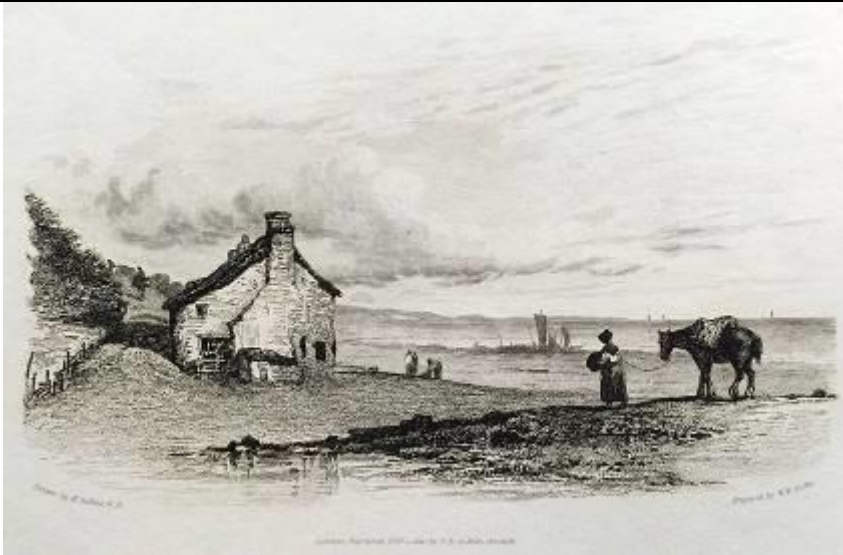
**Figure 13.1:** Lying just to the north of Start Point the fishing community of Hallsands occupied an exposed coastal location. Following dredging for aggregates too close to shore the beach lowered significantly. After a severe storm in 1917 the village was abandoned. This engraving of Hallsands is from an oil painting by William Collins (1846). No other paintings of the village have been found although there are a number of old photographs such as **Figure 13.2 (middle left)**. Where no artworks exist early photographs describe the nature of such relatively unvisited locations although the views are not in colour.

The village of Hallsands to the north of Start Point comprised a small fishing community, which was protected by a sand and shingle beach. In 1897 a major dredging operation took place offshore, leading to a significant reduction in beach levels which allowed the exposed village to be impacted upon directly by high tides and easterly winds. This led to the loss of some properties and, despite the construction of a seawall later, a major storm in 1917 caused further serious damage and the village was abandoned (MDV45491). The coastline to the west near East Prawle is rich in prehistoric archaeological sites and finds, particularly from the Bronze Age. Further evidence of occupation extends through the Roman, Medieval and post-Medieval periods. A signalling station (HER7053), one of a chain along the south coast, was built at Signal House Point in the late eighteenth century and a civilian signal station (HER43349) was established at Prawle Point later. The location had a strategic importance in both World Wars and on into the Cold War period when an RAF airfield and a radar station were established, together with gun emplacements.

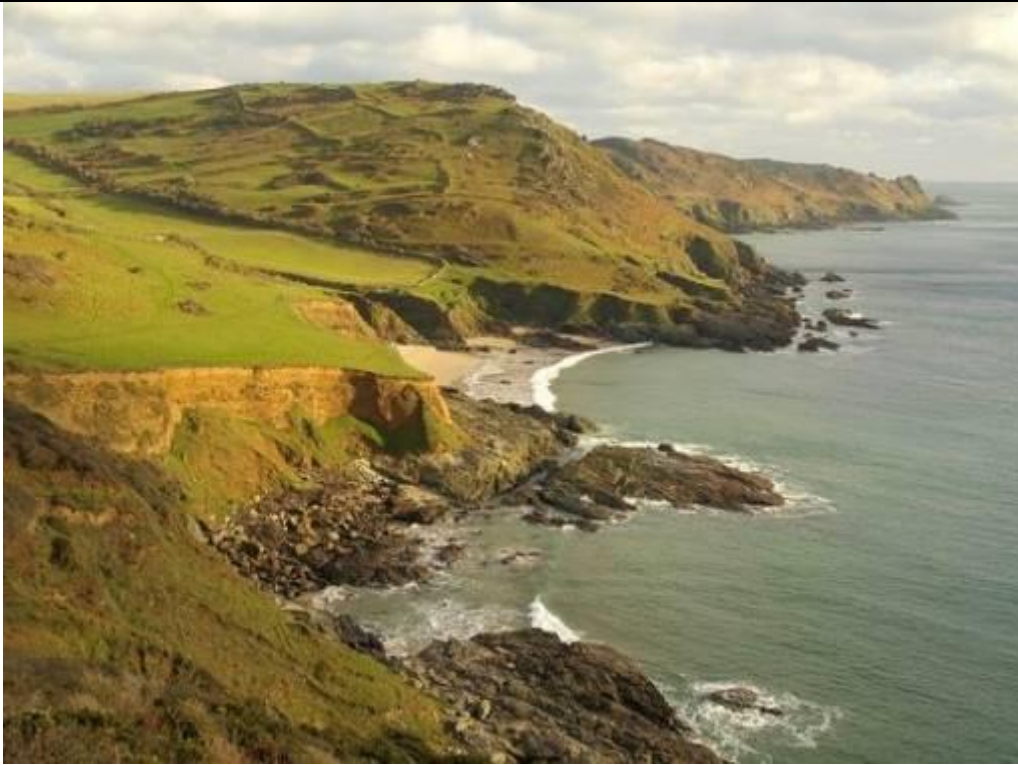
**Figure 13.4:** This recent photograph shows Deckler's Cliff with the ancient field system clearly visible. Although undefended the coastline has changed only slightly since the earlier Frith photograph.

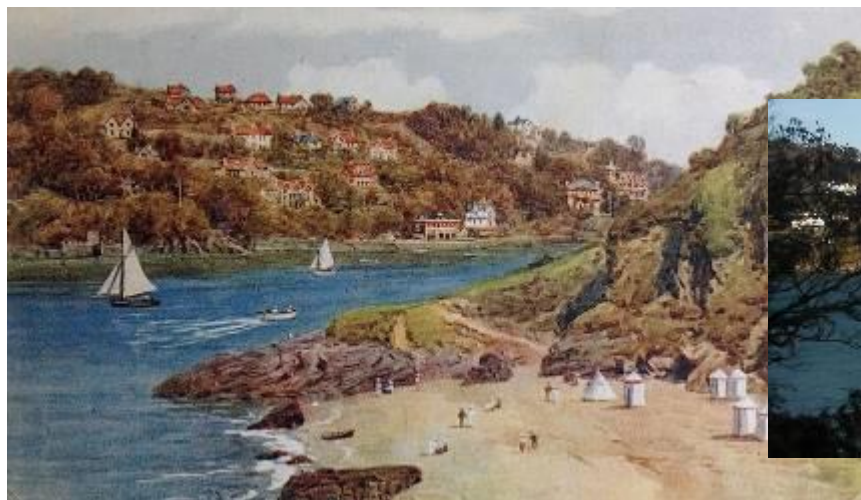
**Figure 13.8:** This view of Salcombe from Sunny Cove by A.R. Quinton shows the typical villa development found on many South Devon estuaries in the early 20th century.

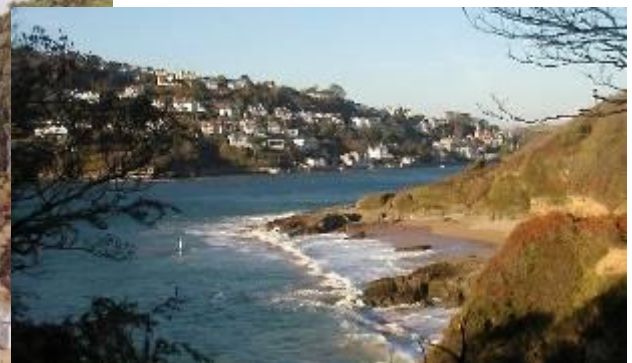
**Figure 13.9 (Right):** shows the location today. Image courtesy of © Chris Hart/Creative Commons License.
