## Case Study Site 15 – Cornish Harbours

## **5. How can historical Imagery inform heritage risk management?**

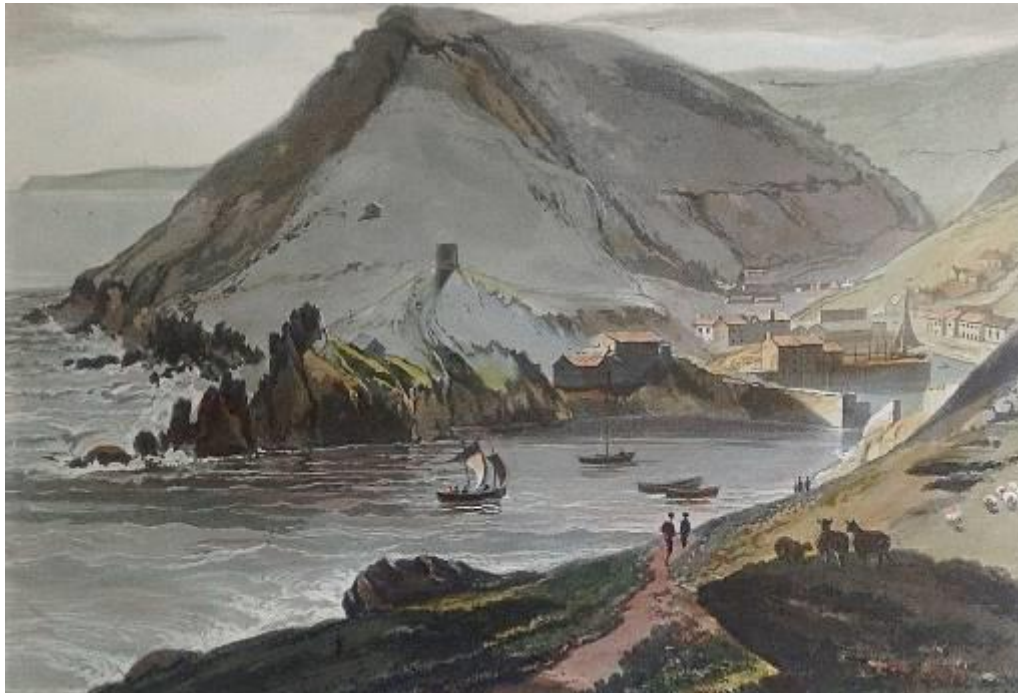
**Figure 15.1 (above):** 'Polperro' by William Daniell RA was engraved in 1825, near the end of his eleven year 'Voyage Round Great Britain'. It compares with the view by David Addey painted in 1988 (**Figure 15.2 below**). Daniell has foreshortened the western side of the entrance to the harbour, and has slightly exaggerated the height of the scenery. Daniell said of Polperro *"the town is very irregularly built; the inhabitants are mostly fishermen, and in the pilchard season, whatever inclination they may have for cleanliness, they cannot be otherwise than dirty. Of course little can be said of the beauty, and nothing of the elegance of Polperro; but the environs abound in picturesque features, though of a humble kind, such as uncouth cottages, so strangely planted amongst the rocks, that they seem to have been dropped there and left to take their chance of a settlement"*. The harbour piers at Polperro were damaged in the late eighteenth and early nineteenth centuries, and nearly destroyed in 1824. A new pier was constructed in 1824 and improved in 1897, due to the growth of the fishing industry. It is possible that Daniell's aquatint engraving was produced as the new pier was being completed. The harbour and pier is listed Grade II. Today the village has become a major tourist attraction and its development is well illustrated in the series of views by Alfred Robert Quinton (below).

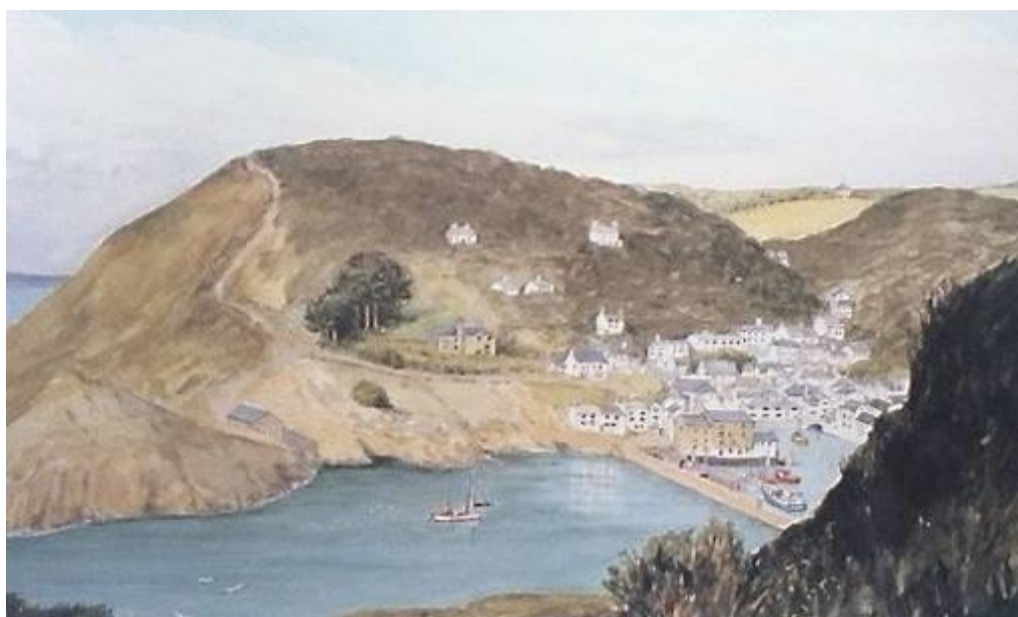
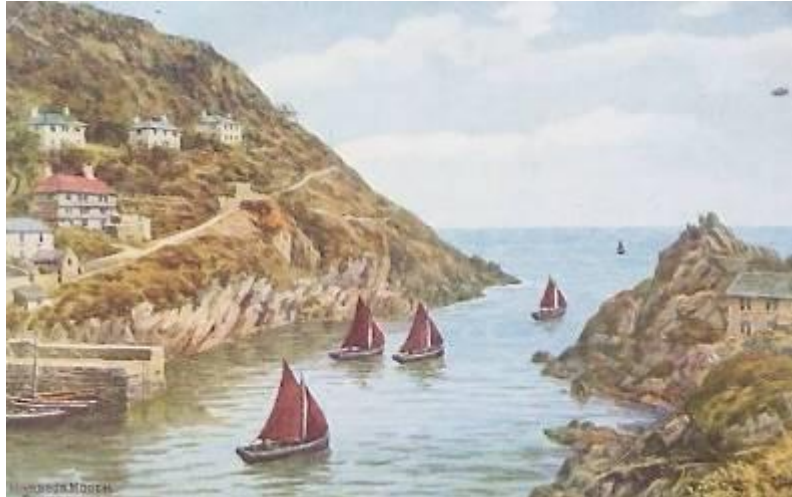
**Figures 15.3 (above) and 15.4 (middle)** show two views of the entrance to the harbour at Polperro taken from the same spot. Figure 3 is a watercolour by Alfred Robert Quinton, painted in about 1920, and, for comparison, a photographic postcard (c.1930) shows an almost identical scene to that painted by Quinton, who was quite meticulous in his detail.

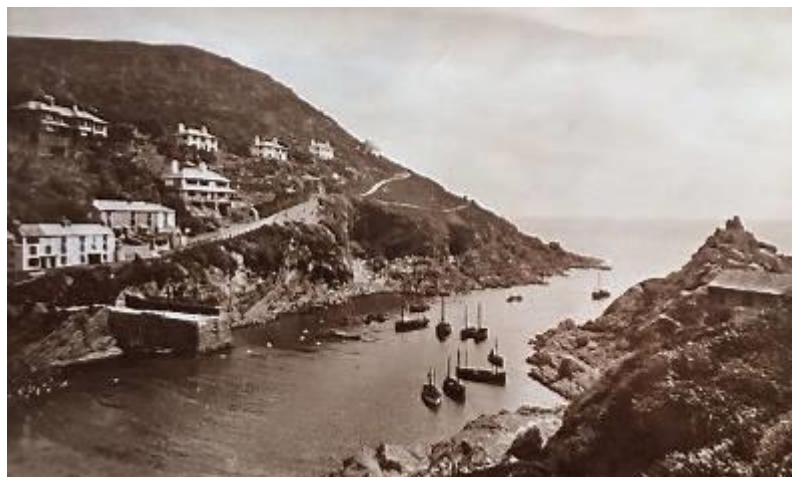
**Figure 15.5 (bottom)** shows the overall situation of Polperro and the adjacent open coast painted in 1920.

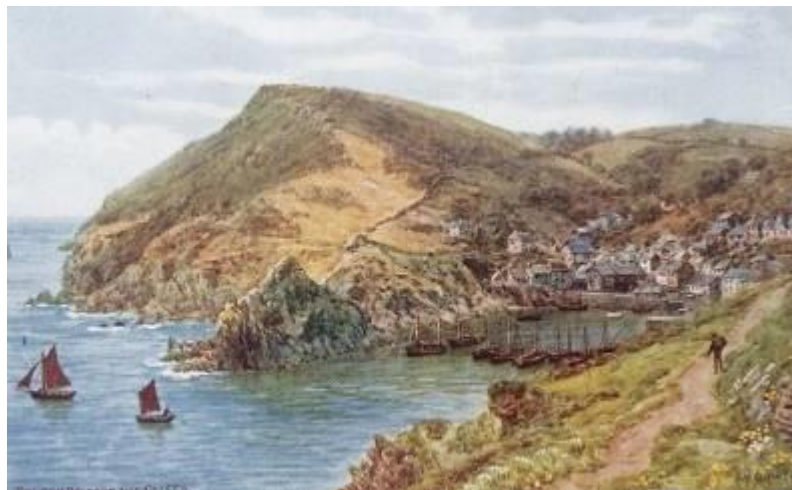
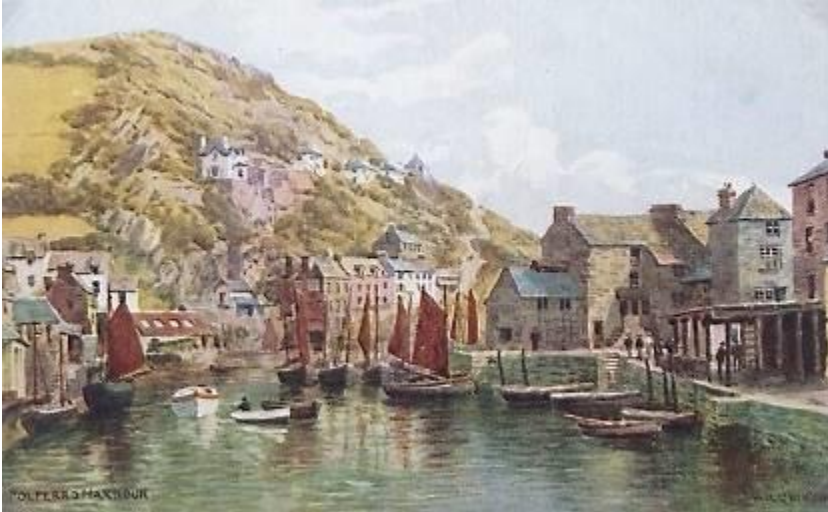
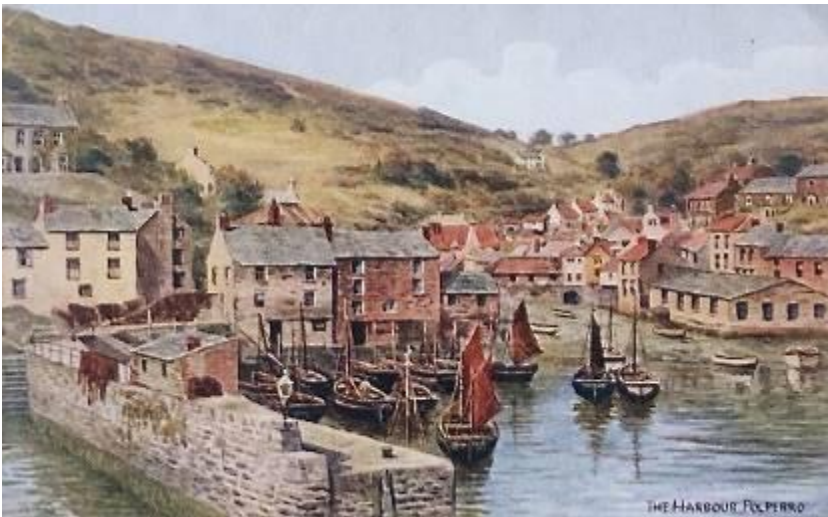
Figures 15.6-15.8 (left) are a series of views, again, by Alfred Robert Quinton, which show the interior of the harbour, together with the harbour arm, painted in about 1915.

Figure 15.8 (bottom) shows the overall setting of Polperro, looking from behind the village, out towards the sea. Quinton's work allows us to examine the nature of the harbourside buildings and the structure of the harbour wall itself. This can be compared with the works of other artists who often painted from the same location.

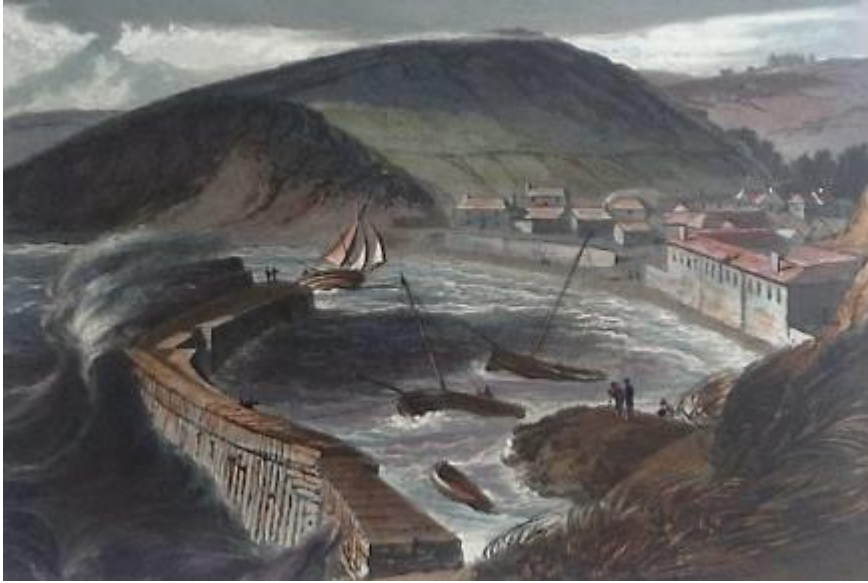
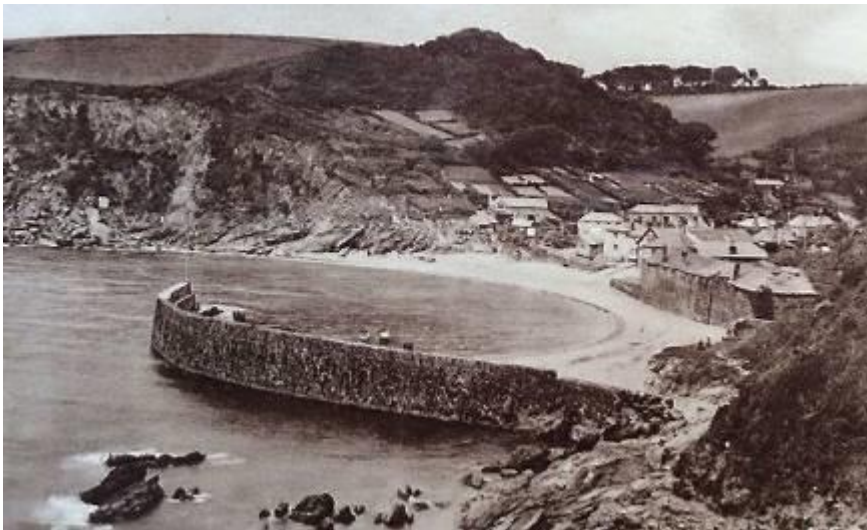
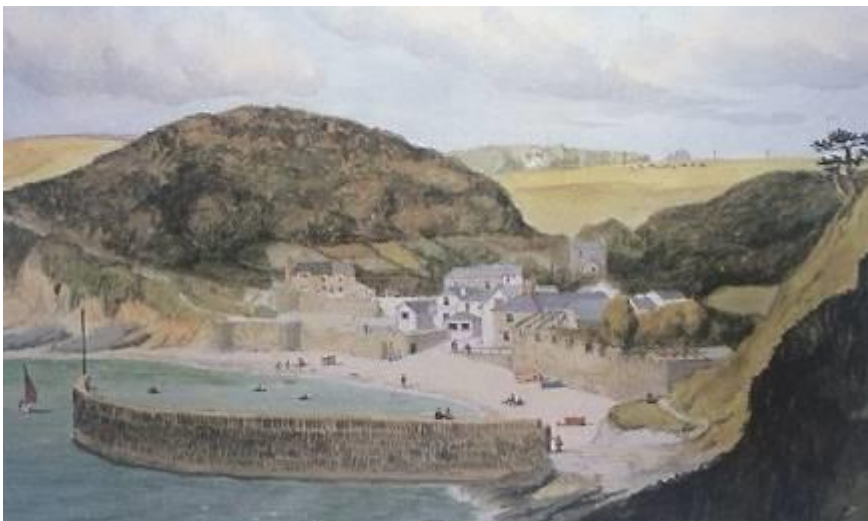
**Figures 15.9-15.11 (left)** show views of the picturesque harbour of Polkerris. The quay here was built in about 1740 to support the pilchard industry at this location. The quay was built of slate and was described by Daniell in the following way: *"the village of Polkerris, with its pier, presented an inviting subject for the pencil. The inhabitants were employed in the pilchard industry. The precipitous bank seen in the view is much worn by the sea and the pier is much exposed to the violence of the westerly winds. In tempestuous weather the waves beat over it so complete as to form an arch, and on these occasions it often happens that the portion of the structure is washed away"*.

**Figure 15.10 (centre)** shows a view of Polkerris harbour in about 1920. The buildings on the right appear quite similar to those associated with the pilchard industry that are shown in Daniell's view on the edge of the shore. However, the harbour arm has deteriorated perhaps through coastal erosion at its landward end. **Figure 15.11 (bottom)** shows David Addey's view (1988) with further retreat of the cliff on the right leaving the remains of the harbour arm separated from the shore.

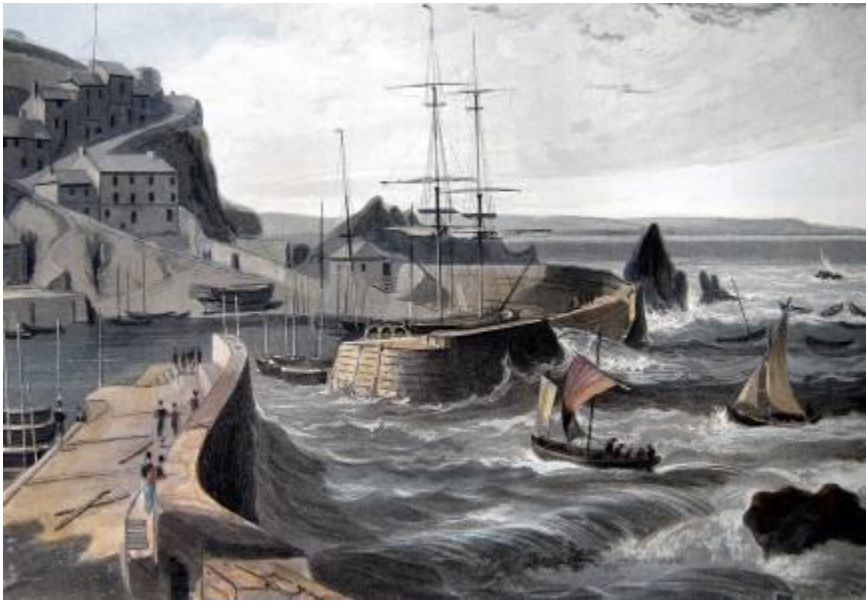
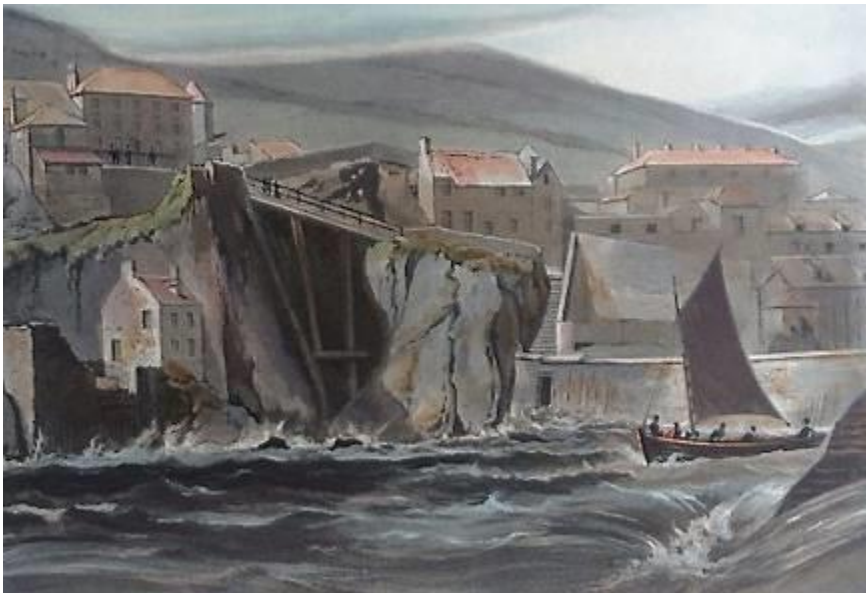
Figures 15.12 and 15.13 show two views of Mevagissey Harbour by William Daniell, engraved in 1825. The nature of the harbour construction is clearly depicted in **Figure 15.12 (top)** and the conditions of the water appear rough outside and more tranquil inside the harbour. In David Addey's 1988 view (**bottom**) he observed that the two main piers are basically unchanged, although a building of pleasing architectural design, had been added to the nearer pier on the left. The rounded end of the main harbour arm, as depicted by Daniell, has been squared off in Addey's view.

It is believed that Mevagissey Harbour dates from as early as the fifteenth century, although, in 1775, a new pier was built enclosing the present day inner harbour, and additional wharfs and jetties were constructed in the late eighteenth century.

The harbour was enlarged in the 1880s with two outer enclosing breakwaters. These were destroyed in the Great Blizzard of 1891, necessitating the harbour to be rebuilt in 1897 (HER, Cornwall County Council, 2012).

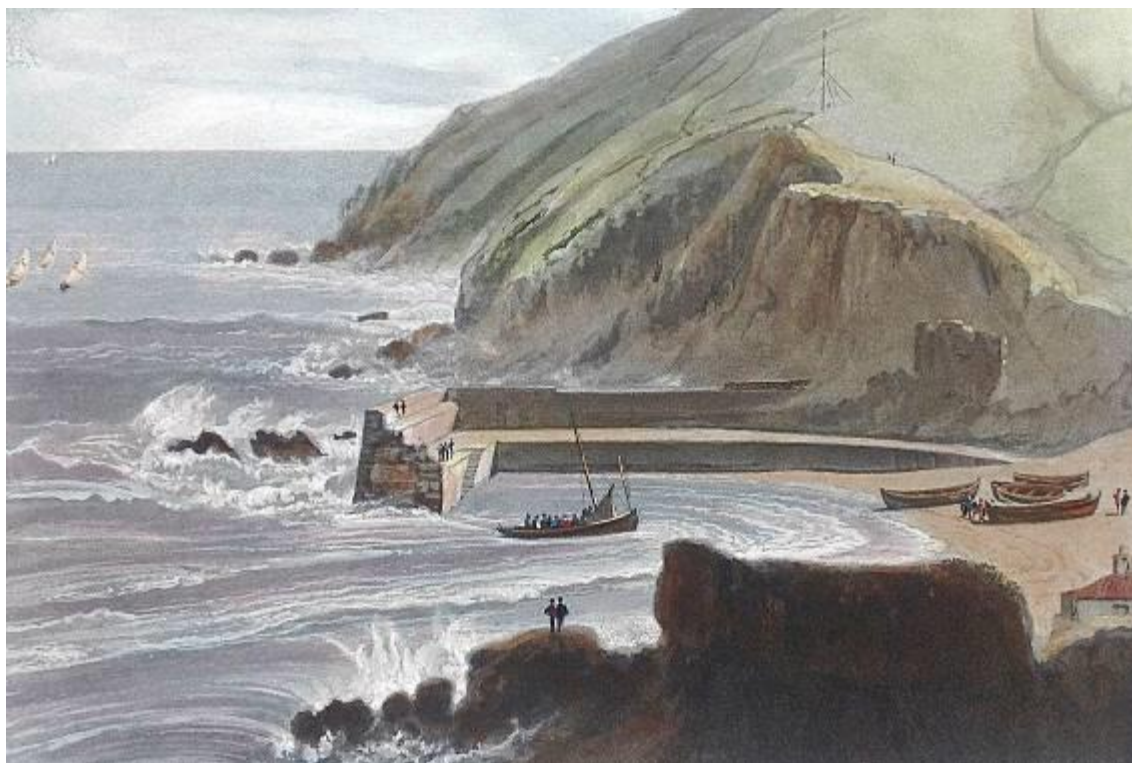
**Figure 15.15 (above)** shows Daniell's view of Gorran Haven, a quay which has existed since Medieval times. Daniell's 1825 engraving of the harbour arm appears very similar in design to that depicted by David Addey in 1988. Daniell noted *"at Gorran Haven there is a little pier for the shelter of the pilchard boats. The rocks here and in the neighbourhood are of a bold and picturesque aspect. On the high ground there is a signal post for the preventive service"*. David Addey noted that, for his watercolour, *"the view has remained almost unchanged since Daniell's visit on the same day 167 years earlier"*.

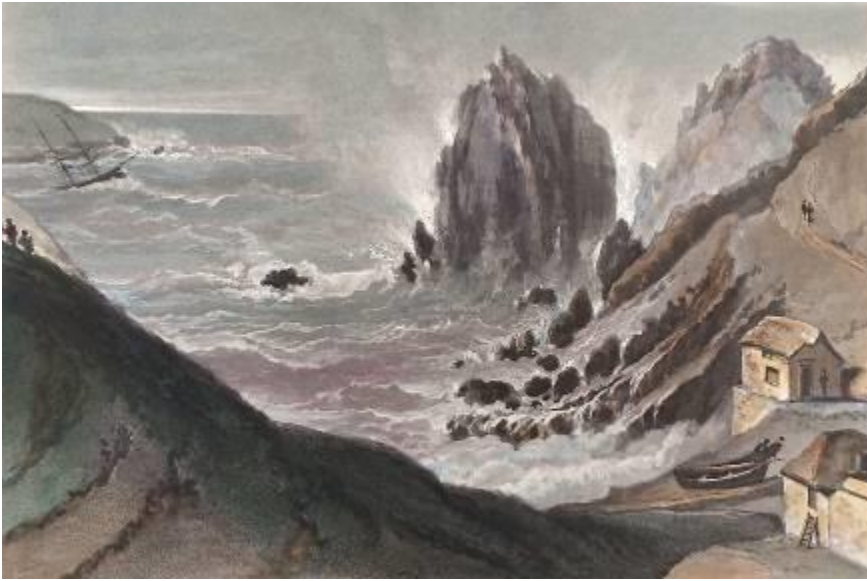
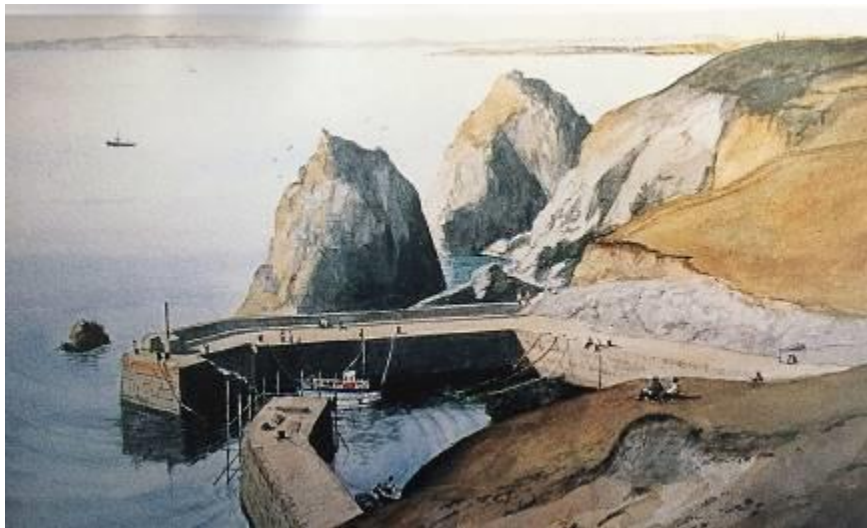
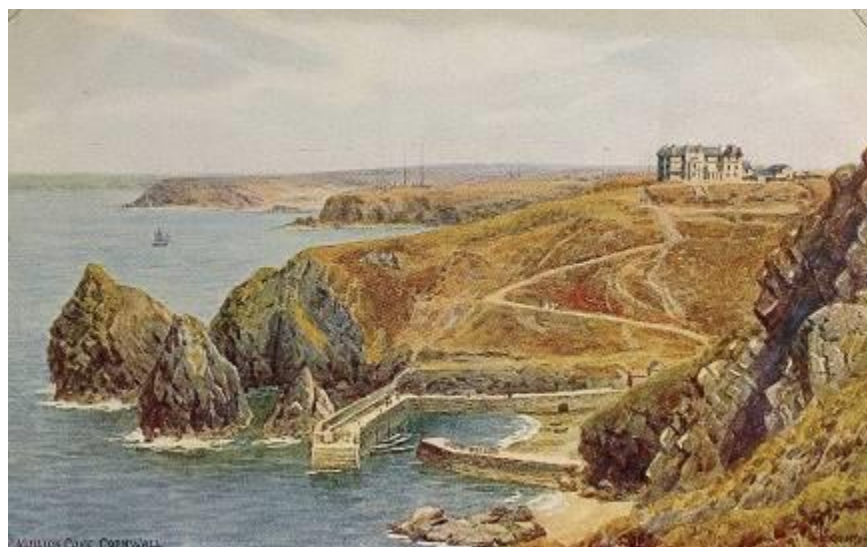
**Figures 15.17-15.19** show the dramatic physical location of Mullion Harbour. At the time Daniell visited the location a harbour did not exist, and he says *"the scenery around Mullion Harbour is rocky and as wild as possible. In heavy gales from the south-west the cave affords safe shelter for small vessels, whilst the Gull Rock protects them from the sudden and dangerous influence of the ground swell"*. **Figure 15.18 (middle)** shows a fine depiction of Mullion Harbour in 1988 by David Addey. The harbour appears to be in good condition at this time. **Figure 15.19 (bottom)** shows the harbour depicted from further uphill by Alfred Robert Quinton in about 1920. Quinton's view provides a panorama along this part of the south-west coast; in the distance the masts of Poldhu can be seen on the headland.

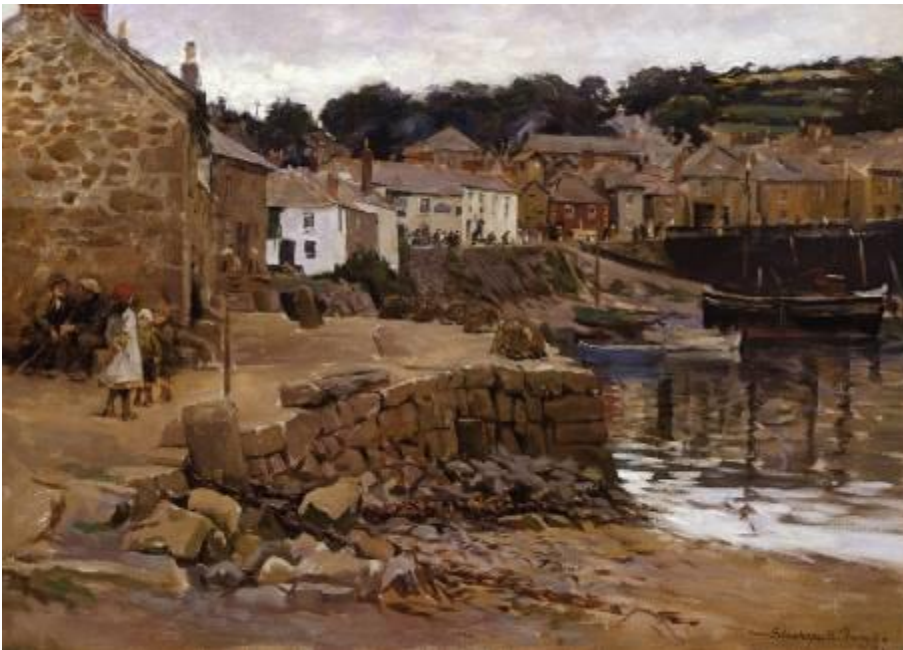
**Figures 15.23-15.25** show three further views of Mousehole. **Figure 15.23 (top)** shows a view of the interior of the harbour by Stanhope Forbes, an oil painting that he completed in 1919. He shows the nature of the cottages clustered around the edge of the harbour, and the apparent state of the interior harbour walls at that time.

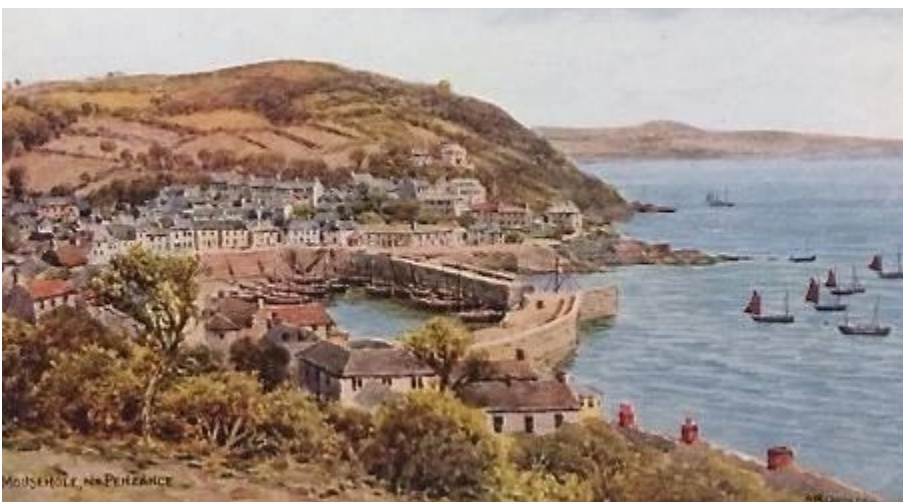
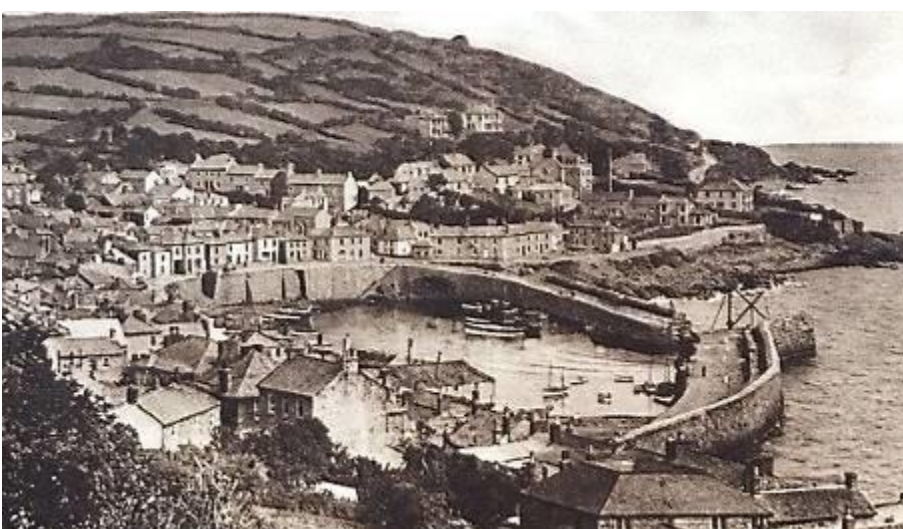
**Figure 15.24 (middle) and 15.25 (bottom)** show two views taken from almost the same spot; the first by the artist, Alfred Robert Quinton, in about 1920 and, below, a photograph also looking down into the harbour. There is a remarkable similarity between all aspects of the artwork and the photograph confirming Quinton's eye for detail.

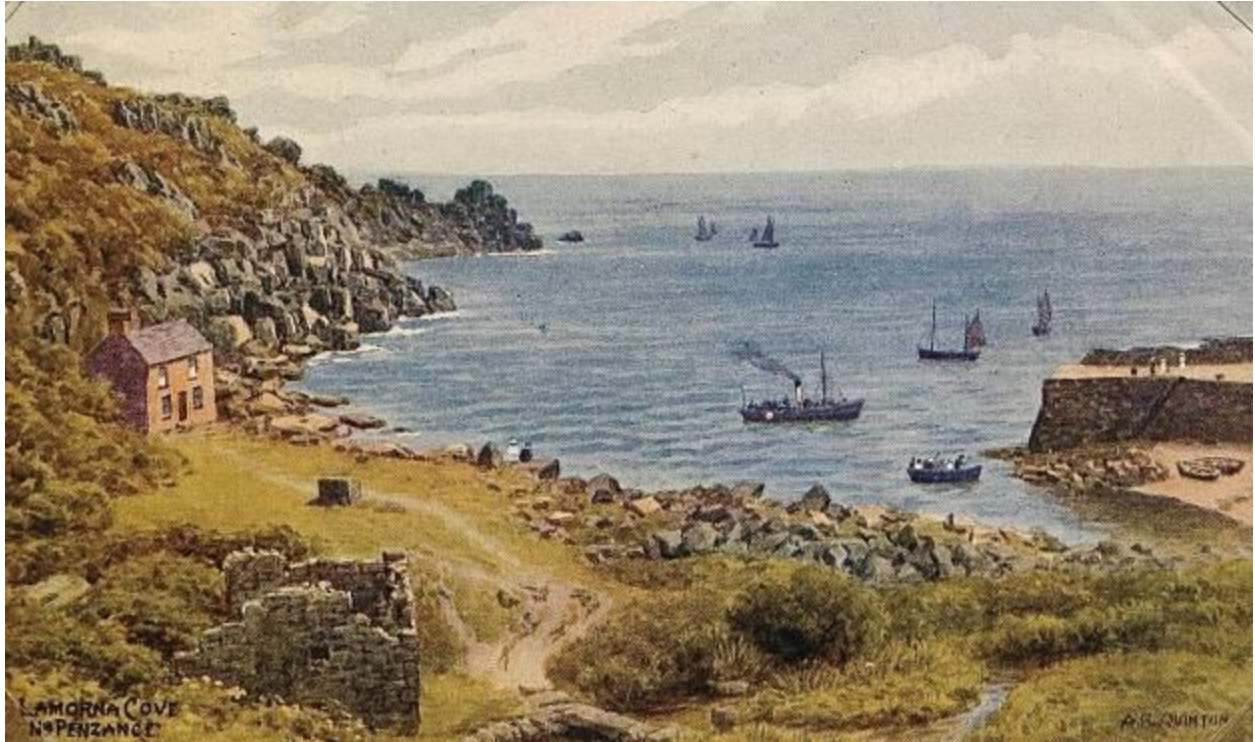
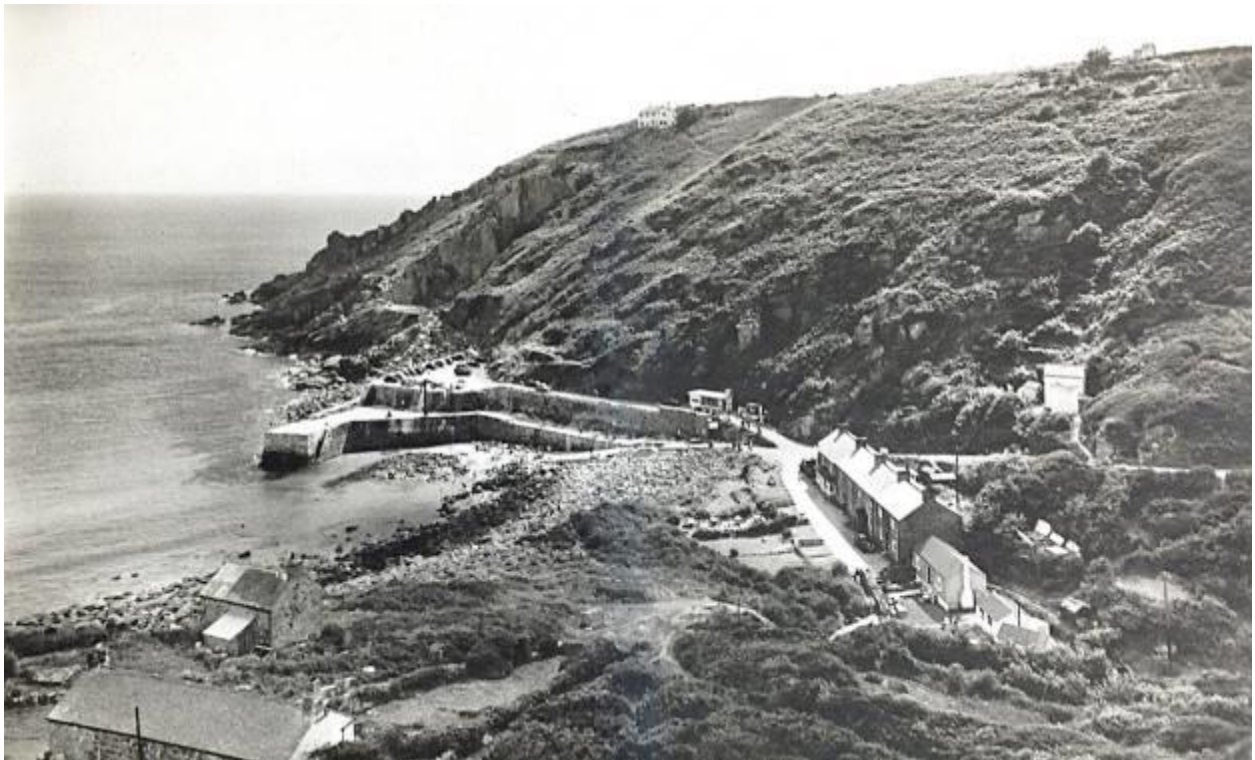
**Figure 15.26 (above) and 15.27 (below)** show two views of Lamorna Cove, which is located in the parish of St. Buryan. The old quay dates from about 1540 and was used for the shipment of granite. In the severe storms of January and February 2014, Lamorna Quay suffered severe damage and has partly collapsed into the sea. **Figure 15.27 (below)**, a postcard dating from about 1920, shows the view from the east and condition of the harbour at that time, together with the cottages in the Cove.

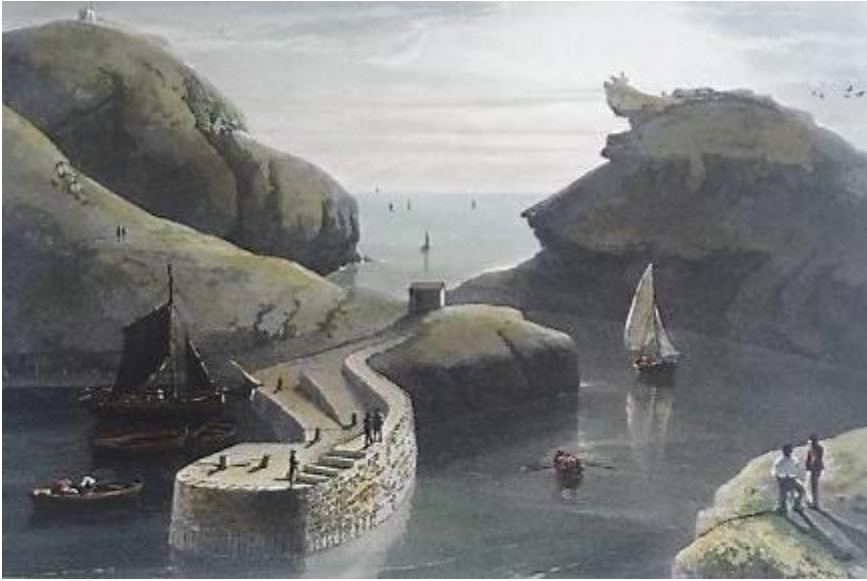
**Figure 15.28 (left)** shows the harbour and quay at Boscastle on the north Cornish coast. The harbour is of Medieval age, whilst the quay was constructed later. This busy port exported corn, slate, bark for leather tanning, as well as Manganese ore from the mines near Launceston and, after 1865, China Clay from Bodmin Moor. The view by Daniell (figure 15.26 top) shows the extraordinary natural location of the harbour of which Daniell said *"the harbour is very frightful; the crookedness of the channel at Boscastle is the cause of many difficulties; the most serious is the contrariness of the wind, which may be fair in one reach and foul in another, and thus occasionally, in so narrow a passage, extreme confusion in the steerage of the vessel and the management of her sails. The pier is very small but forms a pretty line, which is very picturesque in itself and harmonises with the form of the objects above it"*.

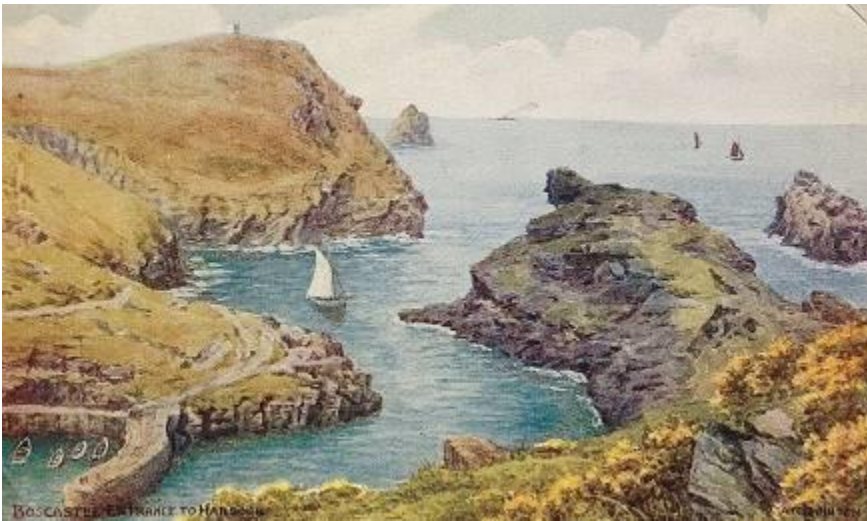
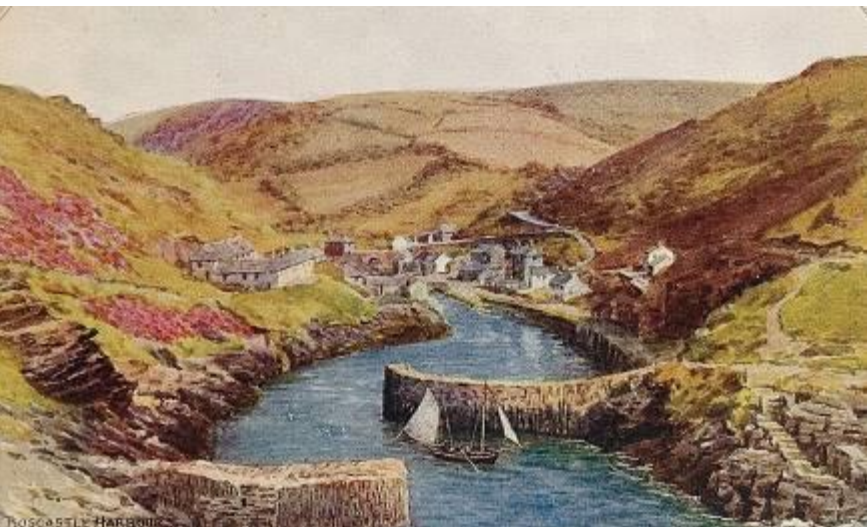
**Figures 15.29 and 15.30 (middle and below)** show two further views of Boscastle harbour by Alfred Robert Quinton. Figure 15.29 (middle) is taken from a similar angle to that of the view by Daniell looking out to sea, whilst Figure 15.30 (bottom) looks inland up through the harbour towards the village. The harbour is now in the care of the National Trust although it and appears to have changed little since Daniell's visit the flood damage in 2004 necessitated rebuilding of many properties flanking the inner end of the harbour as well as the widening and strengthening of the river's channel leading into the harbour.

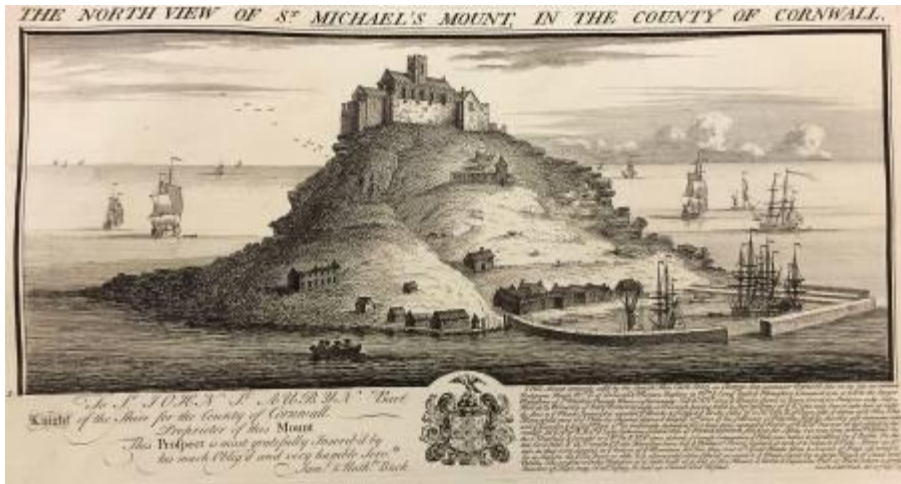
**Figure 16.1:** This copperplate engraving by S. & N. Buck (1734) shows the view of St. Michael's Mount from the shore at High Water. Later artists (**Figures 16.2-16.5 below**) tended to depict the Mount from this vantage point.

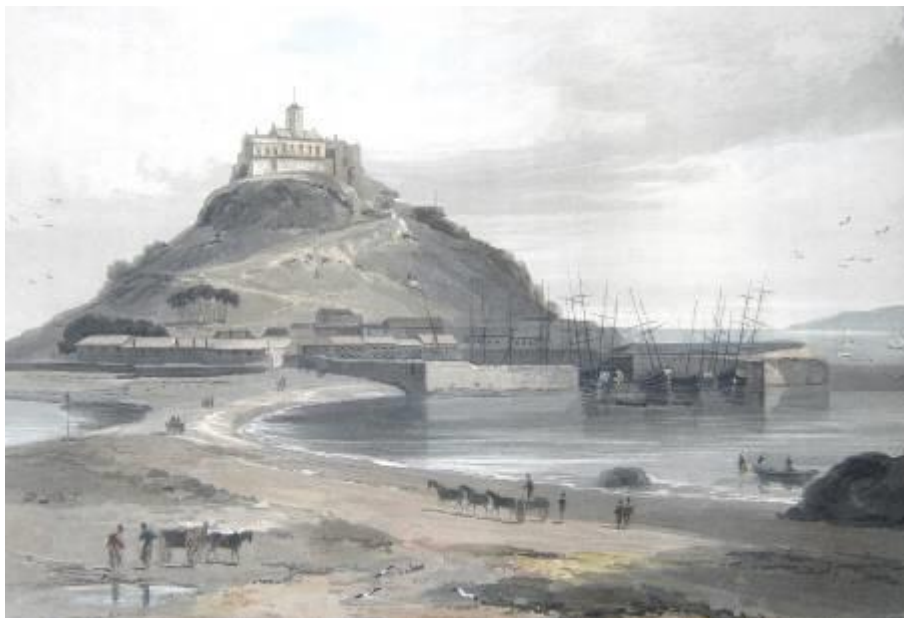
**Figure 16.2:** William Daniell RA produced this detailed aquatint in 1825 and shows the scene at Low Water. The causeway, which provides the only access, is clearly visible.

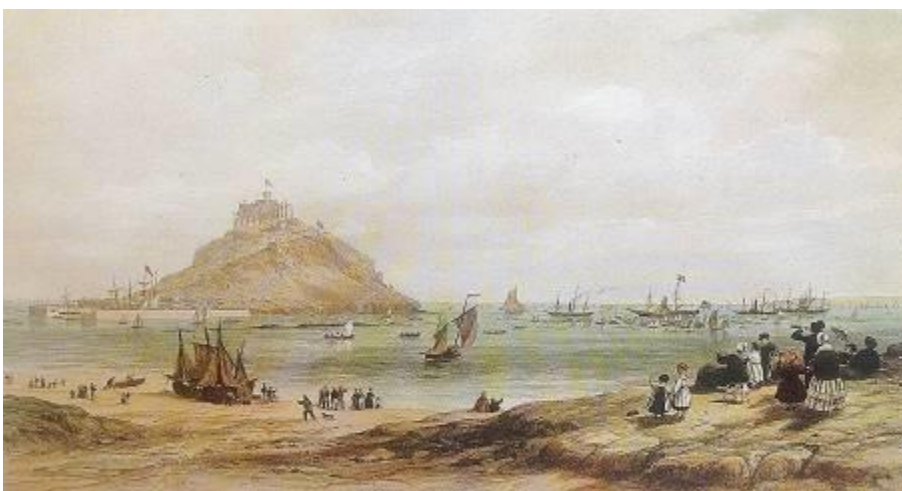
**Figure 16.3:** This fine lithograph was produced to mark the occasion of the visit of Queen Victoria and Prince Albert to the Mount in 1846. The landward end of the causeway can be seen on the left of the picture.

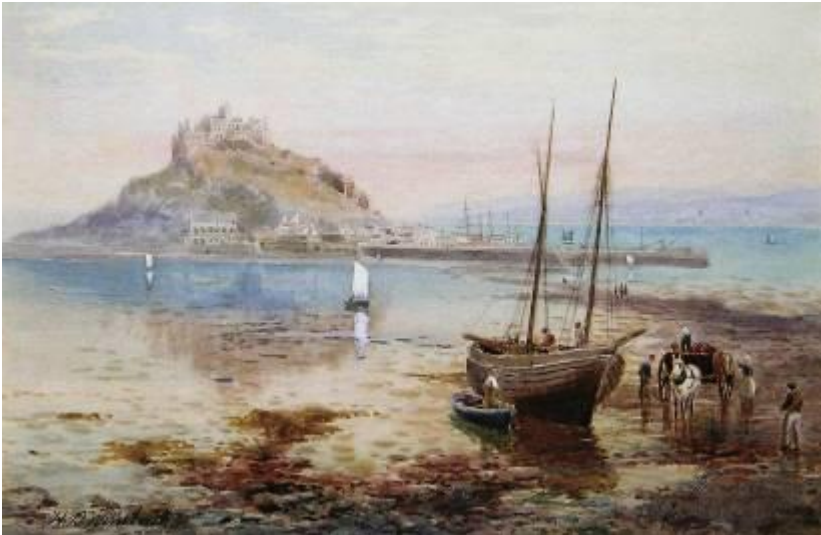
**Figure 16.4** 'St. Michael's Mount' by Henry B. Wimbush. This watercolour (c.1895) shows the scene towards Low Water as the tide recedes to expose the causeway.

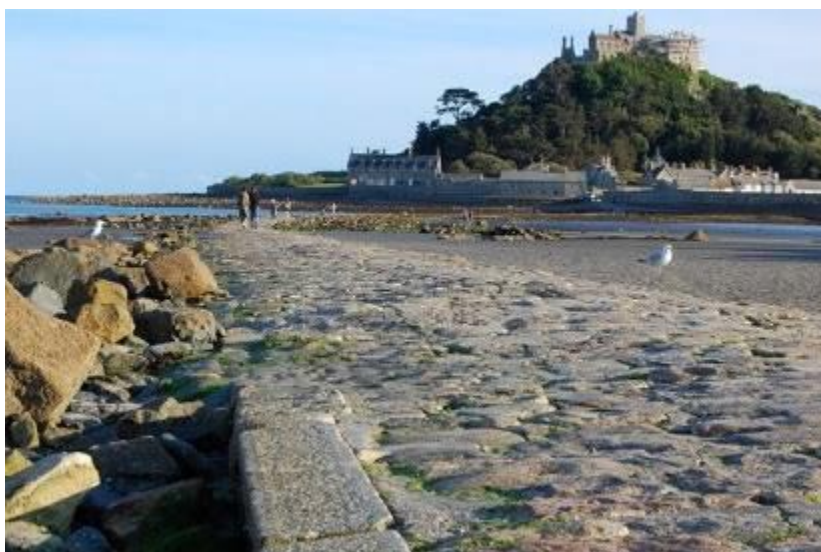
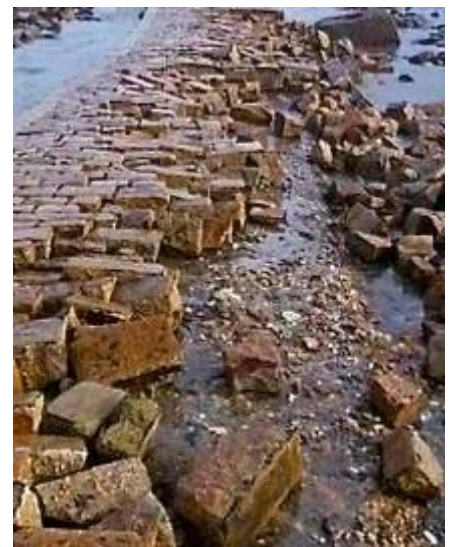
**Figure 16.6 (Above) and Figure 16.7 (Right)** show the granite setts of the causeway before and after the severe storms of 2013/14.

The storms of 2013/14 highlight the potential future risks to the causeway leading from the shore at Marazion out to St Michael’s Mount. The instability of the western harbour arm at St Michael’s Mount has also been highlighted (Royal Haskoning, 2011<sup>1</sup>). The same winter storms also re-exposed evidence of the most extensive submerged forest in Cornwall on the coastline between Long Rock and Wherry Town; the site having been first photographed by Alexander Gibson in 1883. This well-preserved 4,000 year old site includes sub-fossil tree trunks, rooted stumps and branches, as well as other material that have washed out of the early soil horizon. Early accounts (Borlase, 1758<sup>2</sup>) referred to local legends and tales concerning a forest extending out across Mount’s Bay.

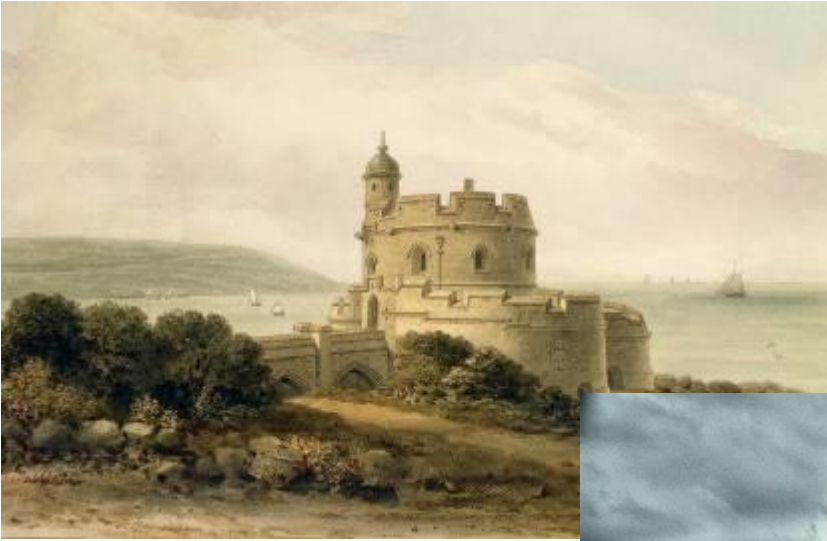
**Figure 17.1 (above):** ‘*St Mawes Castle, Cornwall*’ by John Chessel Buckler. Watercolour. 1821.

In this particular case study two areas were considered. First, the accuracy with which features such as castles were depicted by artists. The fine detail achieved by some artists is clearly illustrated in figures 17.1 and 17.3 in the case of St Mawes Castle. Both John Chessel Buckler (figure 17.1) and Charles Napier Hemy (figure 17.4) were masters in terms of artistic accuracy. Buckler was an architectural draughtsman by training, whilst Hemy was a follower of the Pre-Raphaelite ideal of capturing the landscape in very precise detail. These two examples (a watercolour and an oil painting) show the quality and detail that was achieved by some artists in the nineteenth century. Equally, exceptional detail has been provided by artists such as John Brett (figure 17.6) in his painting of the headland of Treryn Dinas, which was painted from a point high up on Treen Cliff overlooking Porthcurno Bay. Brett again was a significant figure in the Pre-Raphaelite movement and his coastal scenes are perhaps some of the most accurate to be found. In Figure 17.7 a view of Penwith Cliffs (also entitled '*Towards Land End*') by Charles Naper (c.1940) is a masterful depiction of the Cornish coast. A further magnificent view of the headland on which Maen Castle is situated, is provided by Brett in figure 17.9.

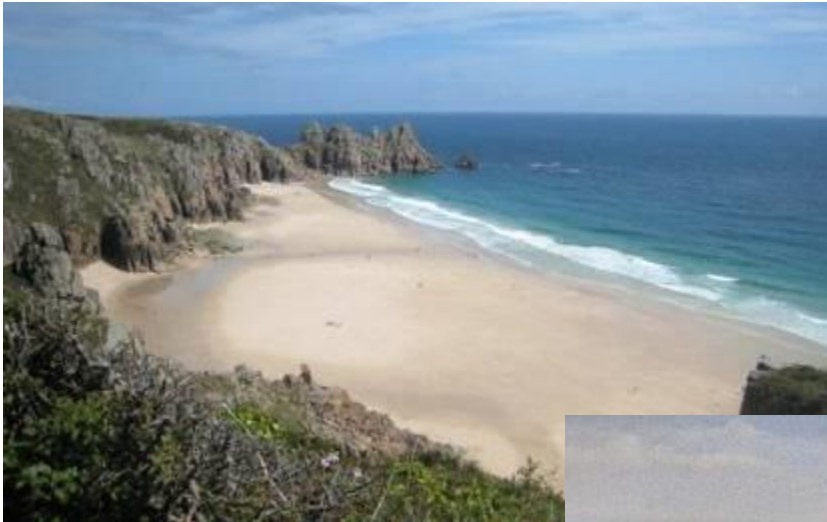
**Figure 17.5 (below):** *'Porth Curnow'* by John Brett. 1880. Oil on Canvas. This view shows Treryn Dinas painted from Treen Cliff overlooking Porth Curnow Bay. The famous Cliff Castle, with its jagged outline, is seen across an expanse of wet sand, with a vista of sea and sky beyond. The present day view can be seen in **Figure 17.6 (left)**.

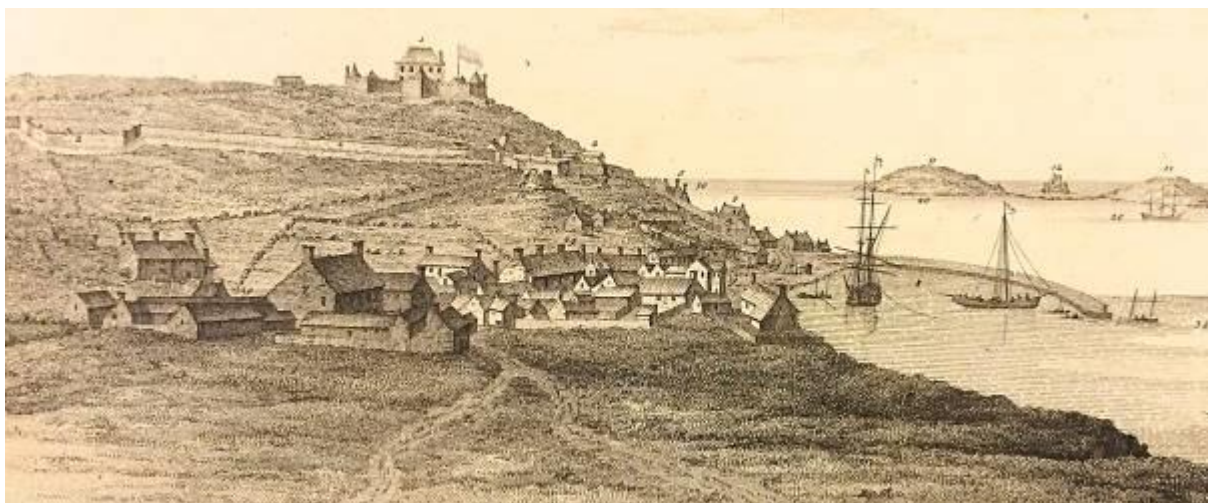
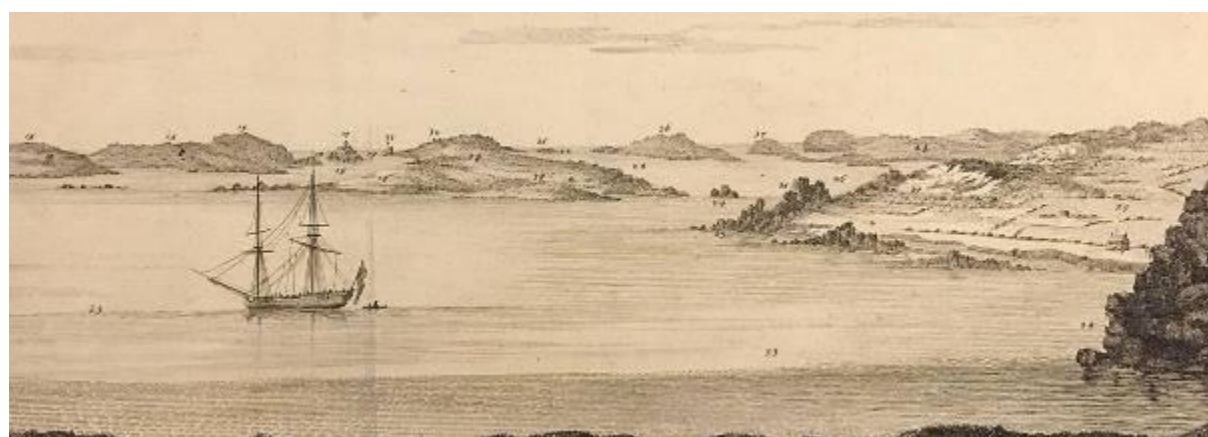
**Figures 18.3 (above) and 18.4 (below)** provide details from a further Borlase engraving of the town pier and harbour of St. Mary's and the Northern Island's taken from Bosou Hill in June 1752.

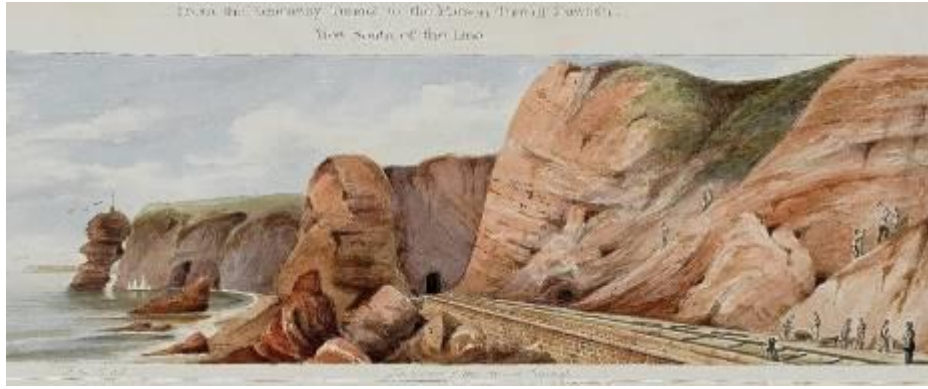
**Figure 19.1:** One of a series of fine lithographs by W. Dawson showing a section of the South Devon 'Atmospheric Railway' constructed by Brunel from 1844. This remarkable route following the coast between Dawlish and Teignmouth was severely damaged in the 2013/14 storms. (See also Case Study 11 for further artworks).

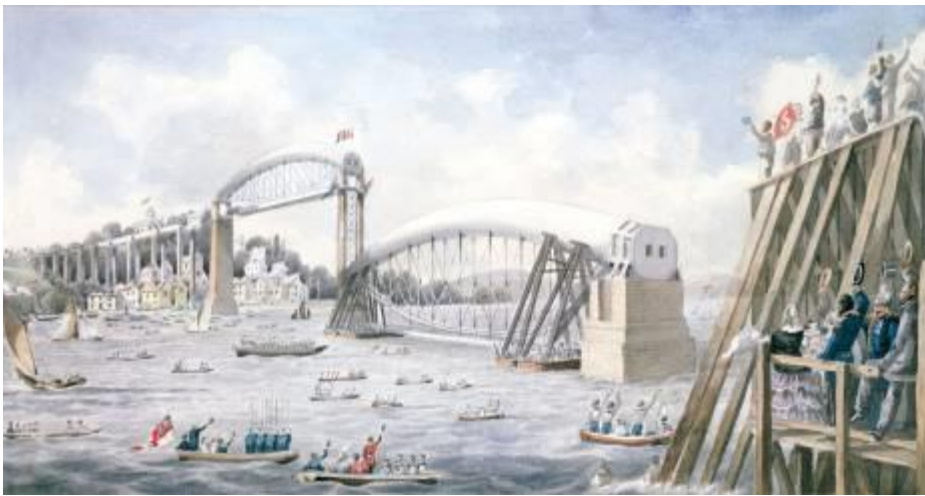
**Figure 19.2:** 'The Floating of the last spar of the Royal Albert Bridge, Saltash'. English School Watercolour. 1859. Another oil painting by T. V. Robins depicts the opening of the bridge by Prince Albert on 2nd May 1859.

The very detailed images provided in this case study illustrate methods of civil engineering construction, for example at Plymouth breakwater and Brunel's Royal Albert Bridge, at Saltash, together with the construction of the pier at Bournemouth. The images also show us the condition of these various structures at the time the views were painted. A watercolour by Alfred Robert Quinton shows the original condition of the elaborate Plymouth pier which was destroyed by enemy action in World War Two, and also the ornate Listed Burgh Island Hotel at Bigbury-on-Sea in about 1920. In compiling a Historic Environment Record for such sites, the addition of images of the structures over time could form a useful addition. Alternatively, a link can be provided to the source of the individual images alongside photographic records.

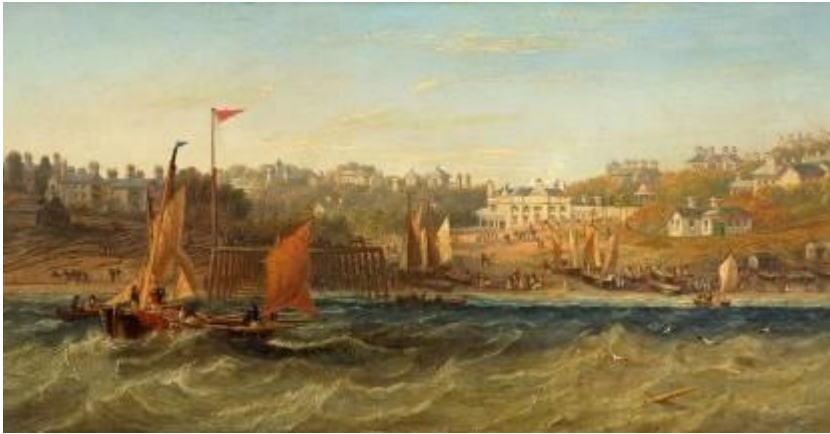
**Figure 19.4:** During the mid-to-late nineteenth century nearly every seaside town saw the construction of a pier or jetty. This oil painting by John Wilson Carmichael painted in 1861 showing construction work in progress on Bournemouth Pier. The 1,000 foot new pier replaced an earlier 100 foot jetty that was built in 1856. The T-shaped pierhead was swept away in a gale in 1867. A further iron pier replaced this structure in 1880.
