## Case Study Site 15 – Cornish Harbours

## **5. How can historical Imagery inform heritage risk management?**

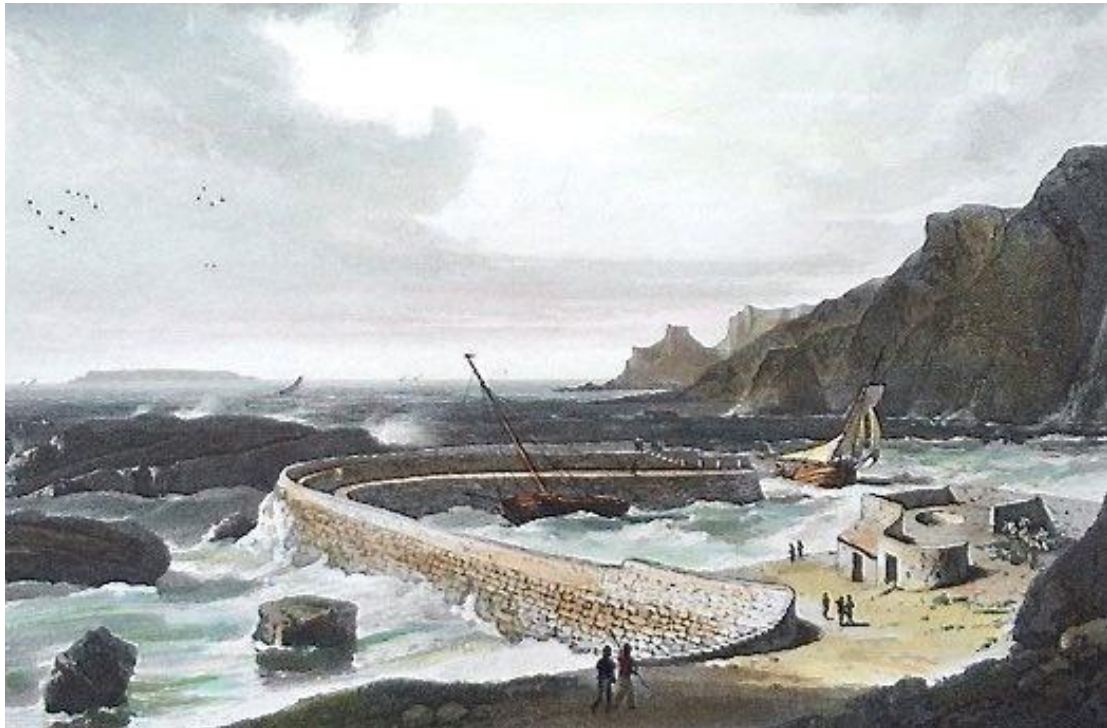
**Figure 20.1:** 'Hartland Pier' by William Daniell RA. Aquatint Engraving. 1814. This view was produced by Daniell at the start of his eleven year '*Voyage Round Great Britain*' (1814-25) and shows the stone arm/pier in sound condition. The rocky, hazardous coastline and exposure of the location to Atlantic storm waves are obvious in Daniell's view.

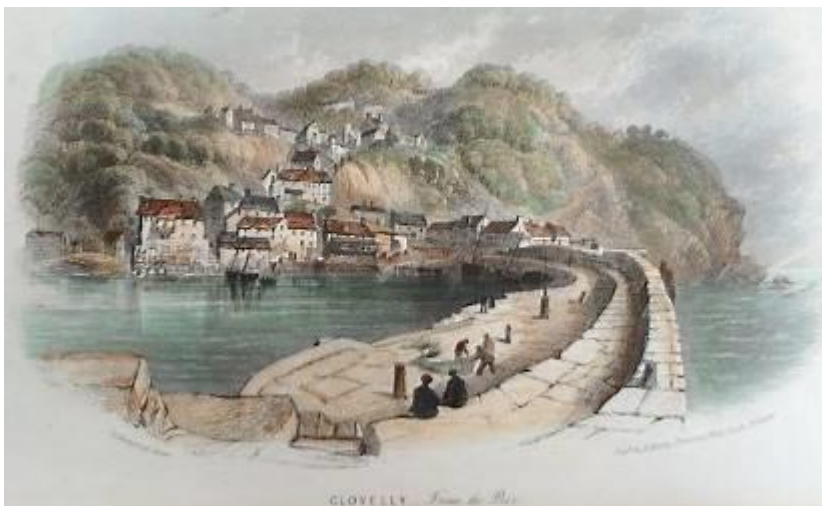
**Figure 20.5:** 'Figures on the Beach at Clovelly' by William Turner of Oxford. Watercolour. c.1840. The massive harbour wall is well illustrated in this view. The cottages in Daniell's view (above) are on the left of the harbour.

Unlike the quays at Hartland and Bucks Mills, that at Clovelly has survived the ravages of storms, and the quay is depicted by numerous artists (see figures 20.5-20.11). Within this Case Study frontage there are three Conservation Areas at Hartland, Clovelly and Bucks Mills, as well as cliff top Scheduled Monuments and numerous Listed Buildings and archaeological sites which are at risk of erosion. Clovelly and Bucks Mills may also be at risk of flooding in the future (Halcrow, 2009<sup>5</sup>).

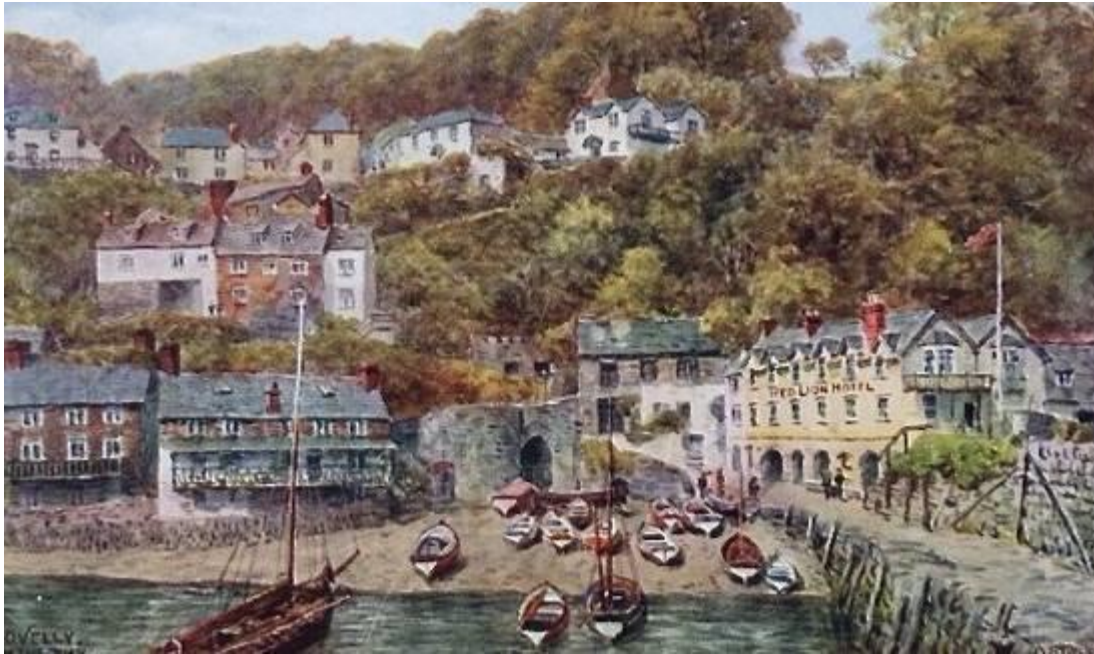
**Figure 20.9:** This watercolour entitled 'Among the Shingles, Clovelly' is by Charles Napier Henry (1864). Painted in Pre-Raphaelite photographic detail every stone on the beach can be seen together with its height and profile as well as the nature and condition of the harbour wall. Artworks of this kind equal a colour photograph of today in their detail.

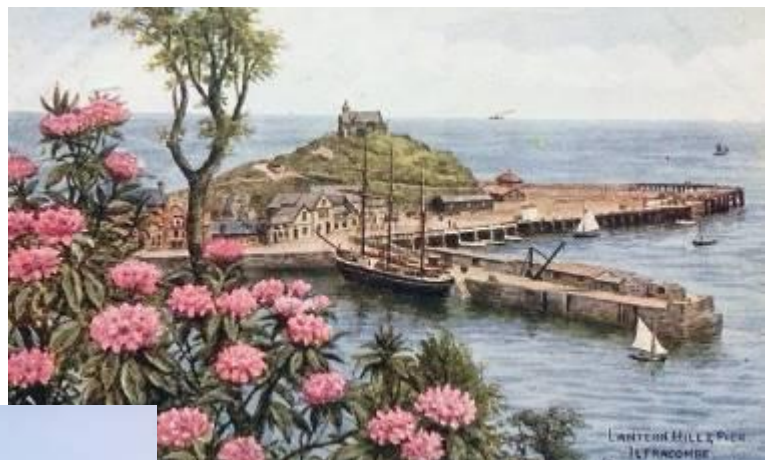
**Figure 21.4:** 'Lantern Hill and Harbour' by Alfred Robert Quinton, watercolour c.1920 shows the harbour before it was extended with a concrete structure in 1958.

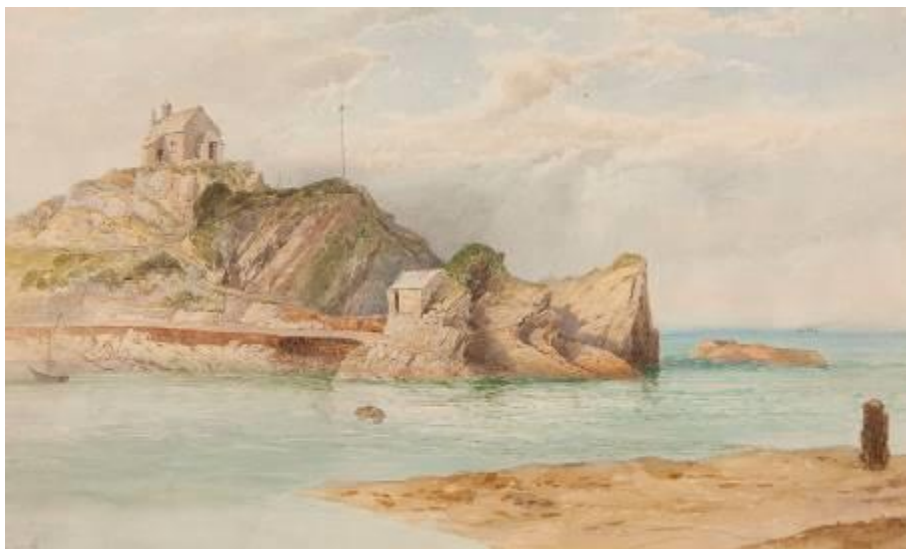
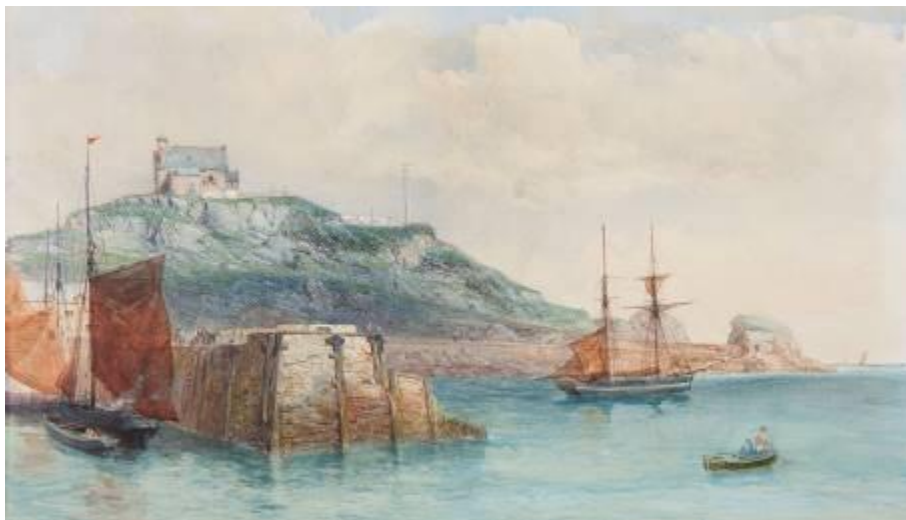
**Figures 21.6 (left) and 21.7 (middle)** provide two further highly detailed 'geological views' of the entrance to Ilfracombe Harbour in the 1860s (a further fine watercolour of this subject is held by Ilfracombe Museum). Frederick Jones' views date from the mid-1860s and show exactly the nature and condition of the harbour arm and the Chapel (see also **Figures 21.1 and 21.2**). **Figure 21.8 (bottom)** shows the view today from the end of the harbour. The chapel on Lantern Hill has been a lighthouse since at least 1852 and was later used as a Summer Reading Room. **Figures 21.6 and 21.7** © British Culture (Bristol Museum & Art Gallery).

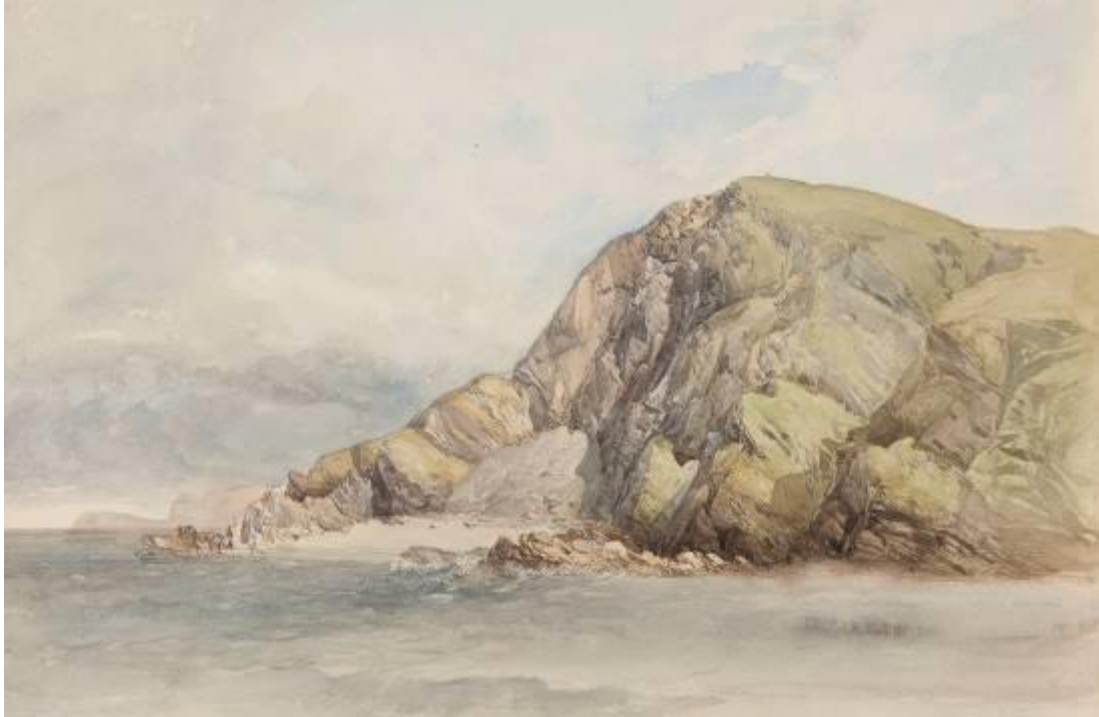
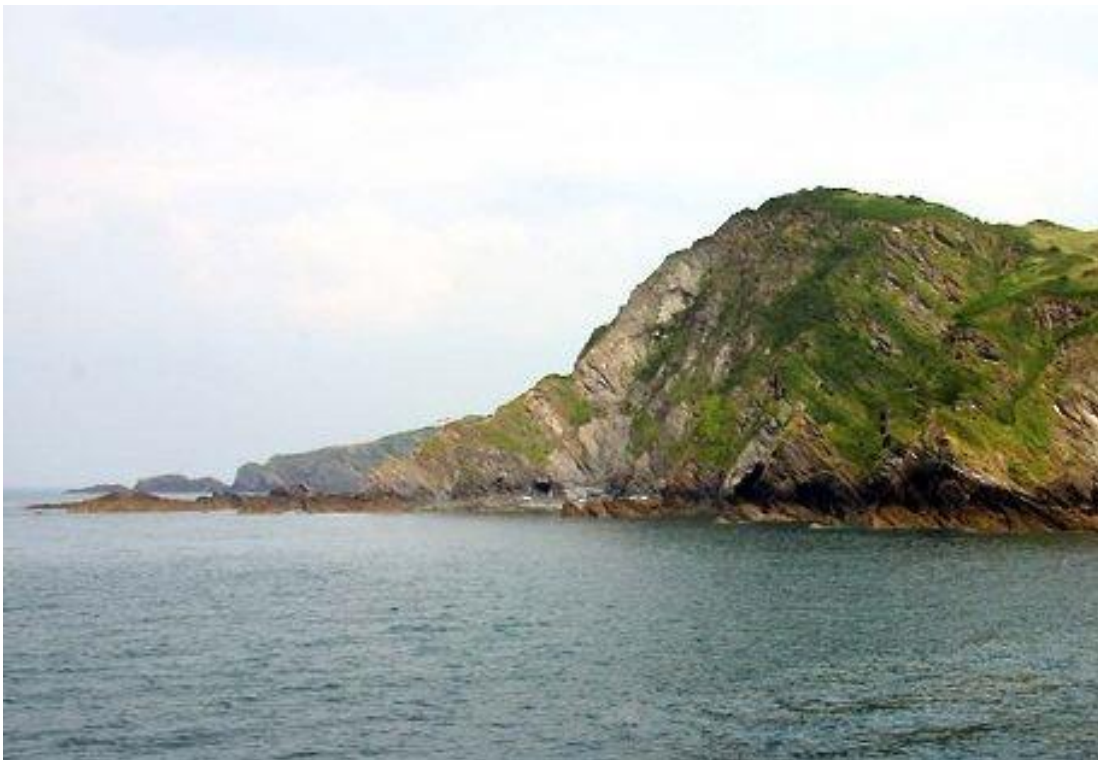
**Figure 21.15 (above):** This pair of views illustrate the photographic accuracy that could be achieved by some of the best nineteenth century artists such as Frederick Jones (Fl.1860s). Such detailed portrayals of cliff faces allow not just qualitative but also quantitative assessments to be made of cliff and coastline change. These views show Hillsborough, which includes a promontory fort on its summit (MDV2210).

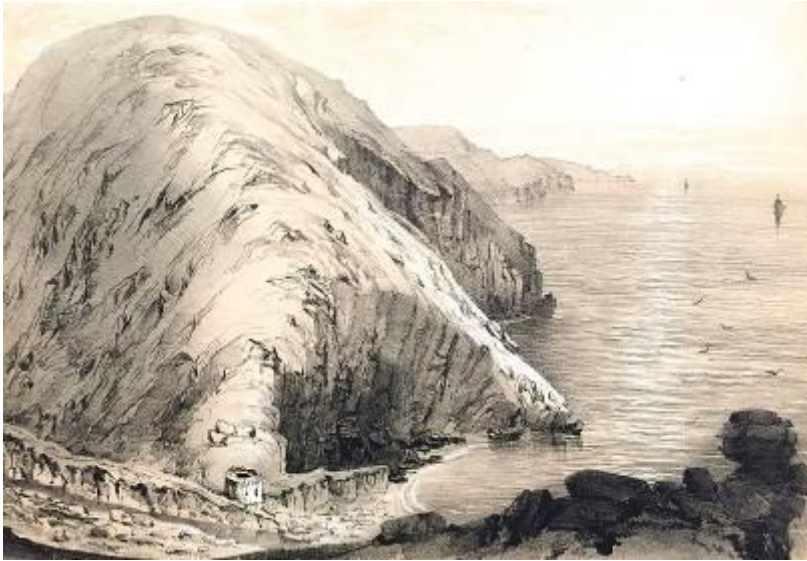
**Figure 22.1:** This lithograph produced in the 1840s shows Heddon's Mouth to the North-West of Martinhoe. The Post-Medieval lime kiln (MDE1026) is located on a ledge above the River Heddon and close to the shore. The structure was restored by the National Trust in 1982. Access steps lead to the kiln working area from the shore. In the past the kiln has suffered severe storm damage in this exposed location.

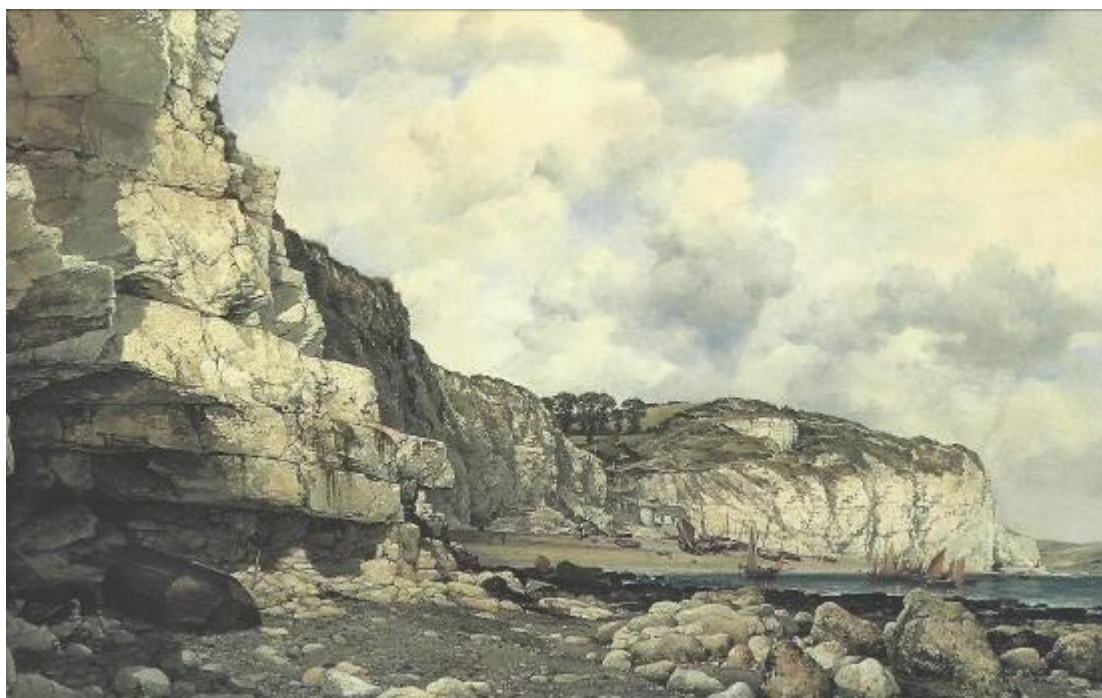
**Figure 6.4.1:** *'The Fishing Cove of Beer'* by E. W. Cooke 1858. The Upper Chalk exposure of Annis Knob also shown in **Figure 6.4.2. (right)** is clearly visible as is the extensive Middle Chalk exposure in the main cliff below. Cooke's painting also shows the nature of the landscape before the extensive tree and vegetation growth that masks the cliff top today. Photograph (right) © Ian West.

Edward William Cooke (1811-1880) was more than just a distinguished landscape painter. He was elected a Fellow of the Linnaean Society in 1857, a Fellow of the Geological Society in 1862 and his election as a Fellow of the Royal Society, an uncommon distinction for a painter, came in 1863 shortly before he was made an RA. Cooke's father, George Cooke, had engraved copper plates for Sir Henry Englefield Bt. that appeared in his *'A Description of the Principal Picturesque Beauties, Antiquities and Geological Phenomena of the Isle of Wight and adjacent Coast of Dorsetshire'* (Englefield, 1816<sup>2</sup>). Englefield had stated that *'in no instance has accuracy been sacrificed to the effect of the engraving'*. This ethos underpinned E. W. Cooke's work throughout his life with him receiving highly favourable comment from John Ruskin the great Victorian art critic (Ruskin, 1853<sup>5</sup>). On Cooke's election to the Royal Academy in 1863 the Illustrated London News said of him *'The prime characteristic of Mr Cooke's art is literal fidelity to nature. He is probably the most scientifically accurate painter we possess. His pictures provide exact reproduction of the outward aspects of the natural world satisfying the geologist, botanist, meteorologist, architects and shipbuilder'* (Illustrated London News, 1863<sup>9</sup>). Cooke's views of the south-west coast were originally intended to form a volume entitled *'The British Coast'*, however, the work was never completed for publication. Figure 6.4.1 shows Cooke's view of *'Fishing Cove of Beer'* one of several views of the location. His artwork compares almost exactly with the photographs below.

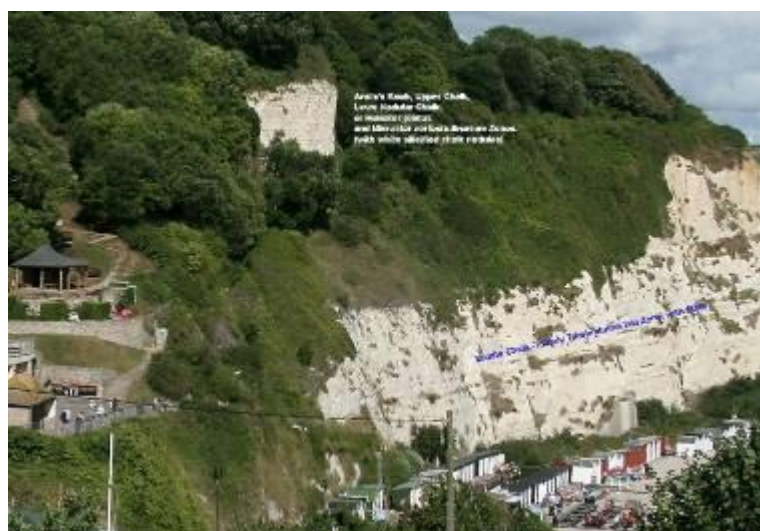
**Figure 6.4.3. (left)** shows the Upper Greensand-Lower Chalk junction on the south side of Small Point, Beer. Cooke has captured this exactly in the bottom left corner of his painting.

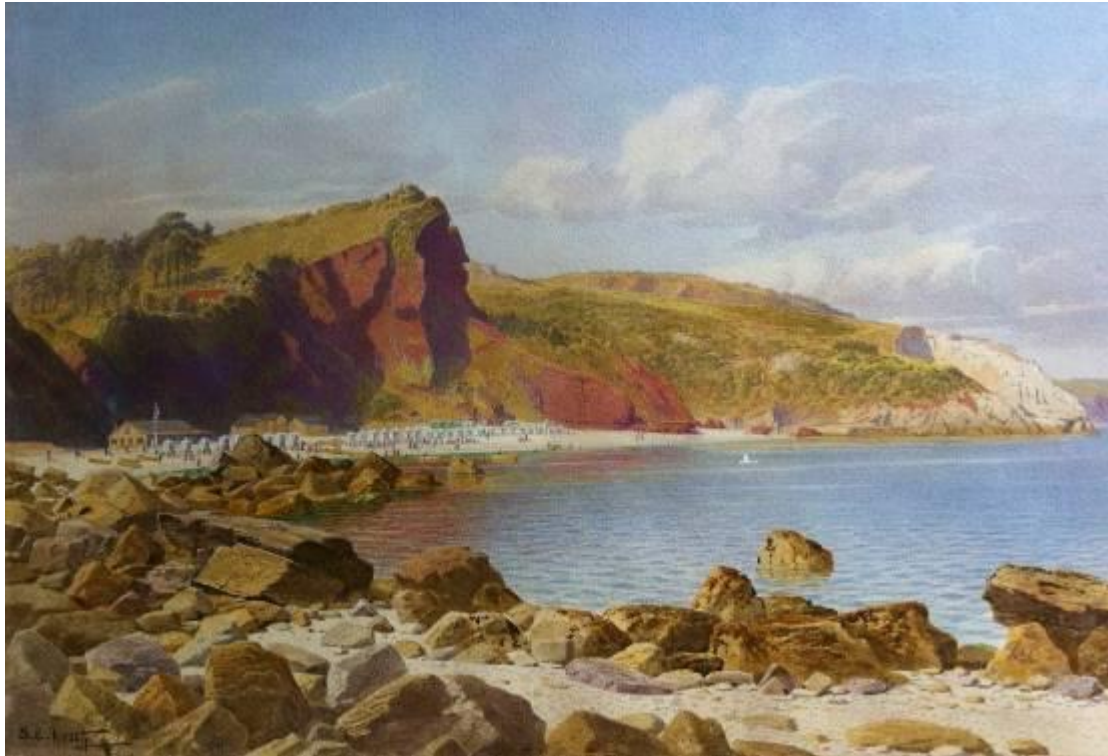
**Figure 6.4.4:** ‘Oddicombe Beach’ near Torquay by Samuel Edward Kelly c.1910. Views such as this remind us of the changing coastal environment both in terms of physical change, and the landscape through development and management practices. Kelly’s watercolour provides evidence of coastal processes at work and risks from the unstable cliff face. It is important to bear in mind that coastal change may pose risks to buried, undiscovered heritage as well as to known heritage assets.

The watercolourist Samuel Edward Kelly (1862-1935) produced highly detailed watercolours of the south-west coast. His view of *'Oddicombe Beach'* near Torquay painted in 1910 is a fine example of his work. Kelly followed the Pre-Raphaelite ideal of capturing nature faithfully and this is evident in this scene, which shows the precarious cliffline above the beach as well as the debris from previous falls. Comparison with recent photographs confirms the level of accuracy that artists could achieve with the brush alongside photography.

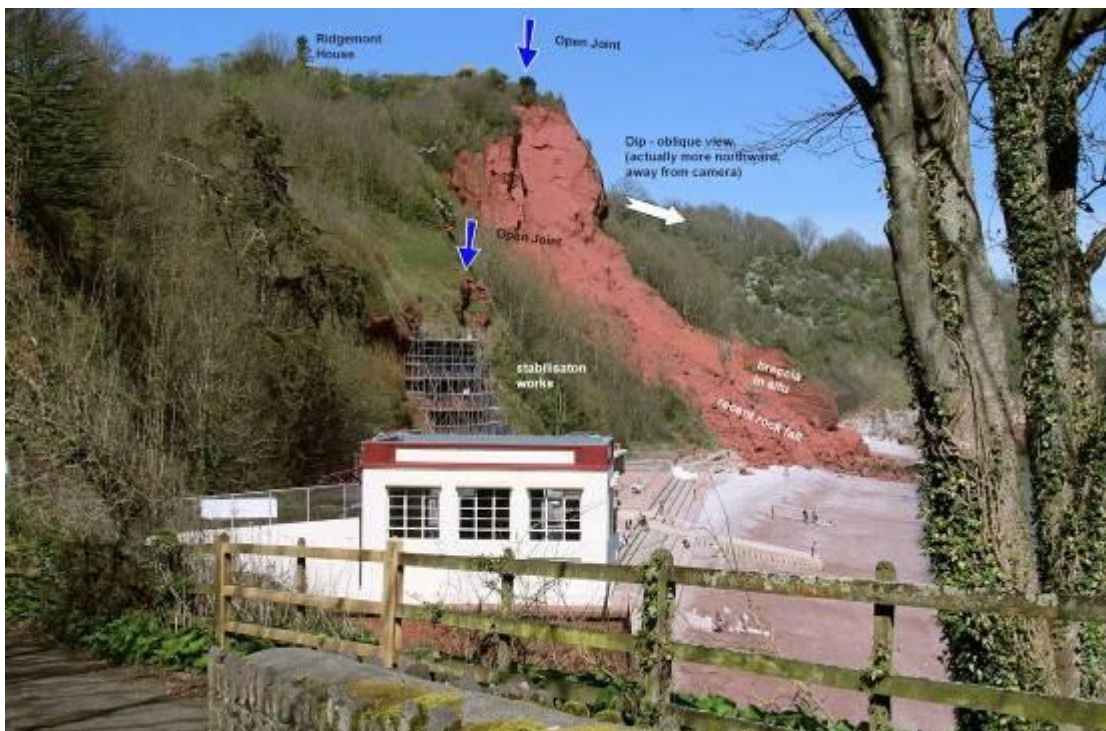
**Figure 6.4.5 (below)** shows the scene on 7<sup>th</sup> April 2011 with a cliff fall and opening joint lines. A major fall here in April 2013 saw the loss of Ridgemont House on the cliff top.

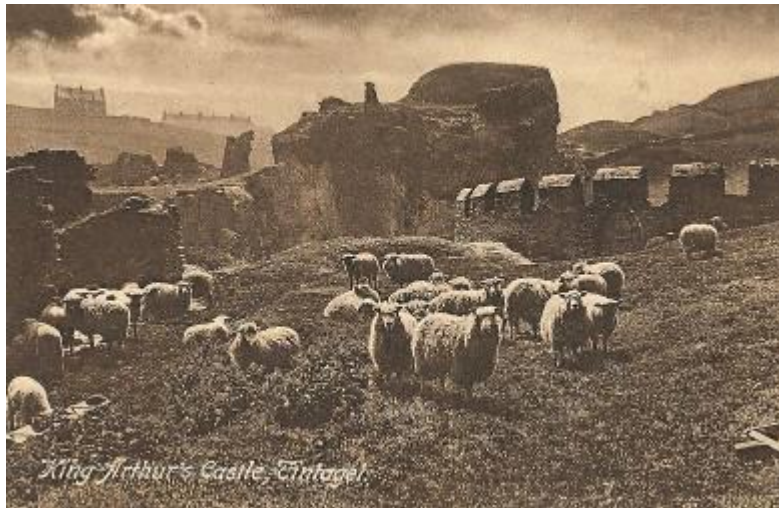
**Figure 6.4.6. (left):** 'Tintagel Castle, Cornwall'. This postcard, which was produced from a photograph taken in about 1900 shows the battlements extending towards the cliff edge. Such structures and the changes observed to them through artworks and photographs over time can provide both qualitative and quantitative evidence of the rate of coastal change.

The enormous value of old photographs and photographic postcards has also been stressed in this report and these images, alongside art, help to provide a more complete illustrated record of coastal change and its impacts on heritage sites in the south-west of England. Sites such as Tintagel Castle in Cornwall (Figures 6.4.6-6.4.8, and Figures 17.15 and 17.16) might appear to be resilient but photographic evidence clearly shows the loss of cliff material over time as a result of weathering and coastal erosion and demonstrates the value of this medium.

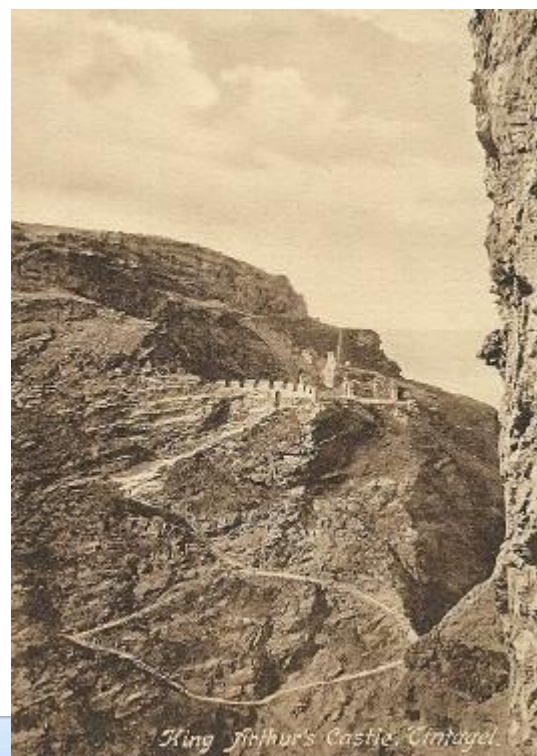
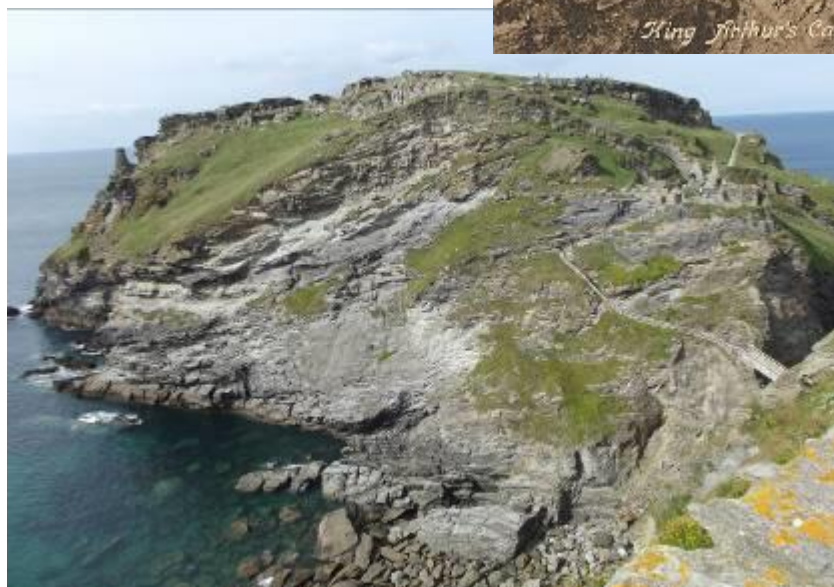
**Figure 6.4.7 (right)** shows a view of Tintagel Castle (pre-1914), which looks directly at the cliff face surmounted by the battlemented wall. This postcard shows a substantial bluff beneath that end of the wall that is now absent in the present day photograph in **Figure 6.4.8 (below)**.

The extent of loss can be seen by comparing the number of battlements to the right of the entrance arch (four) in the postcard, whilst the photograph only shows one battlement remaining.
