## 5.11. River Great Ouse

## 5.12. River Bure

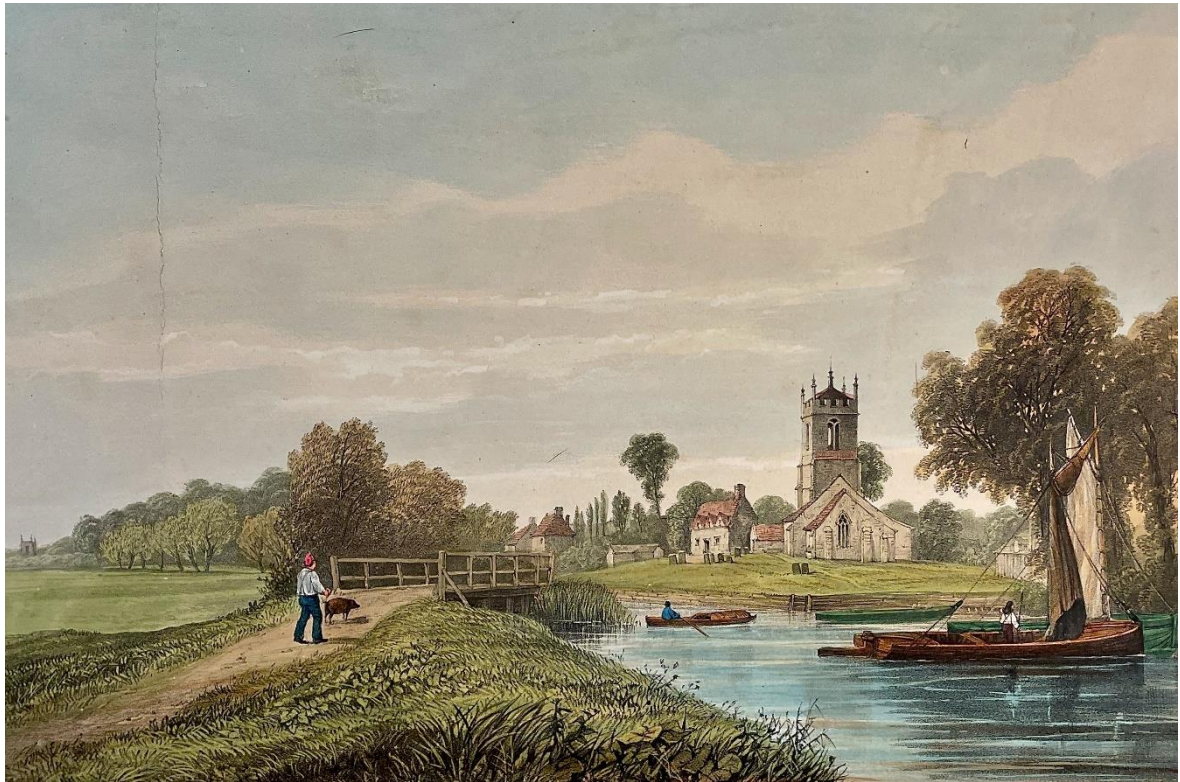
**Figure 11.1:** The hamlet of *Hartford on the Ouse*, a copperplate engraving. c.1830. This picturesque view shows the church close to the river bank which is now strengthened by a wall instead of timber breastwork. The river is wider and the jetty has gone but otherwise the scene has changed little. The wider floodplain can be seen on the left of the engraving. **Figures 11.2 and 11.3 (below)** show the vicinity today.

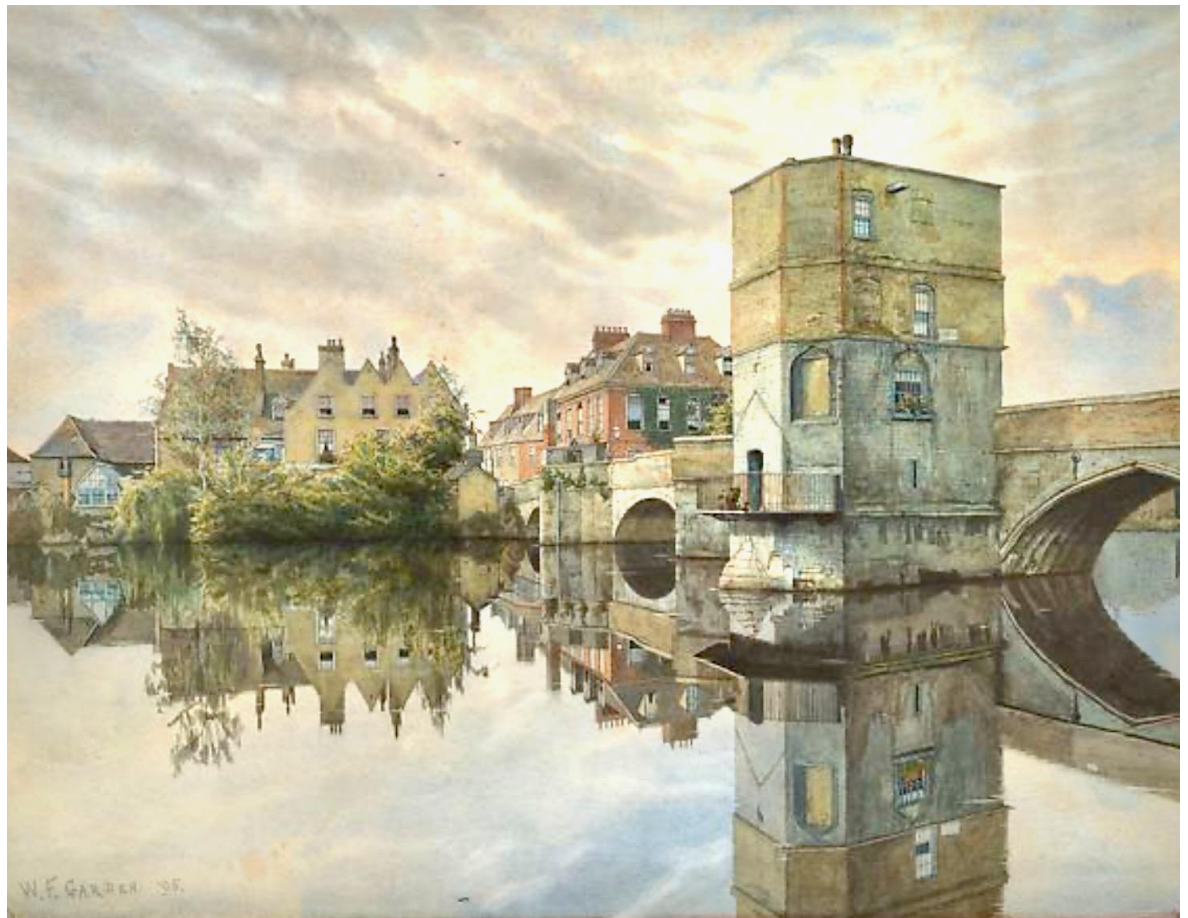
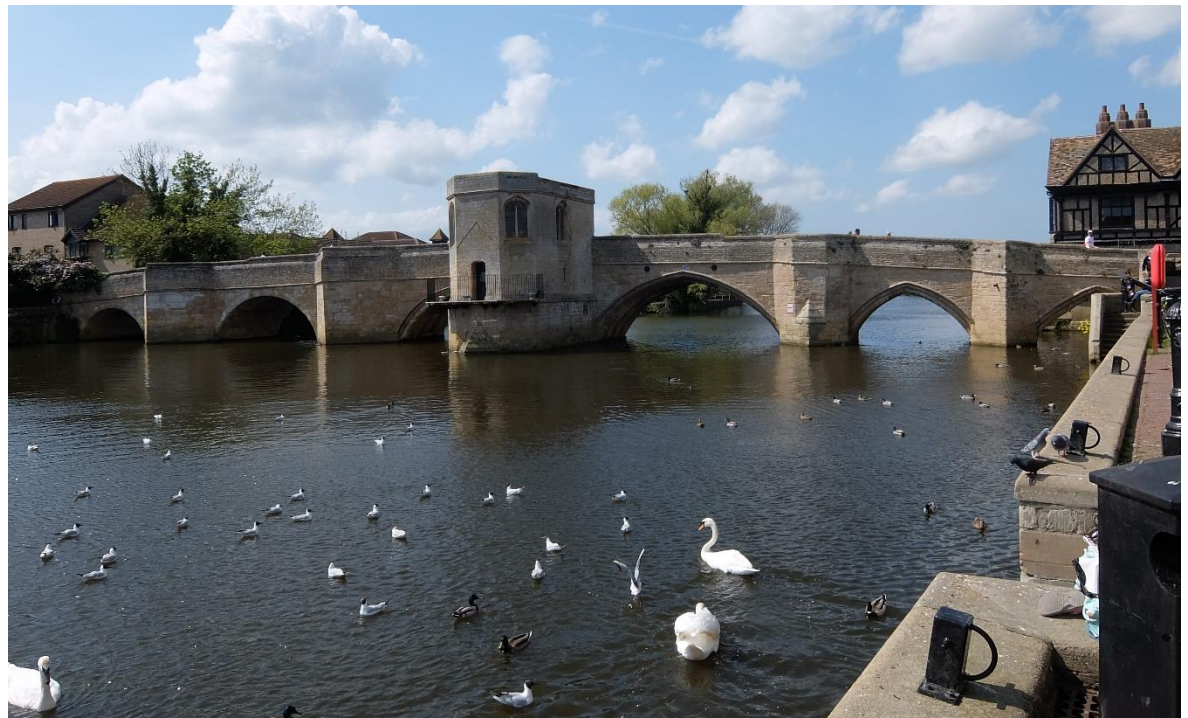
**Figure 11.14 (above):** William Fraser Garden's exceptional watercolour of St Ives bridge has a photographic quality. Painted in 1895 it shows the chapel and two storey extension added in 1736, which was removed in 1930 (**Figure 11.15 below**).

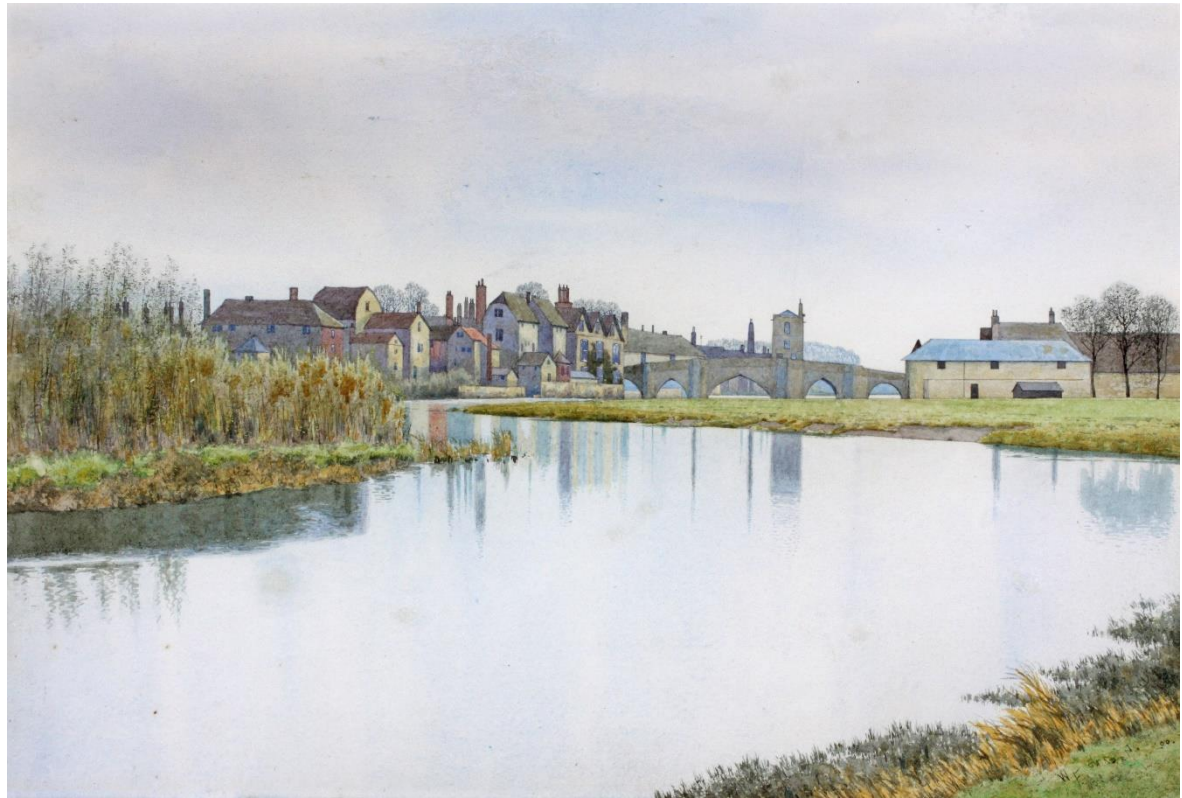
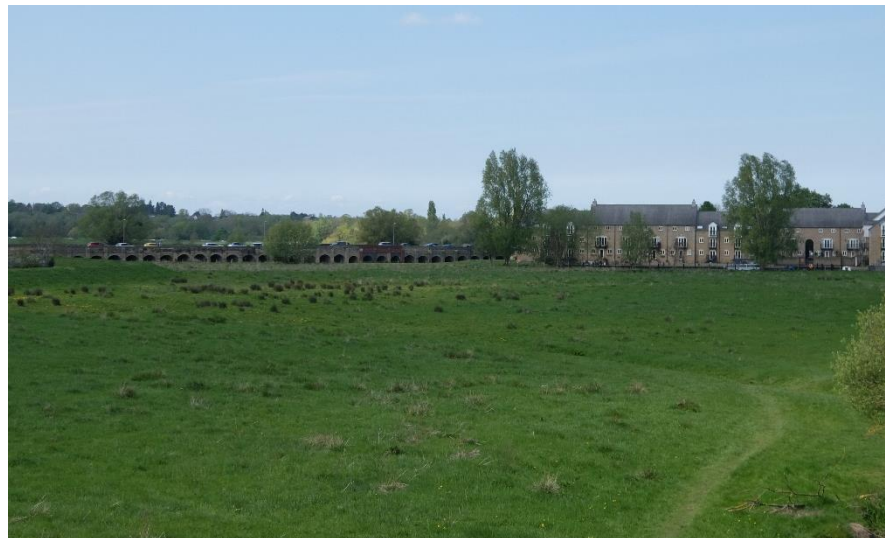
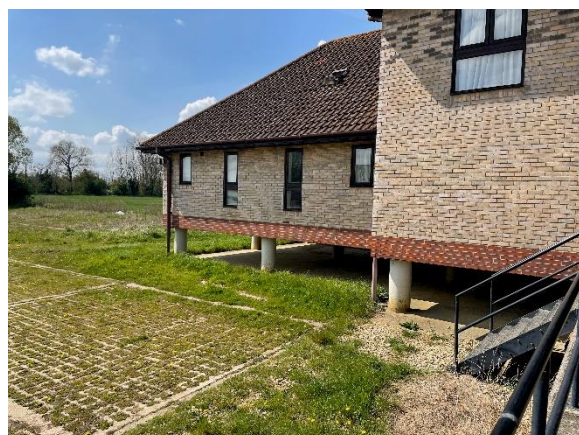
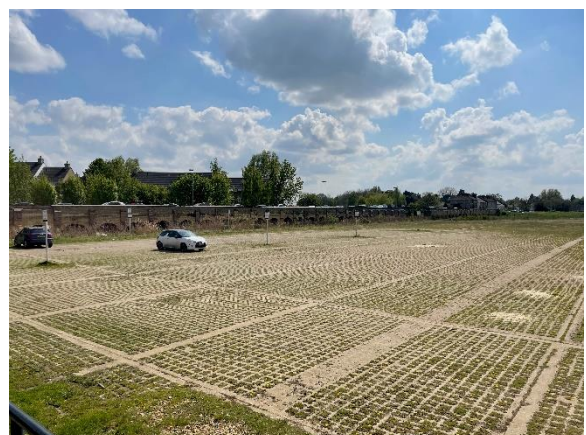
**Figure 11.16 (above):** *The Tranquil River at St Ives* by W. F. Garden. Watercolour. 1890. To mitigate flood risk in St Ives low-lying areas close to the town centre can store flood water and a building is raised on stilts (**Figures 11.17-11.19 left and below**).

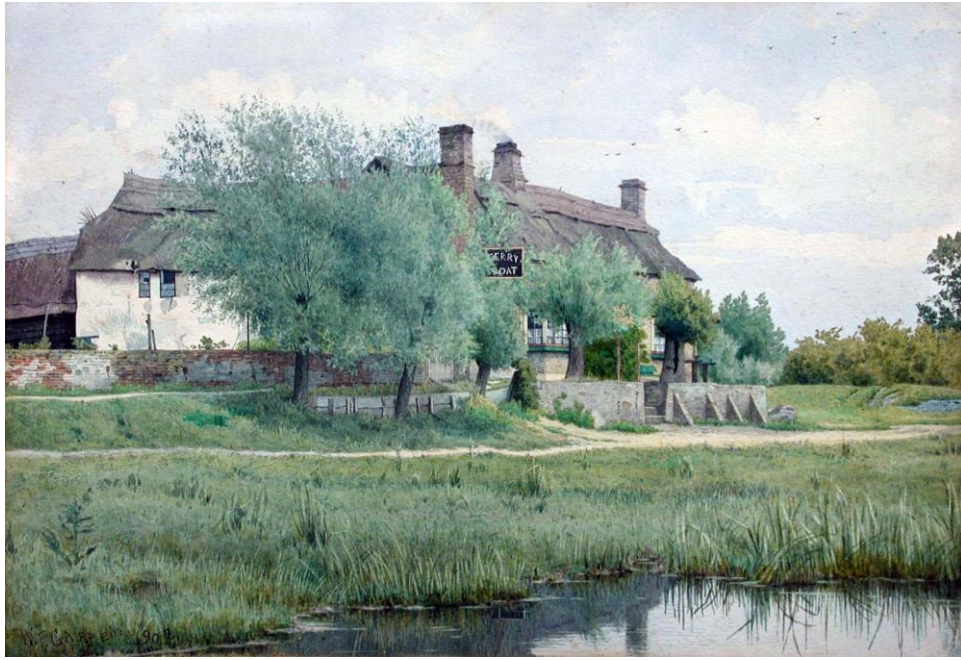
**Figure 11.20 (top)** shows the historic Ferry Boat Inn at Holywell to the east of St Ives on the river bank. The scene was painted by W. F. Garden in 1902.

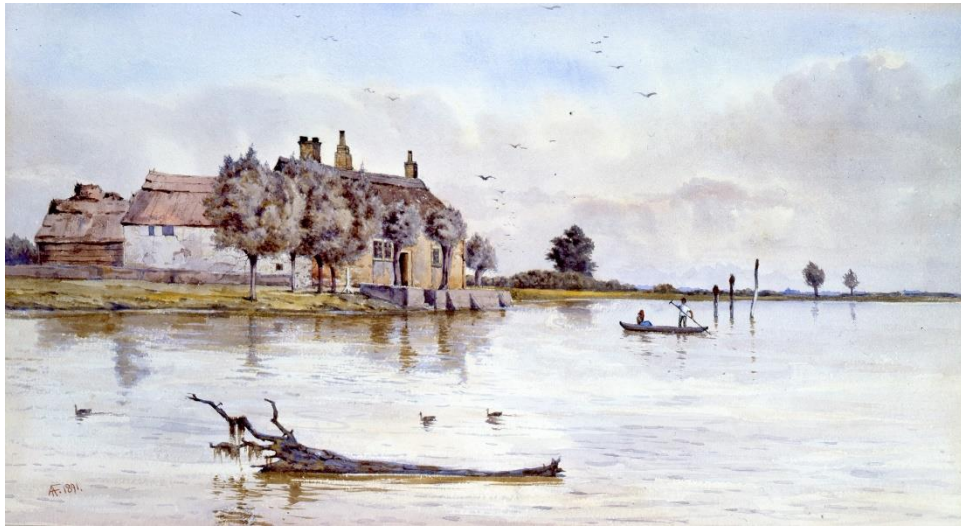
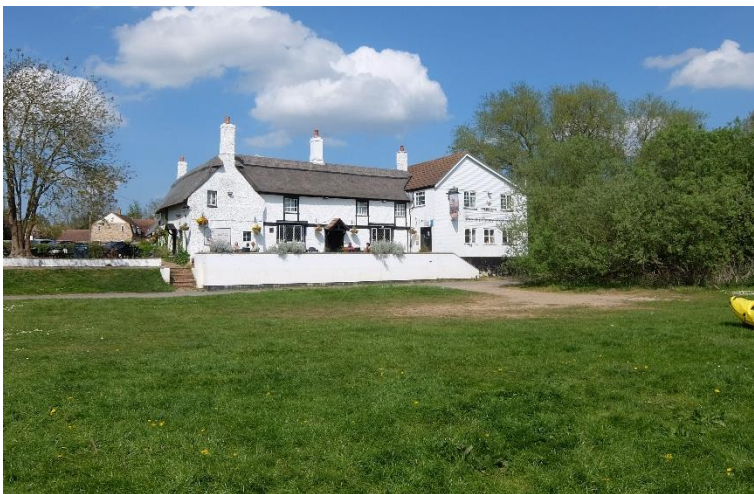
**Figure 11.21 (middle)** shows the Inn in times of flood painted by Arthur Anderson Fraser in 1891.

**Figure 11.22 (bottom)** shows the Inn today. The river embankment has been raised substantially along this frontage and the retaining wall improved.

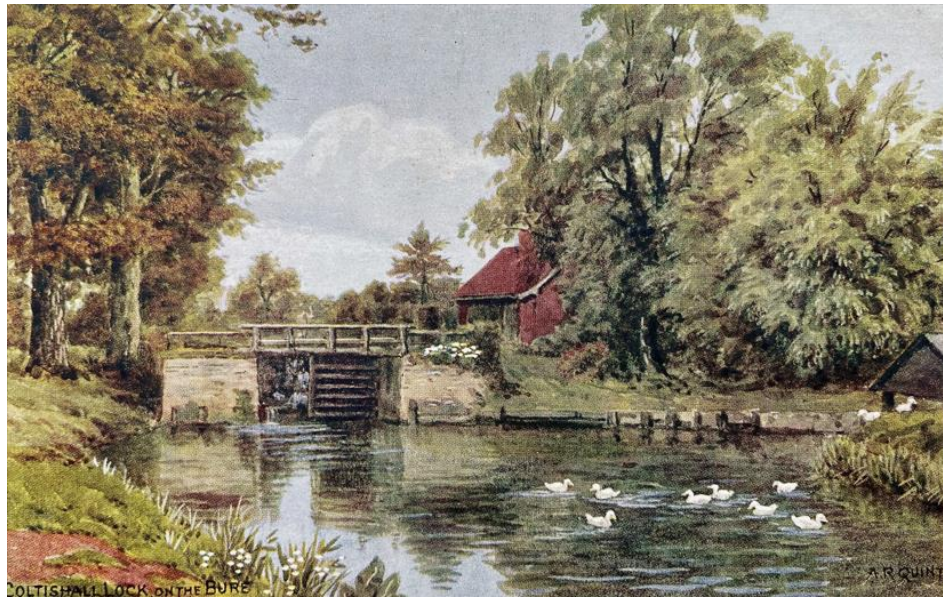
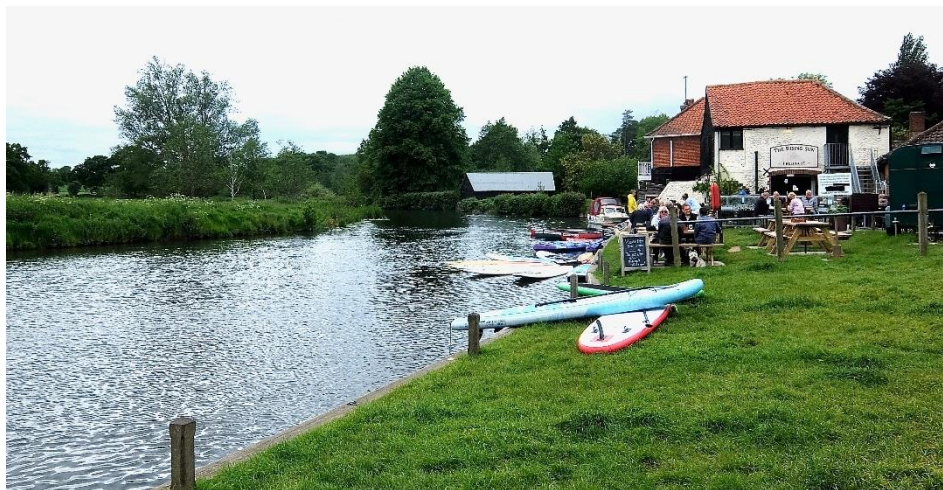
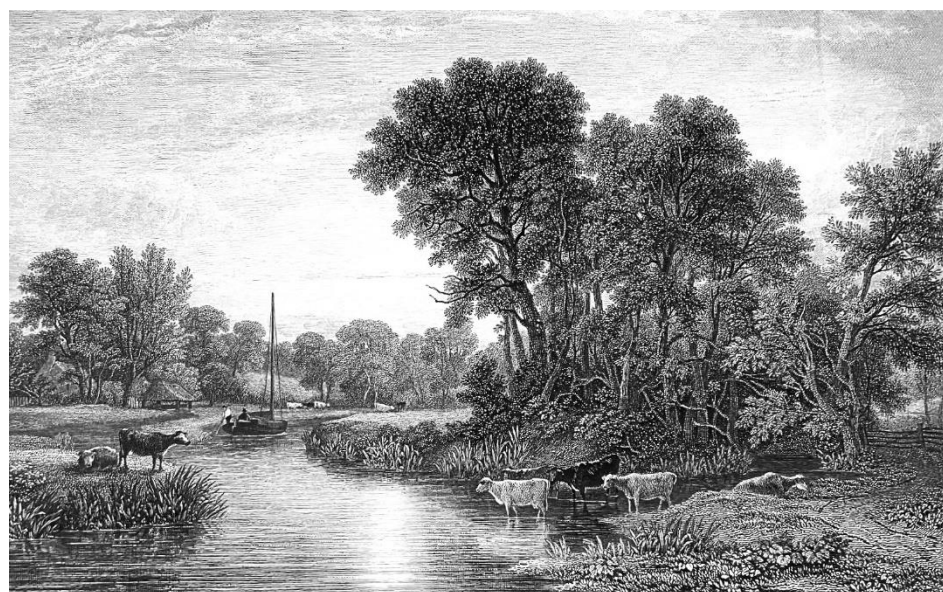
**Figures 12.1-12.3,** left and centre, shows scenes depicting the River Bure in the vicinity of Coltishall painted in watercolour by Alfred Heaton Cooper in c.1924 and engraved by James Stark (bottom) in 1833. The view by Quinton shows Coltishaw Lock. As a prolific watercolour artist, his detailed depictions of locks and weirs illustrate how river water management was practised in the first three decades of the twentieth century. Stark's engraving of Coltishall (bottom) depicts the perfect English river landscape, again at Coltishall, with little evidence of any human intervention. Today, the riverside pub and bank protection on the developed side of the Bure can be seen.

Their illustrations show river scenery at Coltishaw (Figures 12.1-12.3), at Belaugh (Figures 12.4 and 12.5), at Horning (Figures 12.6 and 12.7) and Wroxham (Figures 12.8-12.10). As might be expected in a location of national importance (a National Park) and high environmental and landscape significance, alongside villages with significant cultural heritage, strong regulation has protected these environments and relatively little change can be observed through the images over time. The watercolours by A.R. Quinton, as always, provide interesting local detail, such as the lock at Coltishaw, whilst the views of the waterside village of Horning have changed little except the increase in Broads river traffic. Whilst riverbank defences have been improved, these are very much in character with those that existed in the past. Similarly, at Belaugh, in Figures 12.4 and 12.5, the scene is reminiscent of the view painted by Quinton in c.1924.

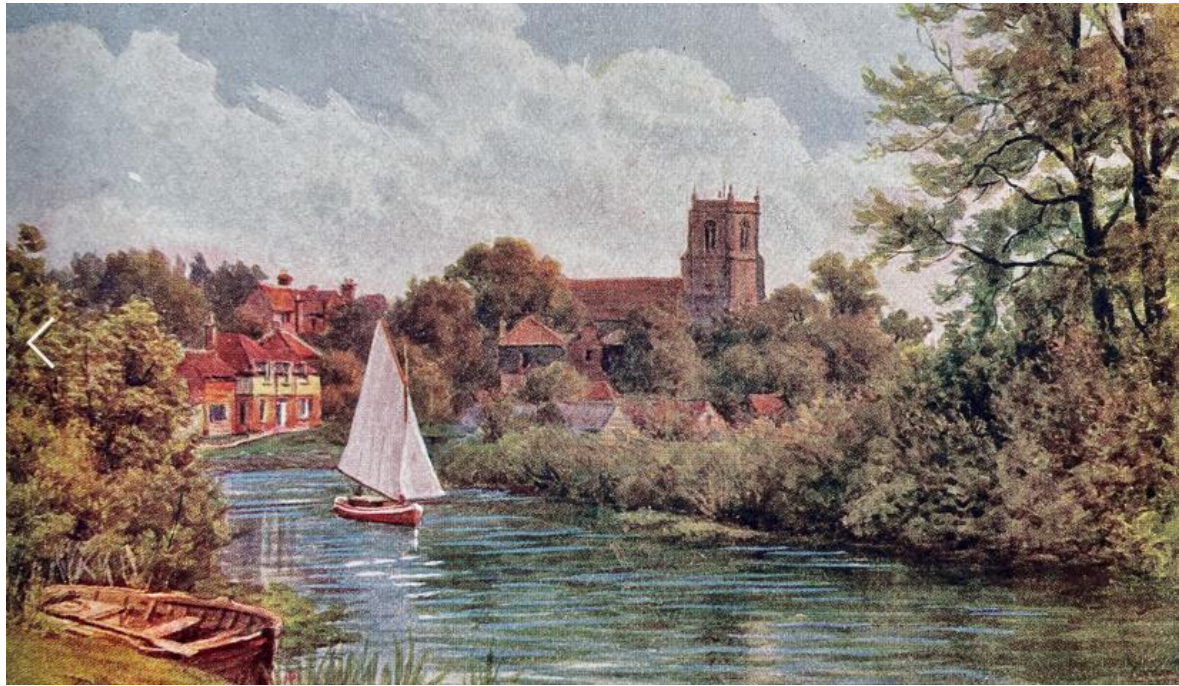
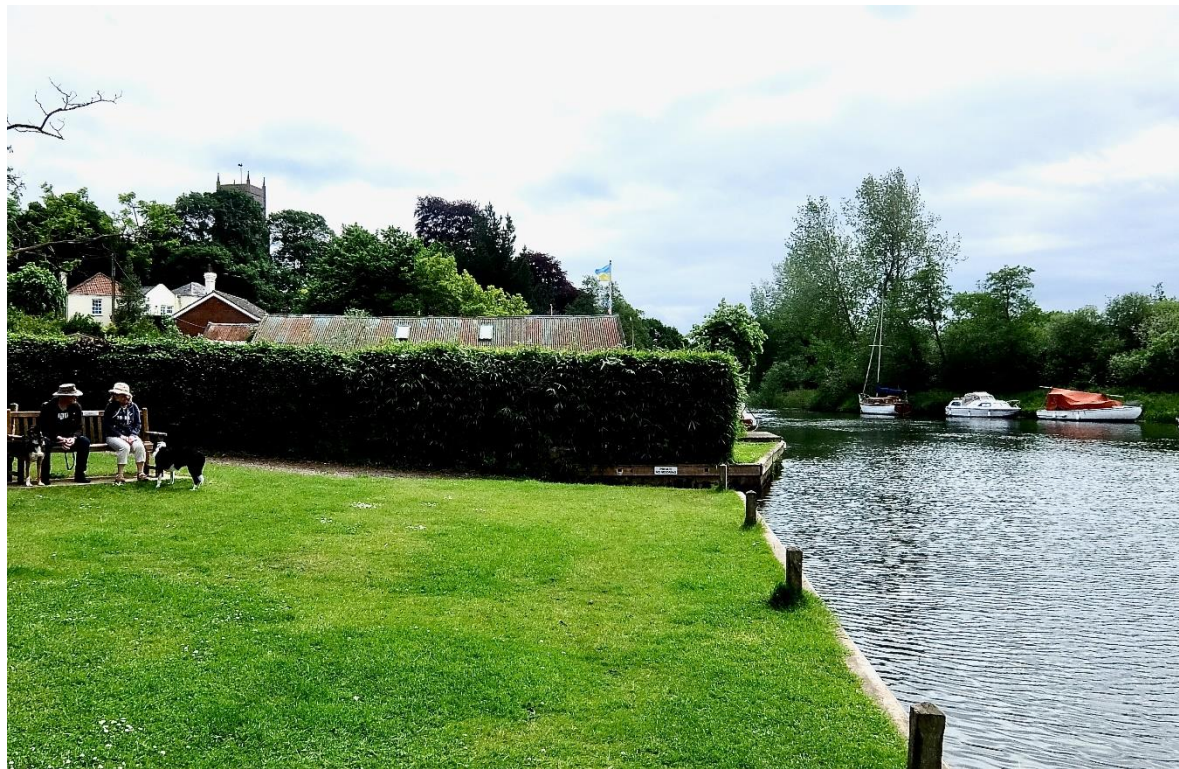
**Figures 12.4 (above) and 12.5 (below)** show the charming village of Belaugh between Coltishall and Wroxham. The church and houses form a picturesque scene alongside the river. Modest riverbank protection comprising a timber breastwork illustrates the 'limited intervention' approach adopted in many Broadlands villages.

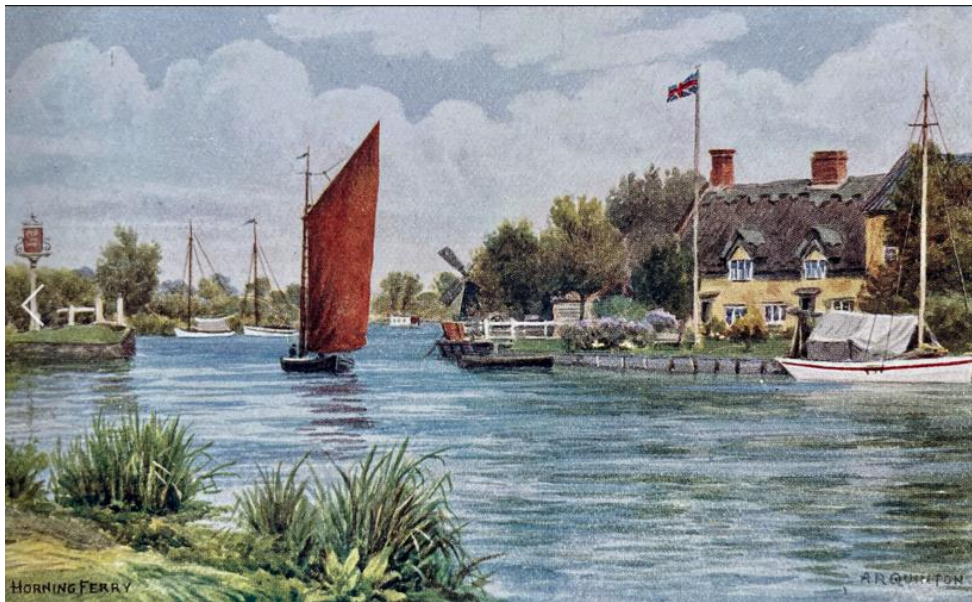
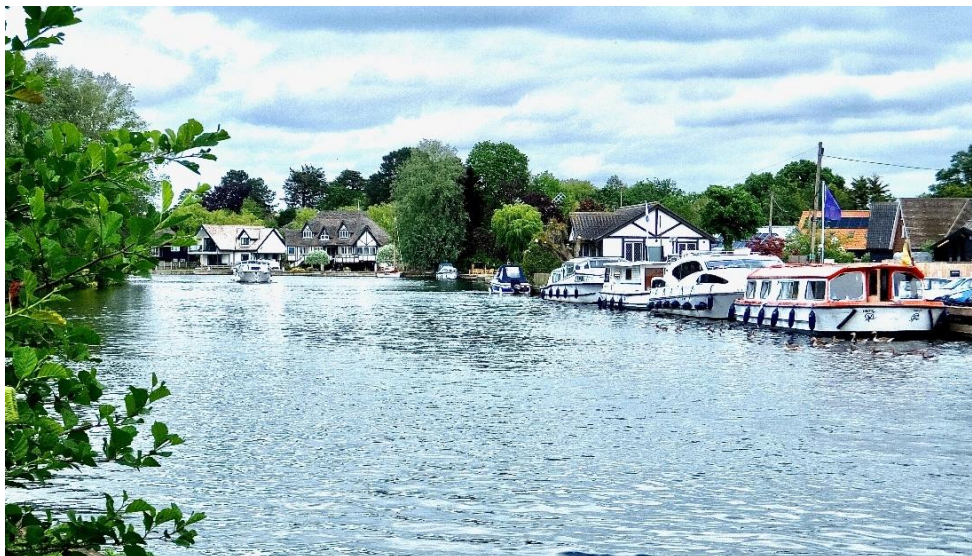
**Figures 12.8-12.10.** To the east of Wroxham is the busy village of Horning fronting the Bure. The watercolours by Alfred Heaton Cooper, c.1913, top and by Quinton, c.1920 (centre) can be easily compared with the present-day view (bottom). As at Wroxham, the development is restricted to a tight envelope with the Bure Marshes National Nature Reserve immediately to the west of the village.
