## 5.2. River Exe

The River Exe rises at Exe Head near the village of Simonsbath on Exmoor in Somerset, 8 kilometres from the Bristol Channel coast, from which it flows more or less directly south across Devon. Extending for a length of 96 kilometres, the Exe reaches the sea as a substantial ria, the Exe Estuary, on the English Channel coast. The Exe flows through a varied landscape, which is composed largely of sandstones, mudstones and limestones of the Devonian, Carboniferous and Permian Periods. The source of the Exe lies within a heather covered upland plateau, flowing through deeply incised valleys on its route southwards, before following a deep wooded valley past the small town of Bampton, and through richly wooded and fertile valleys to the ancient town of Tiverton, where its flows are swelled by the waters of the river Loman.

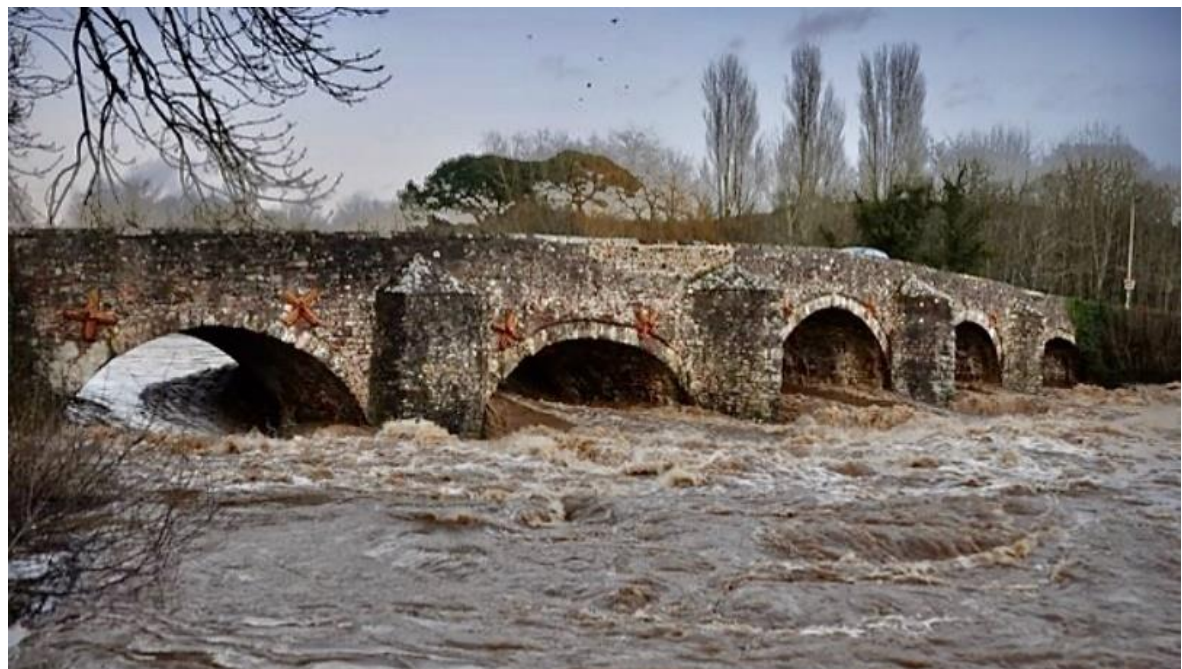
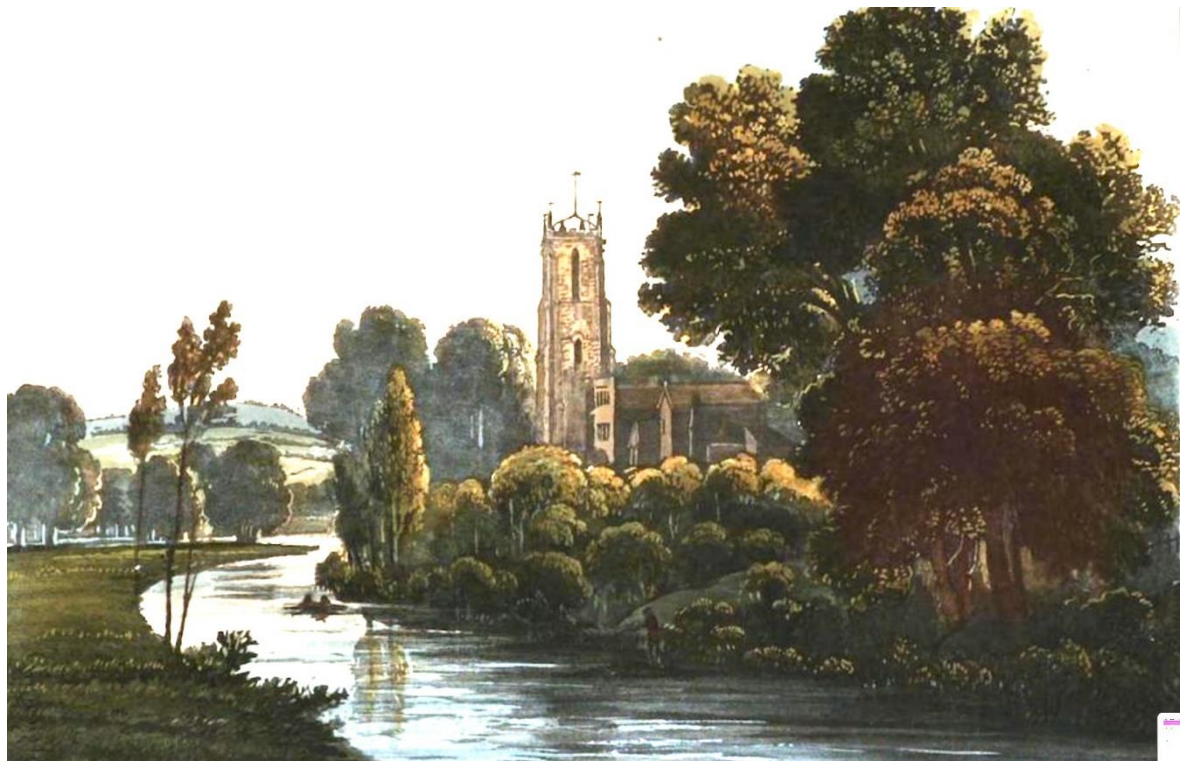
**Figures 2.5 and 2.6** show the River Exe at Tiverton in 1819 and in 1831 respectively. In the view above by Havell (above), the river follows its natural course through the vale adjacent to the church; the location has started to become more developed below, with properties on both sides of the river and the provision of a footbridge.

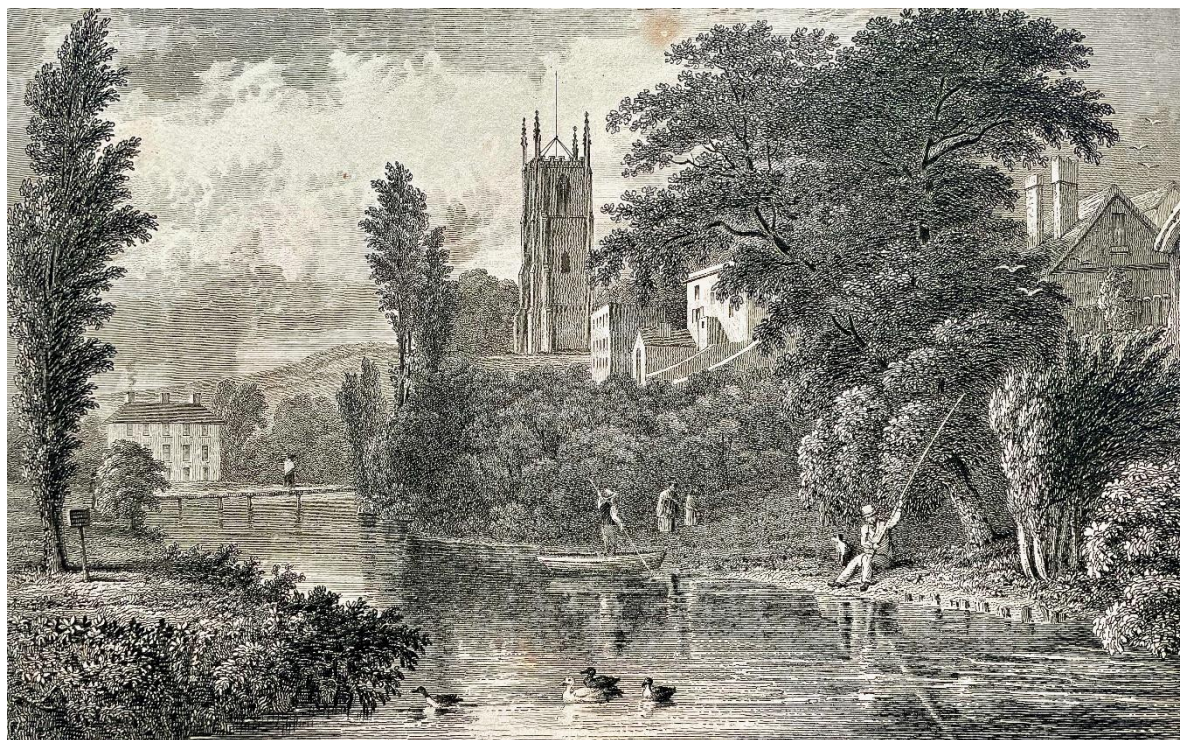
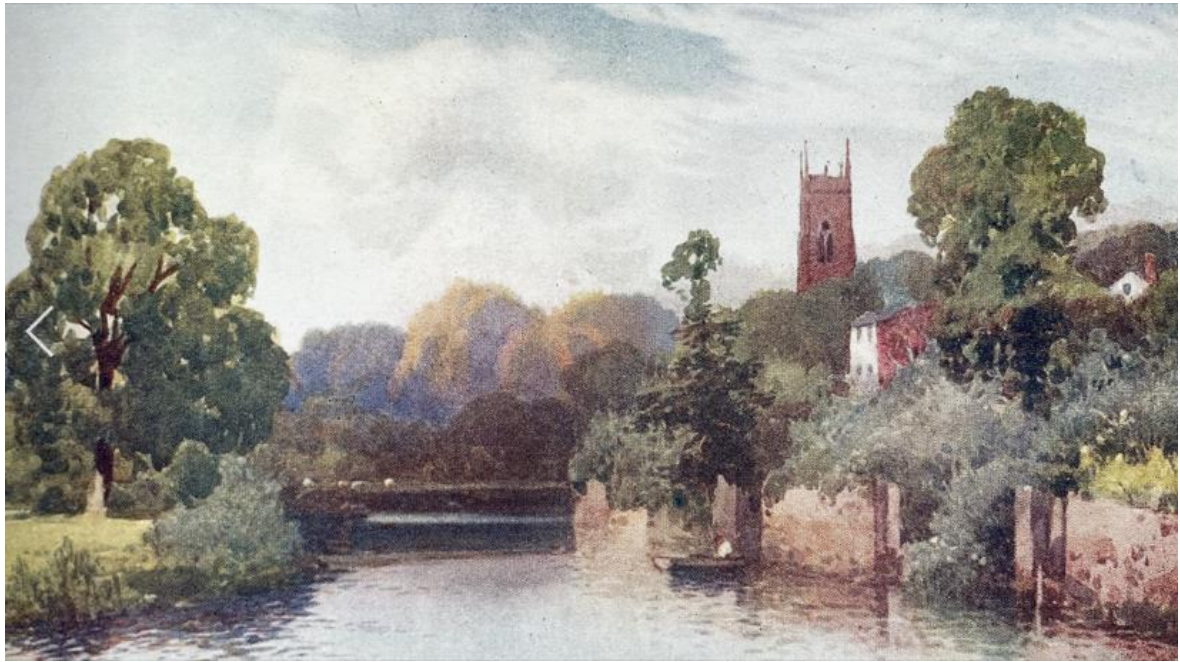
**Figures 2.7 and 2.8** show the same location at Tiverton in 1923 painted by Frederick J. Wiggery and the present-day view. Walls now border the river on the right, with undefended parkland on the left. In the present-day view, the far bank now has concrete flood defences and a road bridge has been installed. Flooding on the Exe, particularly upstream, continues to pose a threat to some of the villages abutting the river.

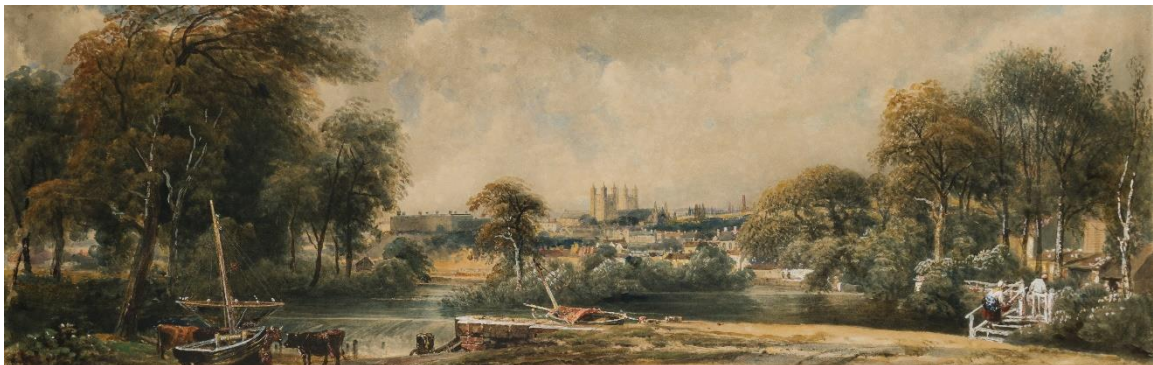
The present-day view, **Figure 2.11**, also shows the Exeter Canal, which was constructed in 1566 leading south from the city's historic quayside, down towards Topsham and the mouth of the Exe.

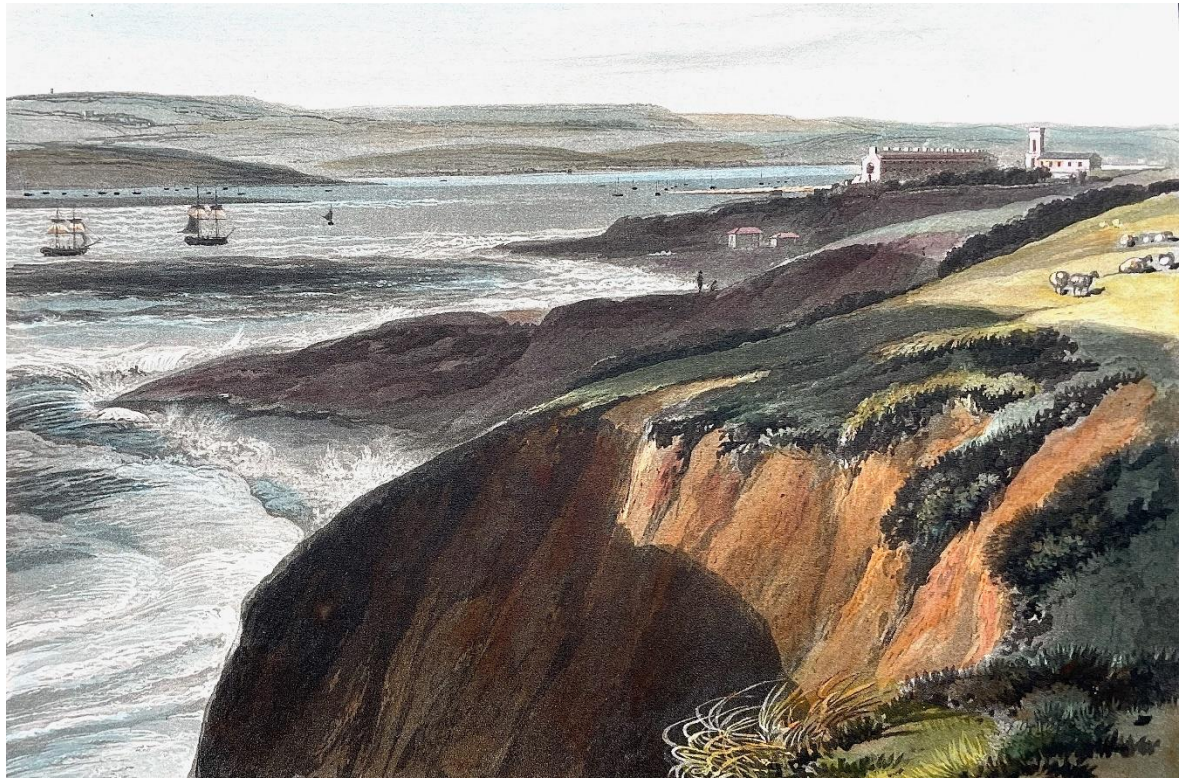
The natural state of the estuary appears to show little change in the present-day photograph, **Figure 2.18 (below)**, and points to careful management of the natural environment. Although the coastline is now defended towards Exmouth, the striking sandstone shown in Daniell's view remain undefended.
