5.5. Western Yar, Isle of Wight

5.6. Eastern Yar, Isle of Wight

5.7. The Sussex Rother

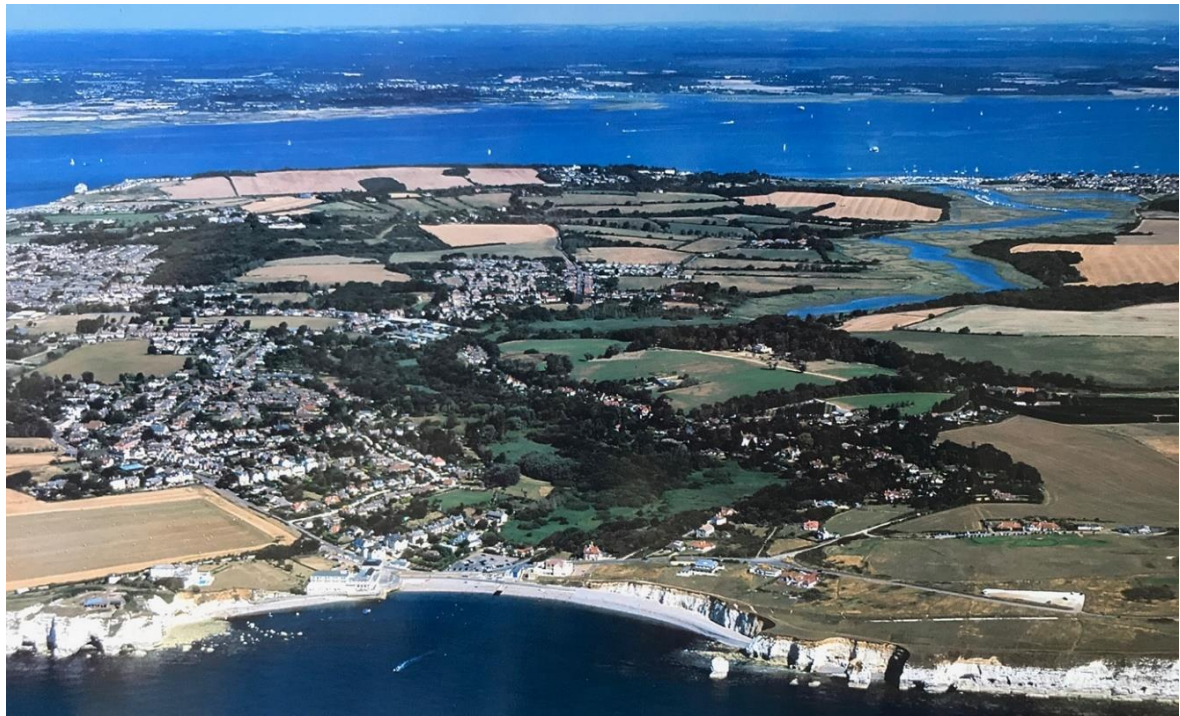
Figure 5.1: Contrasting landscapes with the cliff line of Upper Chalk in the foreground at Freshwater Bay and immediately to the north of the Bay the headwaters of the Western Yar, which flows north into the Solent beyond.

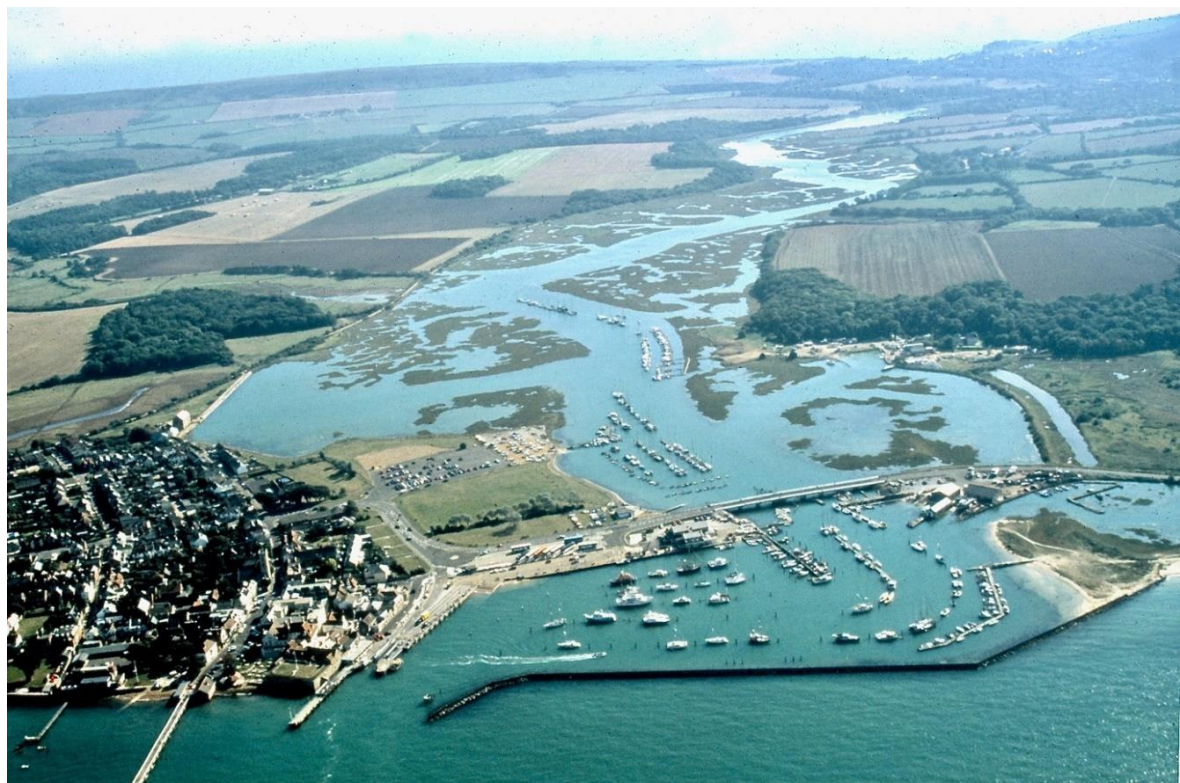
Figure 5.2: The Western Yar after several weeks of rainfall; the ancient town of Yarmouth appears to be almost surrounded by water. With sea level rise the designated inter-tidal saltmarshes and mudflats are likely to be increasingly at risk.

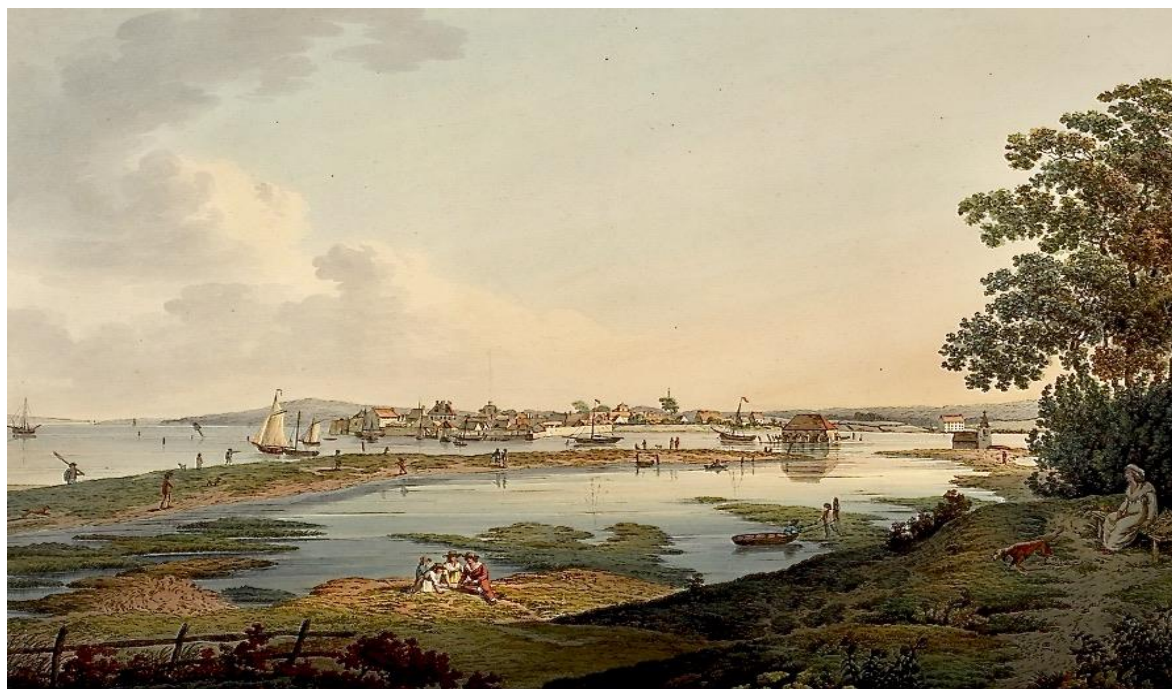
Figure 5.3: For a copperplate engraving from 1813 this early view of Yarmouth from the western side of the harbour is exceptionally detailed. The scene is taken at High Water and shows the ancient sand hut in the river where the white sand from Alum Bay used in making ceramics was stored prior to shipment. A bridge was constructed across the river in the 1850s and a harbour arm was built to shelter craft in the harbour from Solent storms.

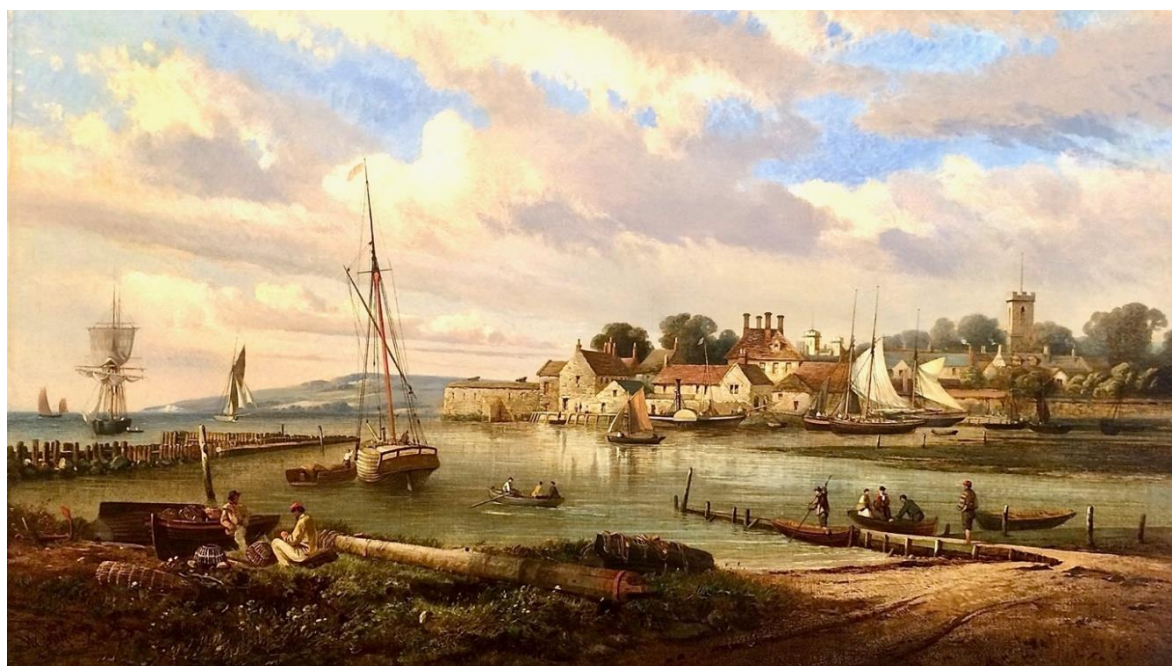
Figure 5.5: This detailed watercolour by Charles Robertson of Yarmouth Harbour and estuary from the west was painted in 1891. Robertson was a follower of the Pre-Raphaelite Brotherhood of Artists whose philosophy was to paint nature truthfully and accurately down to the finest detail. As a result, their works, in particular, provide an important record of past river conditions. Private Collection.

Some artworks, such as the view by Robertson described above, can provide detailed, almost photographic information on the river environment at the time they were painted. Through this study a large number of such artists, who specialised in painting England's river scenery, have been ranked in terms of their topographical accuracy. This initiative saves researchers the need to undertake time-consuming investigations on the question of artistic accuracy and truthfulness, thereby enabling them to search with confidence on art websites, such as ArtUK and Watercolour World, in order to identify those art resources existing for their particular area or location of interest.

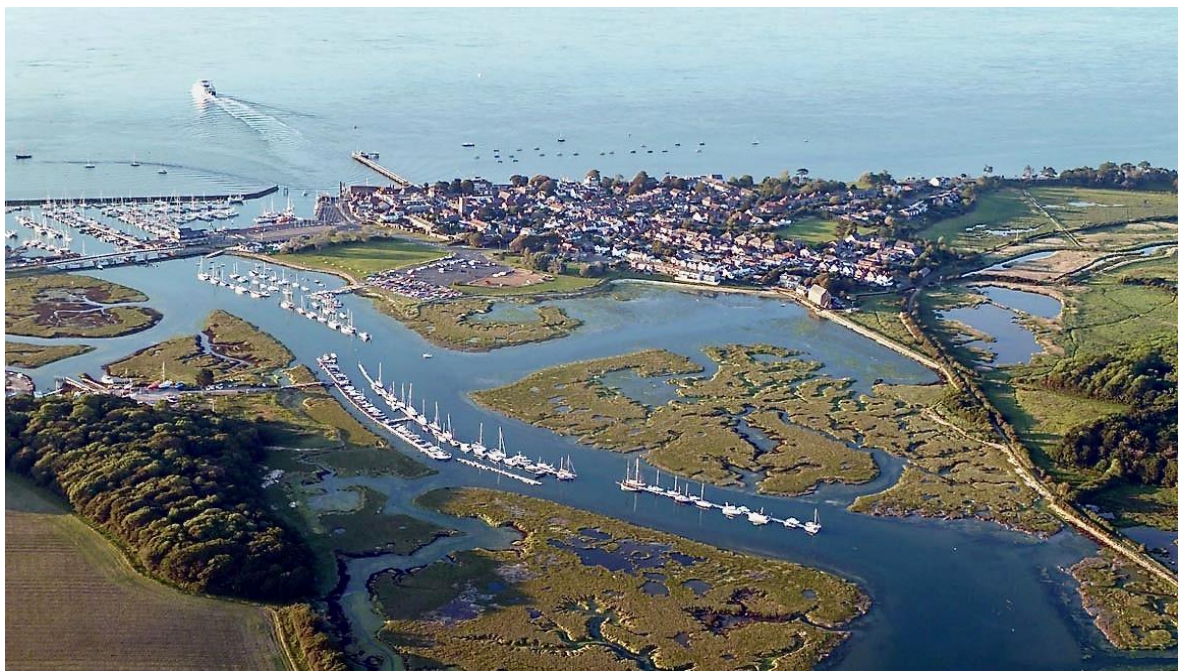
Figure 5.6: The present-day oblique aerial view shows the estuary at High Water with the extensive saltmarshes and mudflats largely obscured. A situation that is becoming increasing common across the river mouths and estuaries bordering both sides of the Solent. Courtesy: Visit IW.

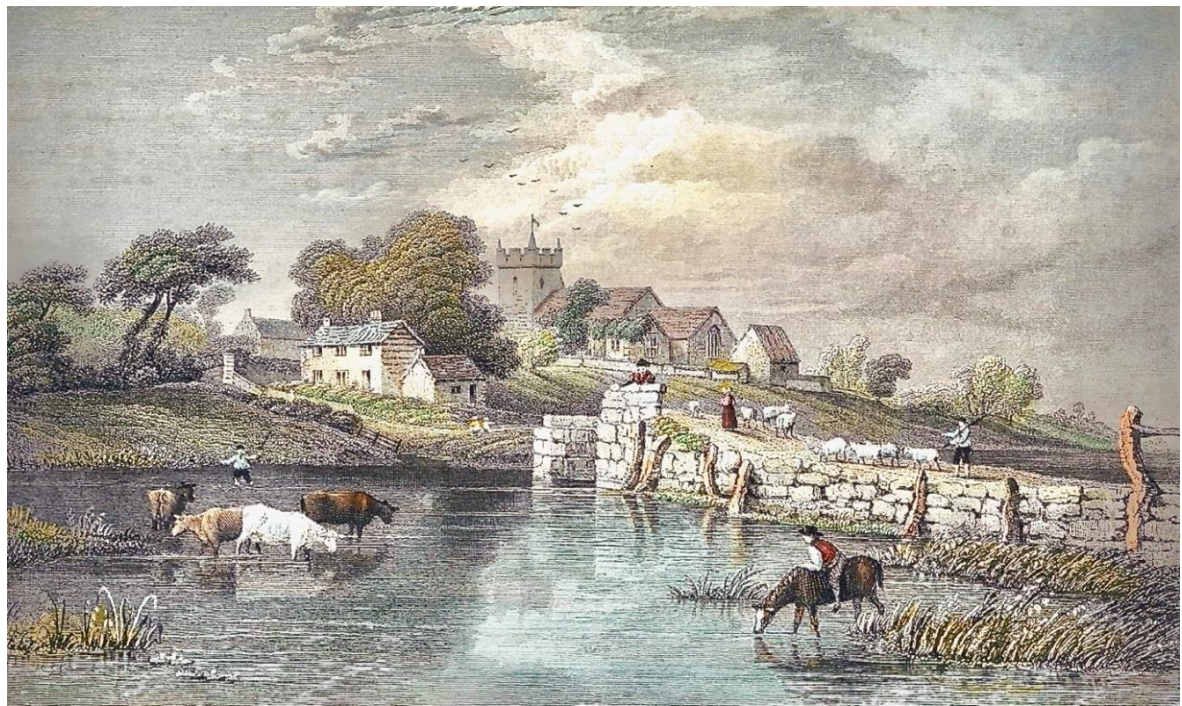
Figure 5.7: The upper reaches of the Western Yar are shown in this steel plate engraving by William H Bartlett in c.1830. The engraving shows a view at The Causeway bridge from the southern side looking towards Freshwater Church. The view with the open water upstream of the bridge contrasts markedly with the present-day view in **Figure 5.8 (below)** which is covered with Ash and reedbeds, now a protected habitat.

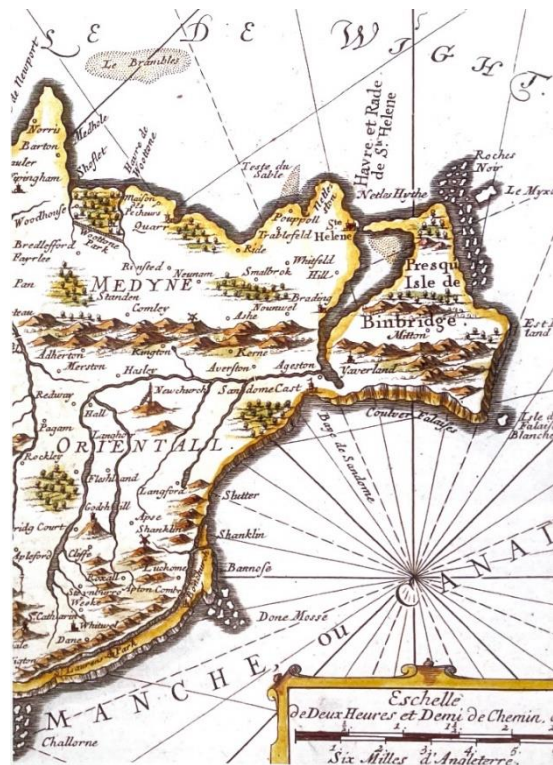
Figure 6.1: Detail of a map of the Isle of Wight by Nicholas de Fer (1762). It shows the course of the Eastern Yar from the northern side of the downs behind Ventnor, before it cuts through the central chalk downs to emerge at Bembridge Harbour. The passage of the river almost created the 'Isle de Bembridge' to its east rather as the Western Yar does also at Freshwater Bay.

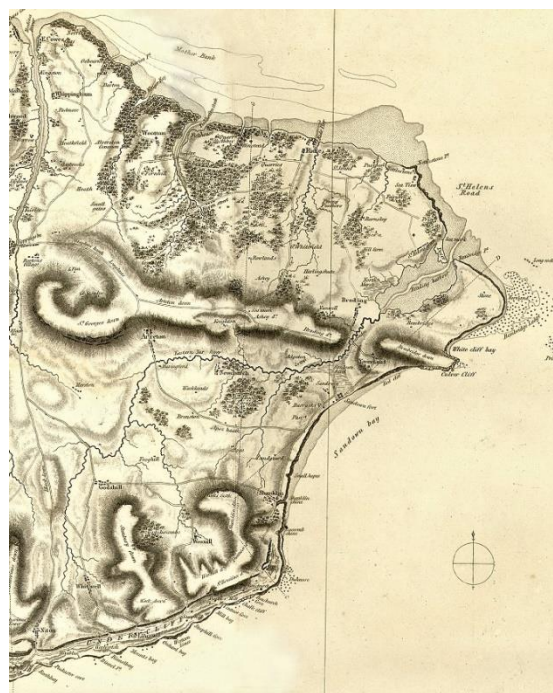
Figure 6.2: This map of the Isle of Wight by Sir Henry Englefield (1816) shows the extent of the Eastern Yar catchment, emerging as springs from the Gault Clay springline behind Wroxall and Whitwell, before joining to cross the Arreton Valley, and then subsequently forming a cutting through the Chalk Downs to emerge at Brading Harbour.

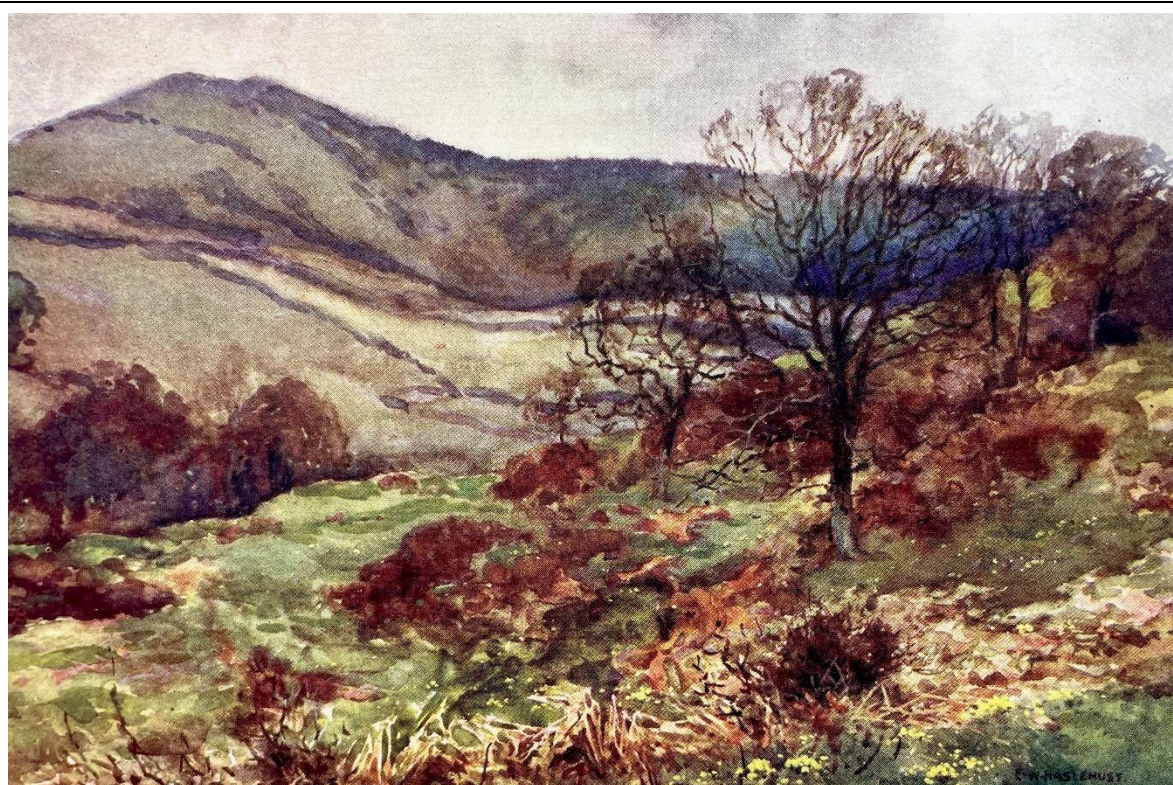
Figure 6.3: This watercolour by Ernest William Haslehust (c.1920) shows the Southern Downs from the northern side. The Downs are composed of chalk which overlies the Upper Greensand and the Gault Clay. Rainwater percolates through the permeable strata above to the Gault Clay springline, where it emerges as a stream, which forms the source of the Eastern Yar.

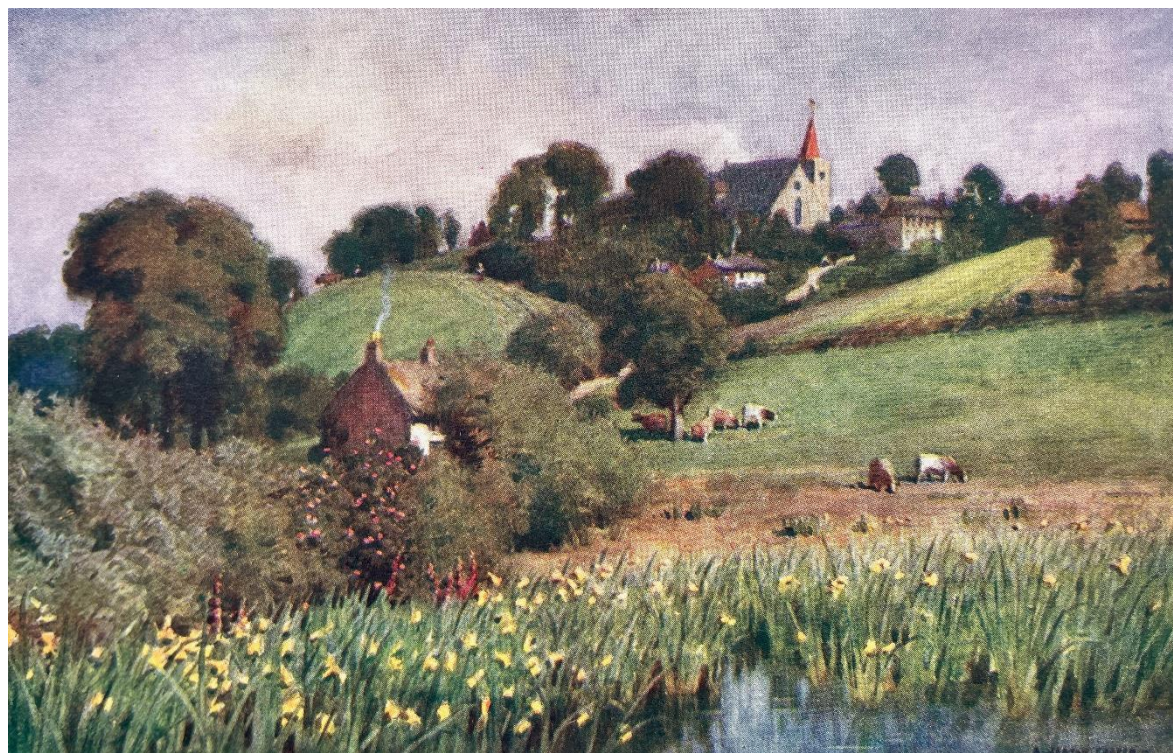
Figure 6.5: A further view of the Eastern Yar in flood conditions near Alverstone, also by Alfred Heaton Cooper. Images such as this show how river systems could cope with flood events in the past, through overtopping of the banks and the creation of adjacent water meadows. In some locations increased development has encroached on water meadows and floodplains, posing a consequent risk to properties and businesses located in the vicinity.

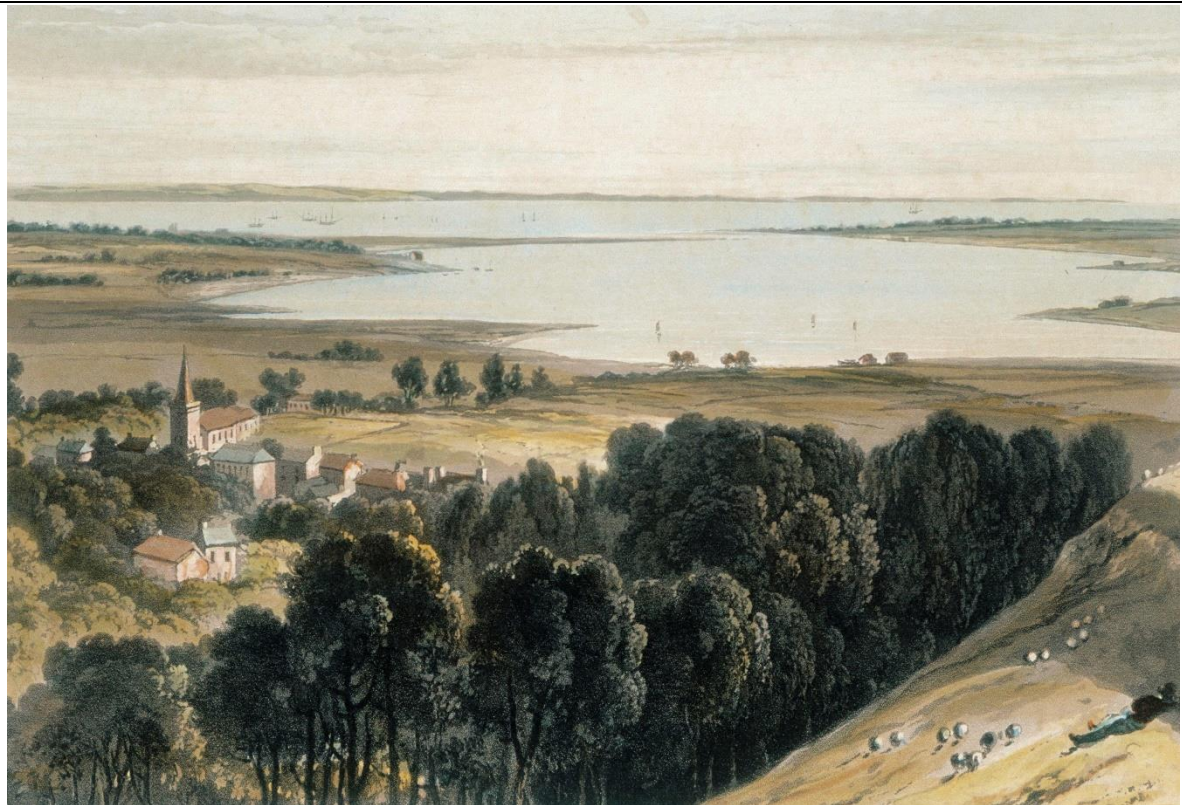
Figure 6.7: This fine aquatint engraving by William Daniell (1823) as part of his *Voyage Round Great Britain* (Daniell & Ayton, 1814-1825²) is taken from the downs to the south, and looks across Brading towards the harbour (then at its full extent before subsequent drainage). From such images it is possible to view river systems and estuaries in their natural, unaltered state. Such information proved useful when undertaking studies and investigations, such as the *Eastern Yar Estuary Management Plan* (2007²) and the *Eastern Yar Restoration Plan* (Arup, 2015³).

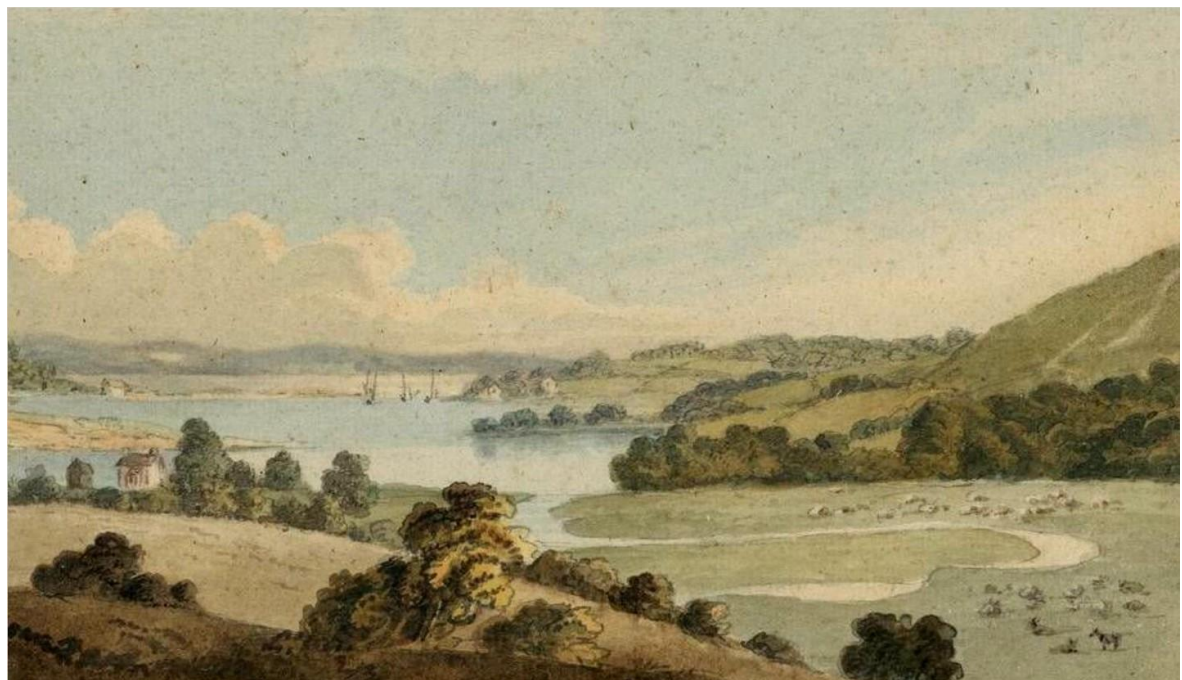
Figure 6.8: This watercolour drawing by John Nixon (c.1770) shows the meandering course of the Eastern Yar as it emerges to the north of the Central Downs. Some of the meanders and ox-bow features can be seen in the annotated aerial photograph as Figure 6.17 on page 97.

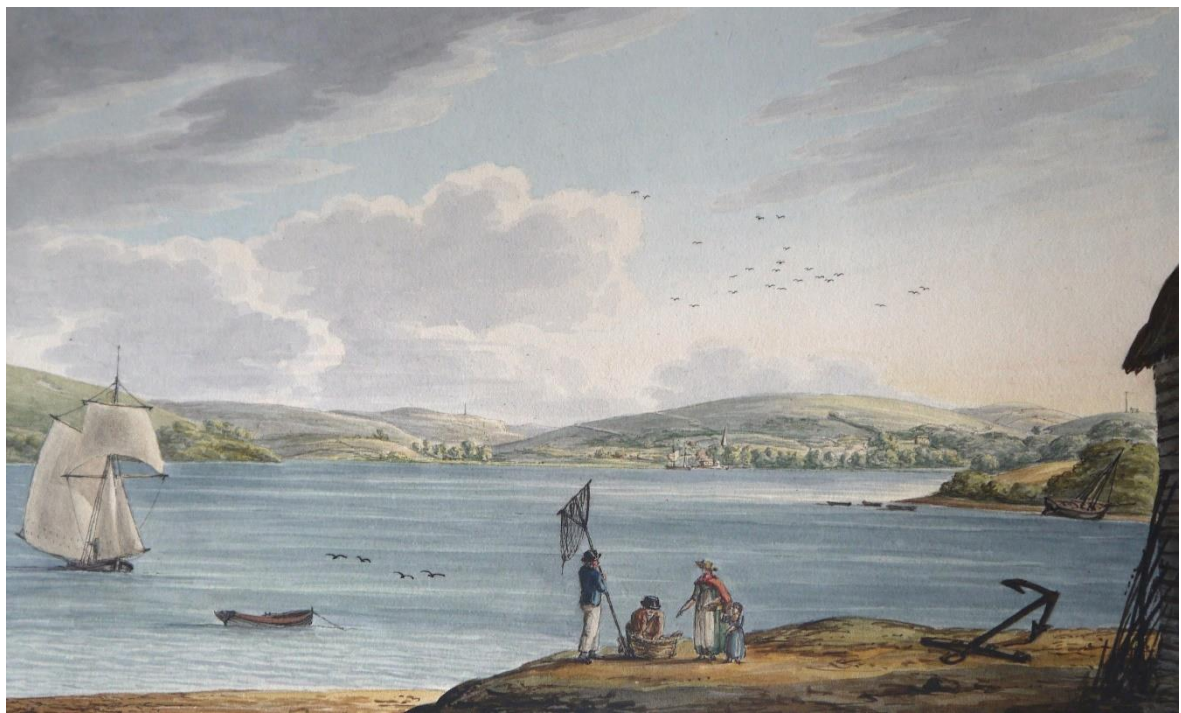
Figure 6.9: This watercolour by Charles Tomkins (1809) provides a panoramic view looking across Bembridge Harbour northwards from the spit at St Helens. The town of Brading with the church spire can be seen (centre right) and the true extent of this waterway, before drainage took place, can be fully appreciated. Extending to some 324 ha, the harbour was able to accommodate a significant number of Men O' War from the Armada Fleet. Private collection.

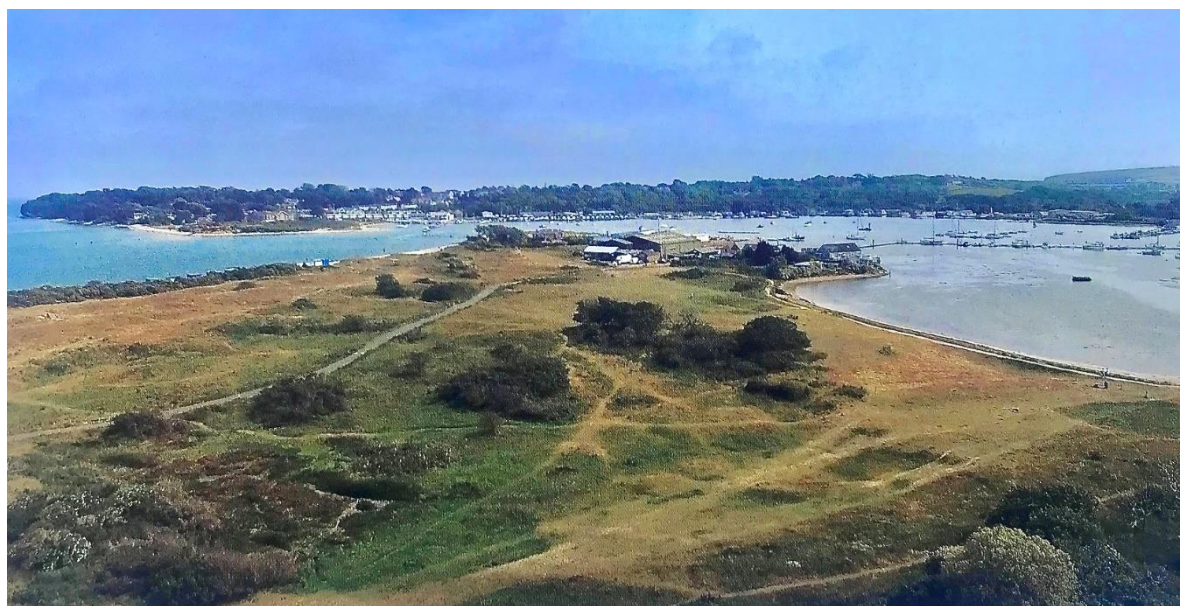
Figure 6.17: This aerial photograph shows some of the features of the Eastern Yar at Bembridge Marshes with the Harbour beyond. The RSPB has been actively working to improve the wildlife habitats since acquiring the site.

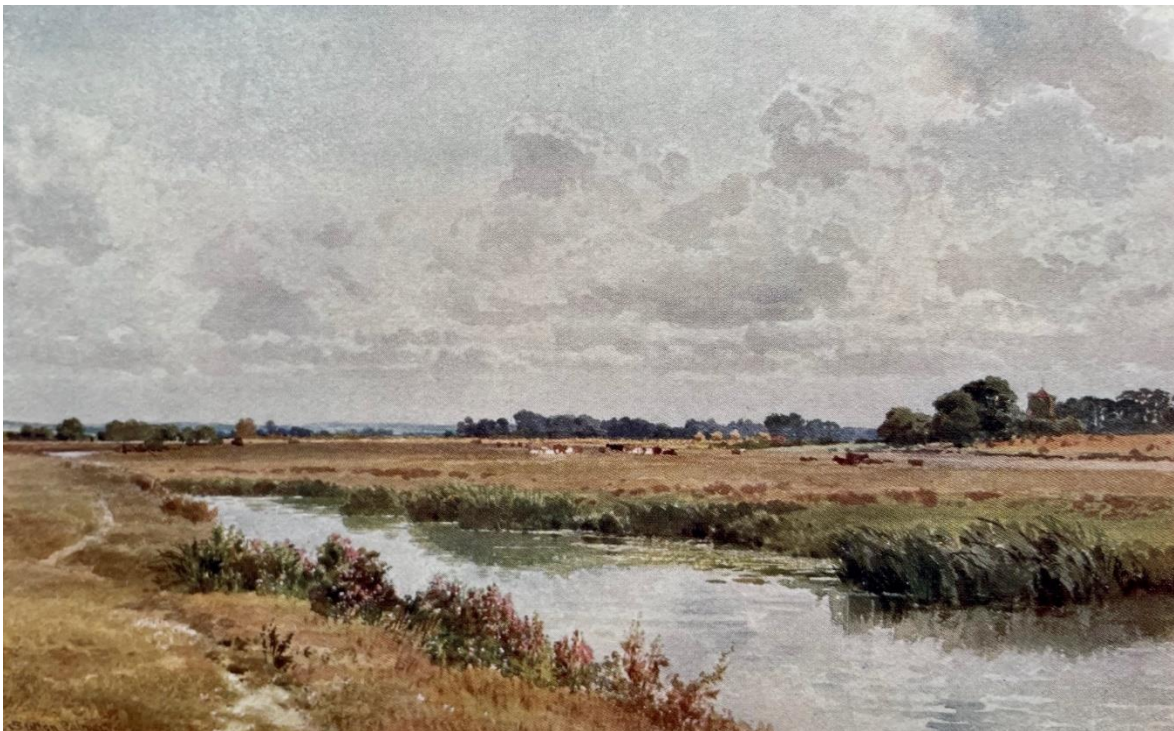
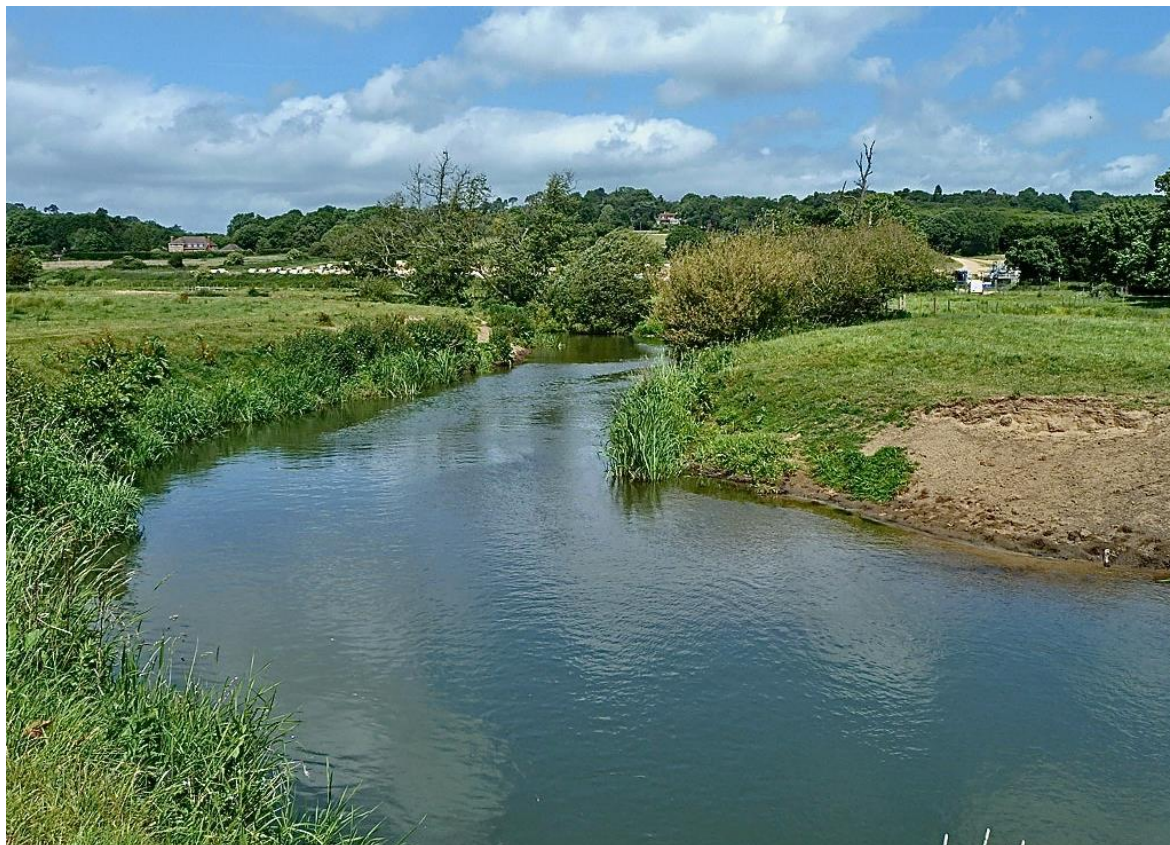
Figures 7.3 (above) and 7.4 (below) provide comparative present-day views of the Rother scenery near Fittleworth. Apart from the earth flood embankments bordering the river, the scene appears to show little change over the last century.

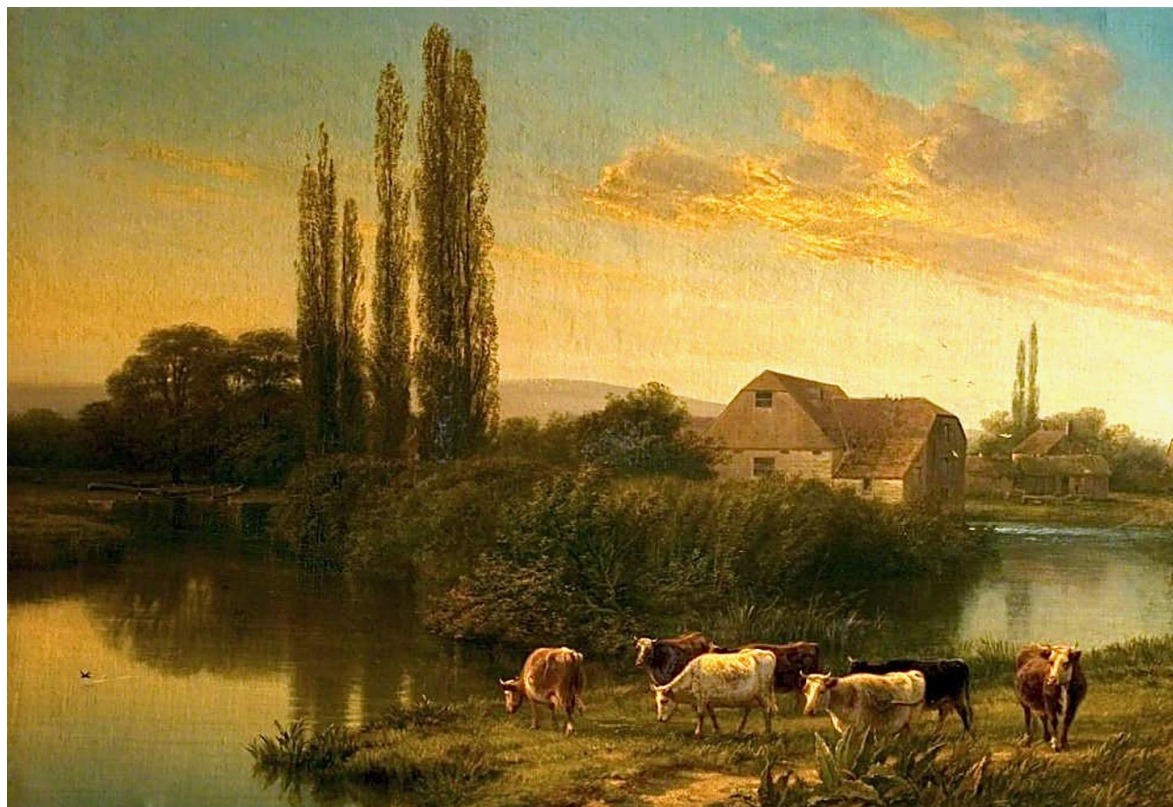
Figure 7.7 (above) shows the nature of the river scenery at Fittleworth Bridge close to the mill today. The river is much narrower and is contained between flood banks, although a wide flood plain is clearly evident.

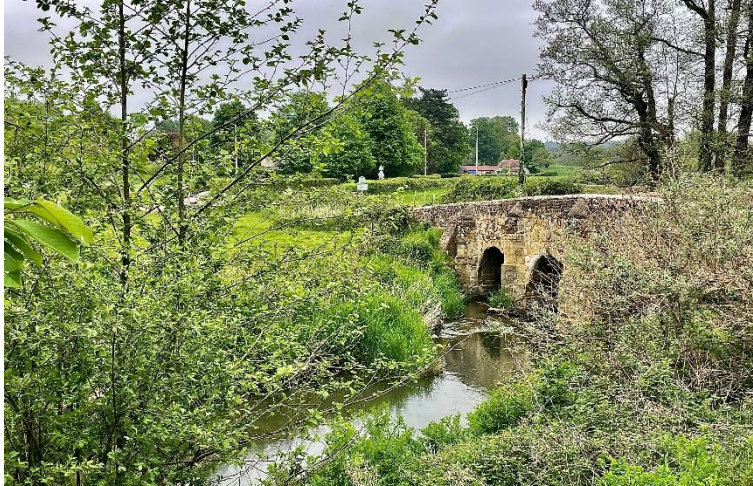
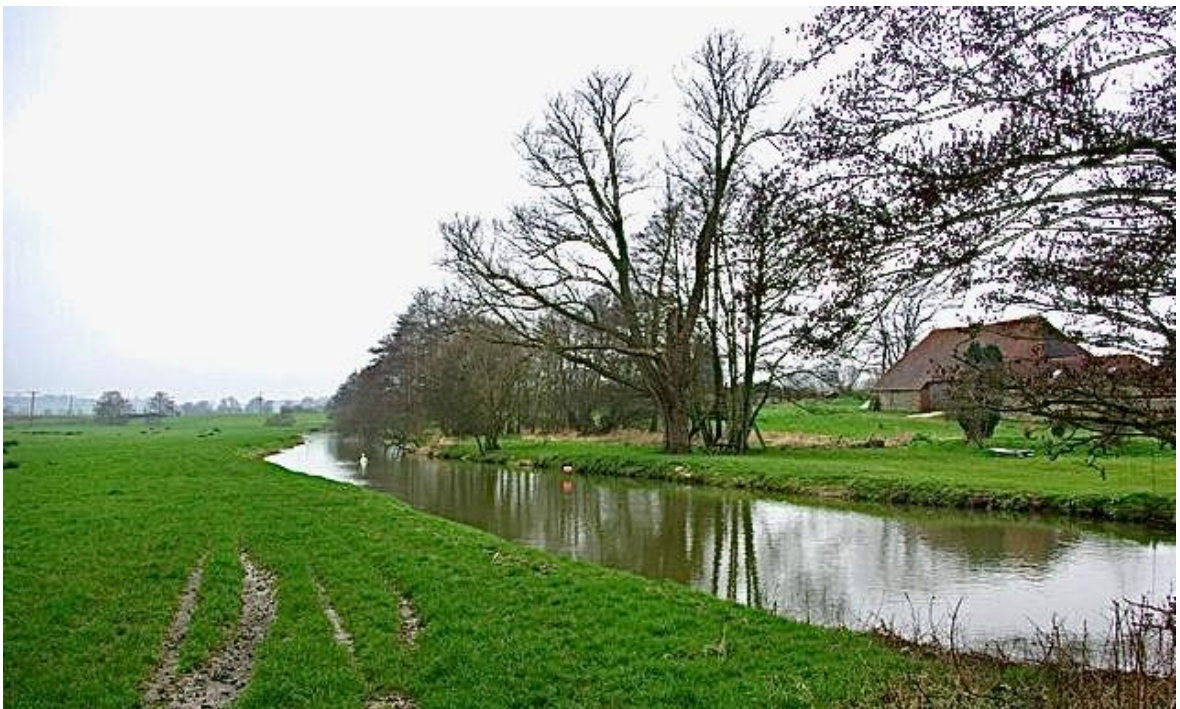
Figures 7.13-7.15 on this page show the rural character preserved along the course of the Rother at Habin to the south of Rogate (top) and at Rotherbridge (bottom).

Particularly in the narrower sections of the river there is evidence of active riverbank erosion and under-cutting, whilst the scene (bottom) shows the river close to overtopping.
