# Chapter 4: Case Studies

# Case Study 1 - The North-East Coast of England

## Case Study 1.1 – Berwick-Upon-Tweed to Amble, Northumberland

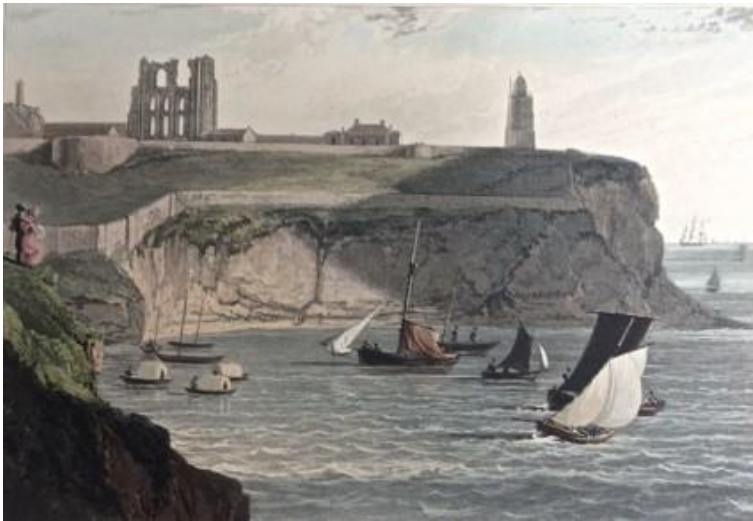
**Fig. CS1.1.5. (left)** *'Tynemouth'* by William Daniell RA, 1822, showing the ruined Priory and the lighthouse on the headland. The cliff shows signs of instability with debris at its foot.

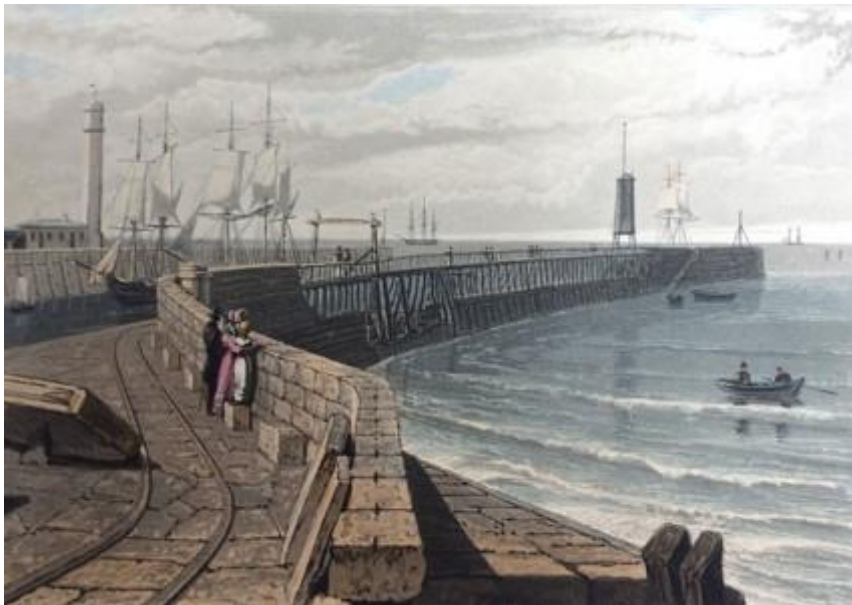
**Fig. CS1.1.10.** '*Sunderland Pier*' by William Daniell, 1822. At the time of his visit the structure had been damaged by severe easterly storms. Over the next century and a half, the harbour and its lighthouses were continuously improved, although storm damage is still a risk today.

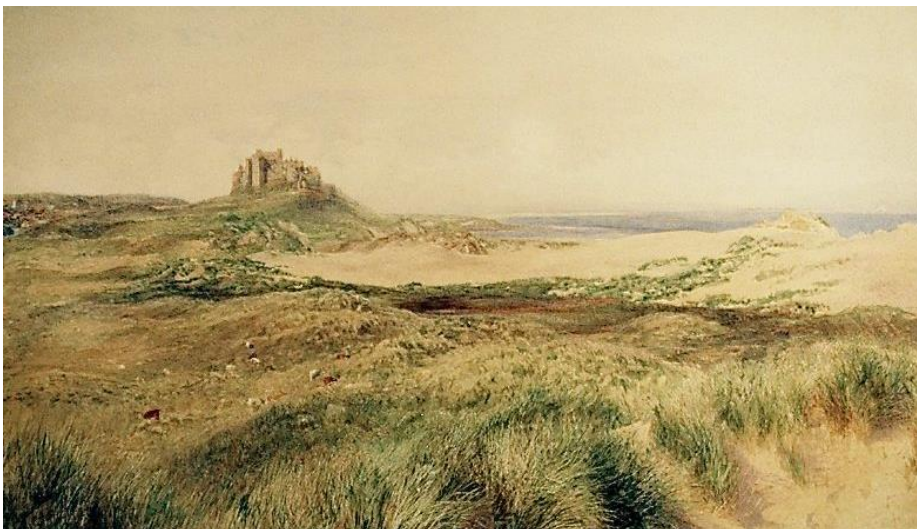
**Fig. CS1.1.23.** Early artworks often allow us to view the natural environments of the time. Here Alfred W. Hunt's watercolour (c.1870s) shows the nature of the dune coast surrounding the Castle at that time.

In terms of the natural environment, the coastal dune systems in the vicinity of Bamburgh Castle are illustrated by the watercolourist, Alfred William Hunt (see **Fig. CS1.1.23**), whilst a view of the Farne Islands by John Wykeham (**Fig. CS1.1.24**) below shows the rich ornithological interest of the islands in the middle of the nineteenth century.

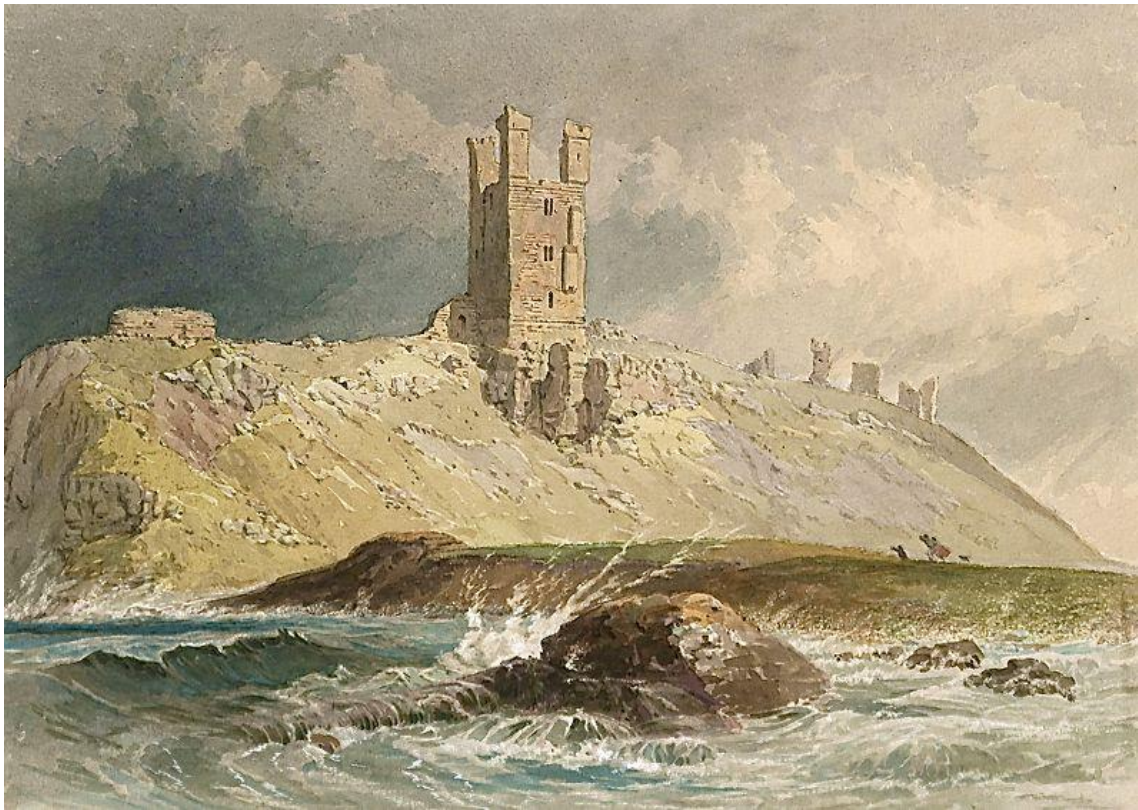
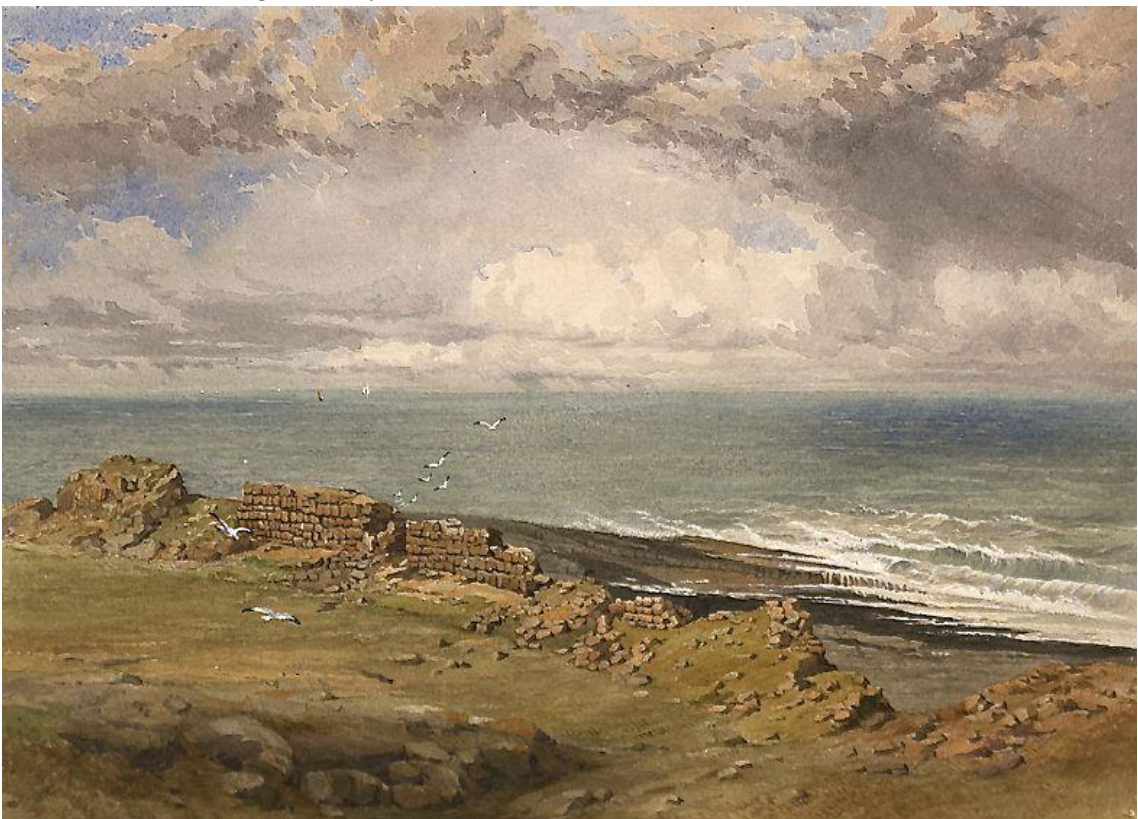
**Fig. CS1.1.25. (above) & CS1.1.26. (below)** A pair of very detailed watercolours by John Wykeham painted in 1853 and 1856 respectively, which show the gradual deterioration of Dunstanburgh Castle, which is located between Embleton and Craster. Such images form important records of the changes and losses affecting our coastal heritage.

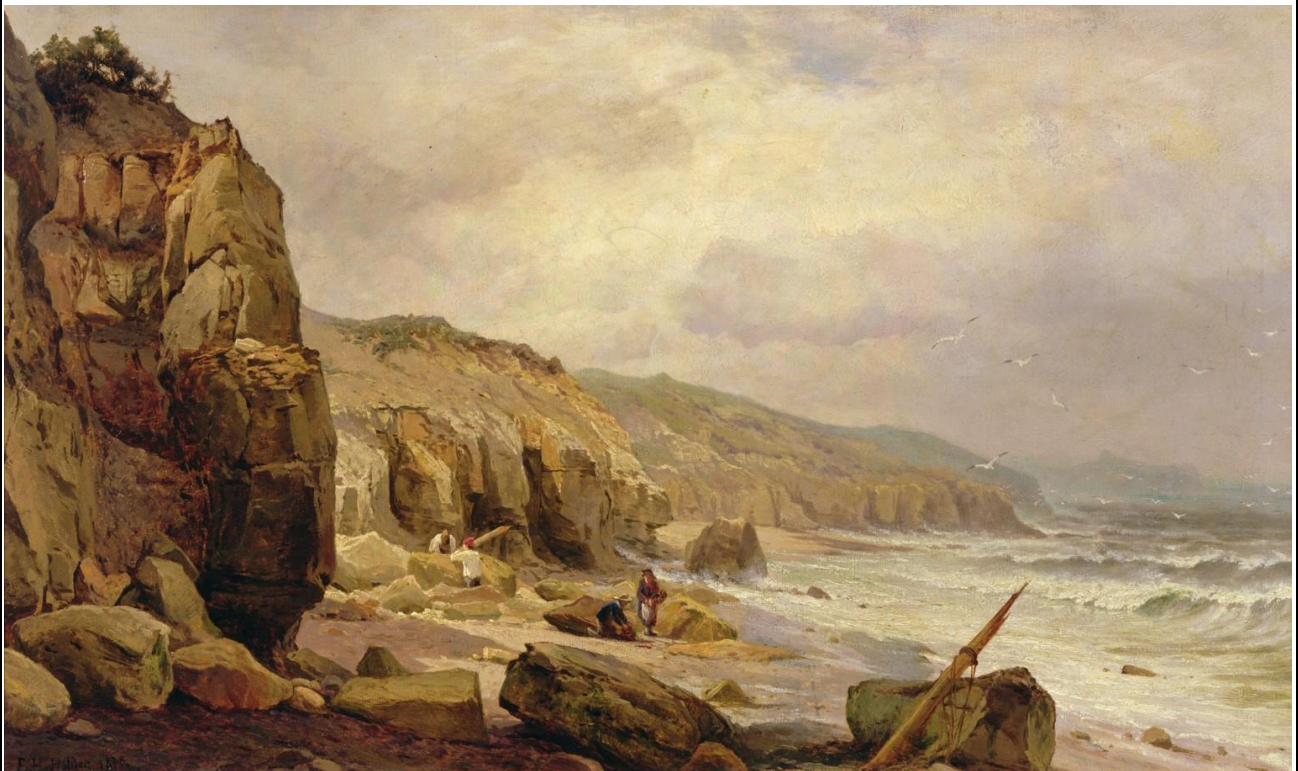
**Fig. CS1.2.1.** This oil painting by Edward Henry Holder depicts '*Cornelian Bay, Scarborough*' in 1878. Painted between White Nab and Knife Point, the unstable nature of the cliffline is clearly illustrated.

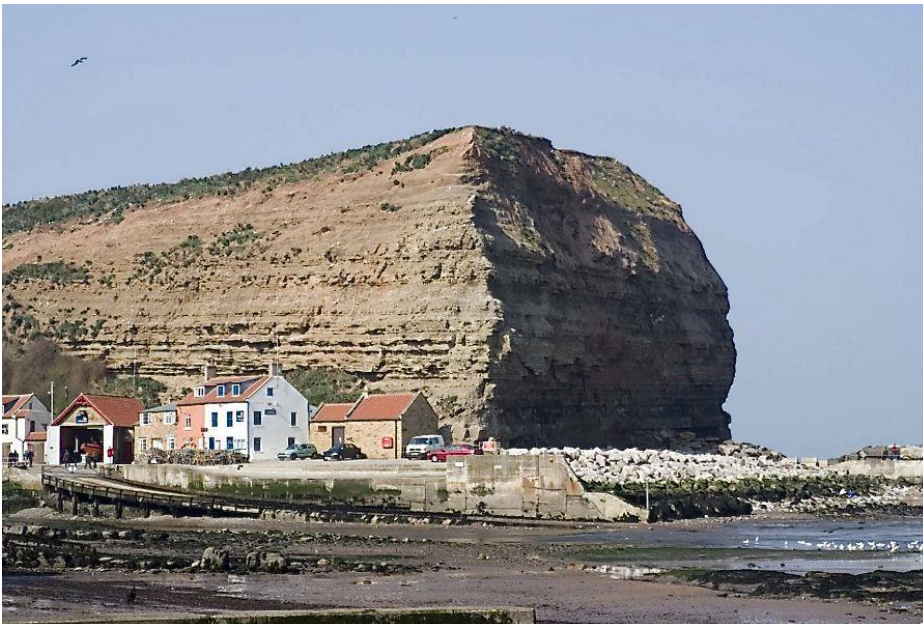
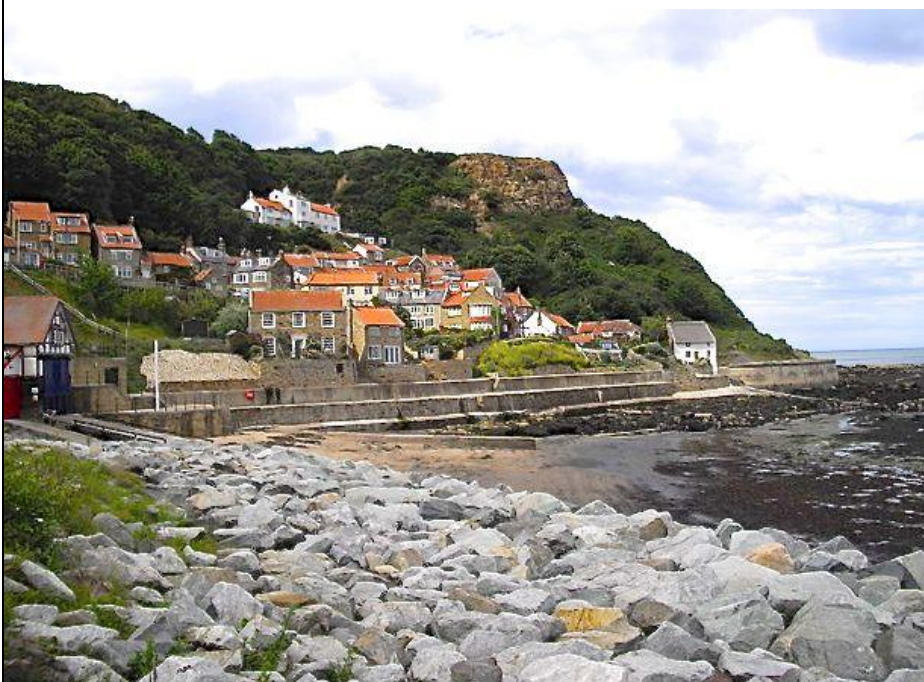
**Fig. CS1.2.5. (top) & Fig. CS1.2.6. (middle)** illustrate little change in the physical appearance of the cliffline and beach since the 1920s. The constrained nature of the site of the village has ensured its architectural charm has been largely preserved.

Coastal erosion has required the placing of rock armour below the cliffs to the north of Staithes Wyke and some further protection may be required depending on the rate of cliff retreat.

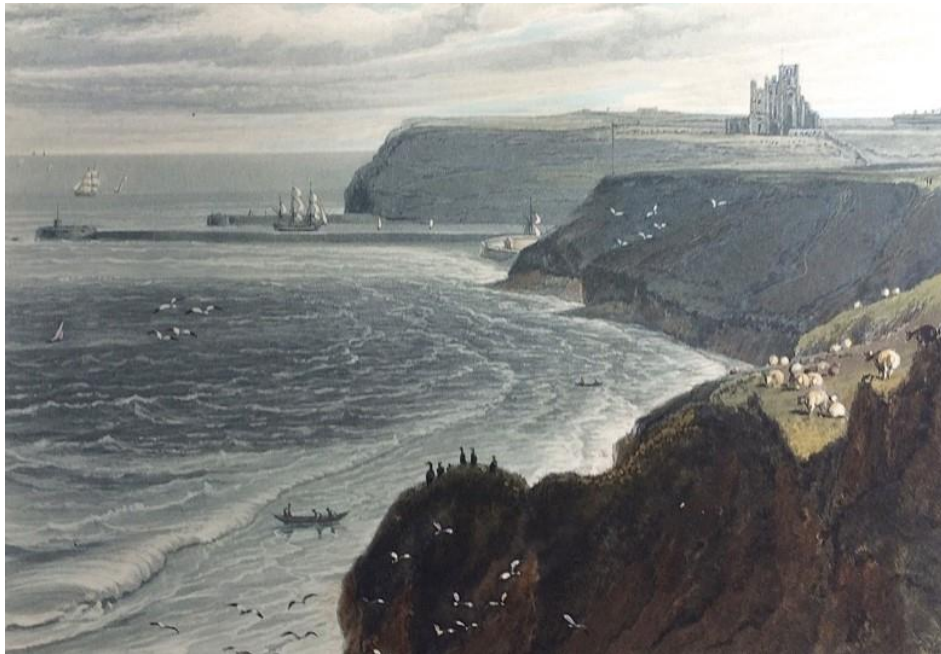
**Fig. CS1.2.8.** William Daniell RA travelled down the Yorkshire coast painting Whitby and Scarborough in 1822. This view looks south towards the harbour mouth with the unstable cliffline in the foreground.

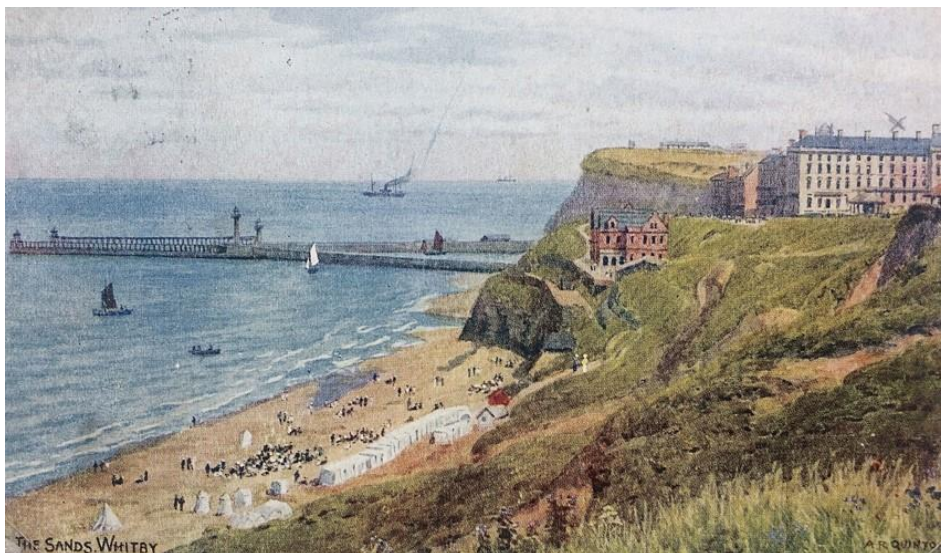
**Fig. CS1.2.9.** By the time Alfred Robert Quinton visited the same location one hundred years later, the cliff tops were developed with fashionable residences and hotels. The sandy beach is healthy but the cliff in the foreground shows signs of instability.

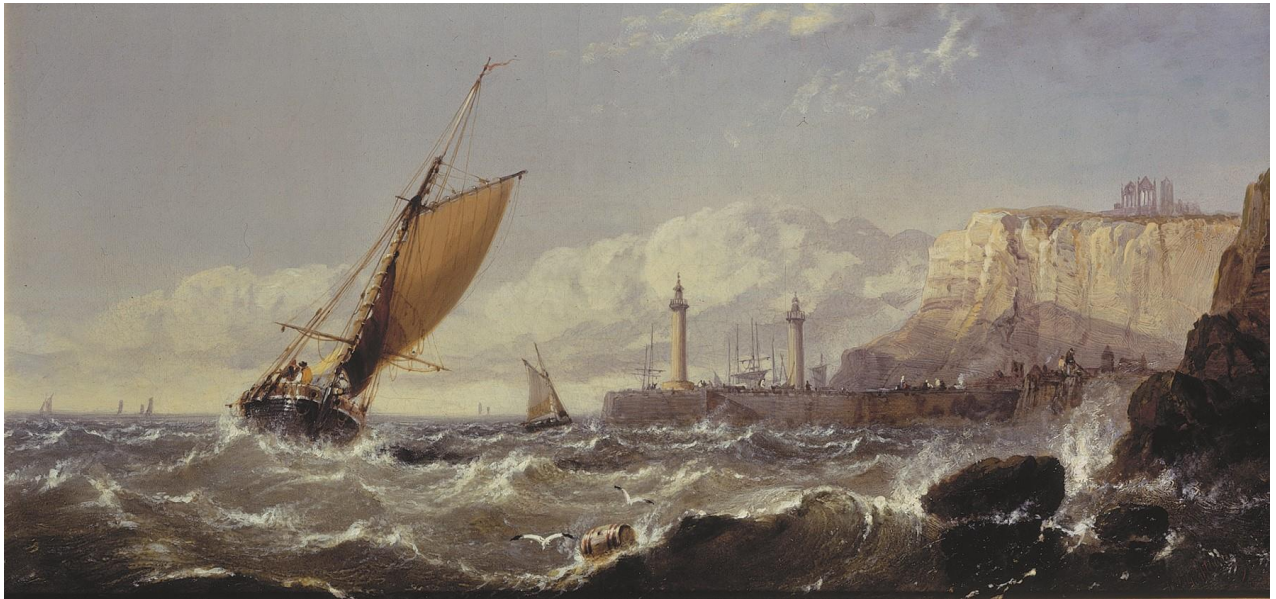
**Fig. CS1.2.11. (above)** *'Choppy Waters off Whitby Harbour'* by Arthur J. Meadows; a late nineteenth century oil painting. The harbour arms with their tall lights can be seen clearly and date from 1831.

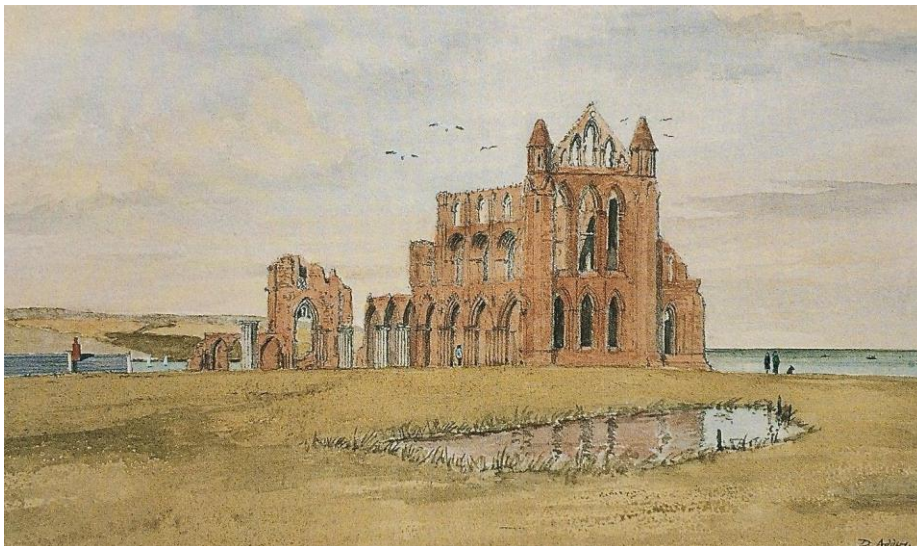
**Fig. CS1.2.17.** shows the same scene by the distinguished architect and watercolourist, David Addey, who followed in Daniell's footsteps painting from the same locations 180 years later. The ruins of the Abbey have deteriorated with the loss of the tower, although other restoration work can be seen. Image courtesy of David Addey.

This sequence of three views of Whitby Abbey (1822, 2002 and present day) show the ruin depicted over time.

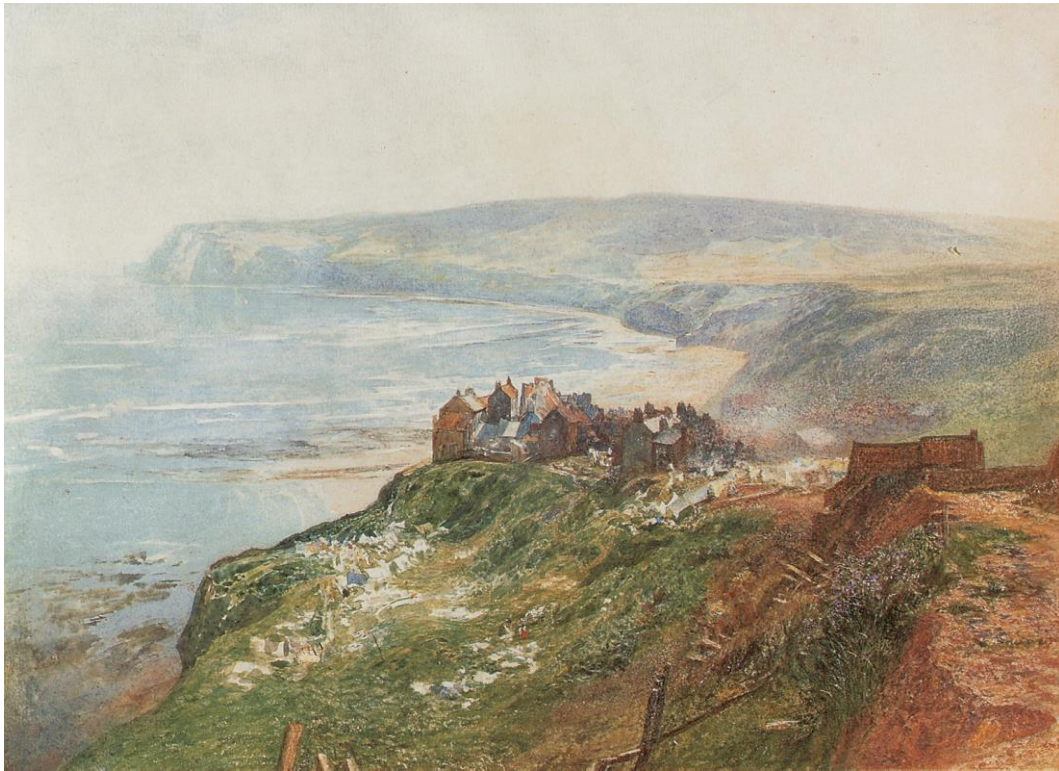
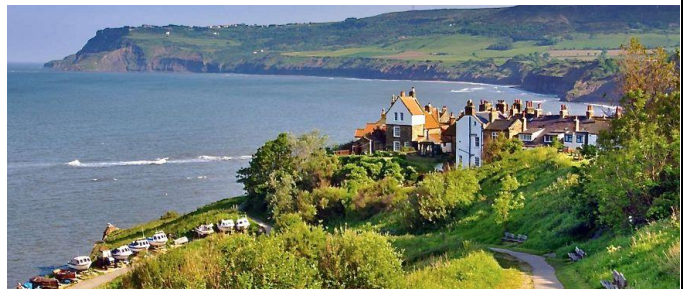
The pair of watercolours (**Fig. CS1.2.19. above** and **Fig. CS1.2.20. below**) are by Alfred William Hunt and Myles Birket Foster respectively; both artists are recognised for their detailed, accurate depictions. Painted twenty years apart, it can be seen that a section of cliff has been lost below the cottages in Birket Foster's later view (below). A substantial seawall provides protection for the village today.

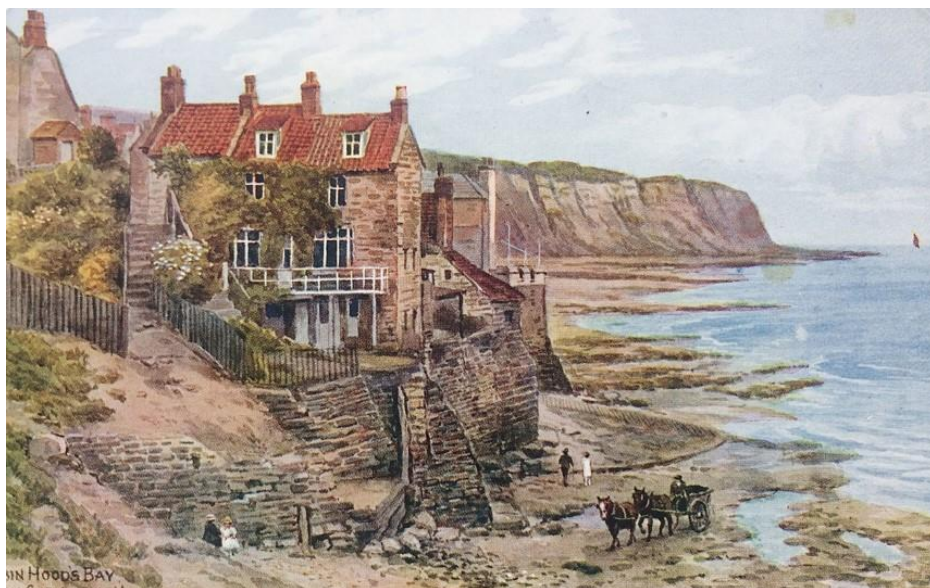
**Fig. CS1.2.22.** This watercolour by A. R. Quinton shows the cottages adjacent to the beach in c.1920. The extensive shore wave cut platform of Jurassic sequences of rocks is visible (see also **Fig. CS1.2.25. middle**). Quinton's watercolours such as this offer a wealth of detail, including the nature of construction of coastal defences, architecture and the early layout of the coastal villages.

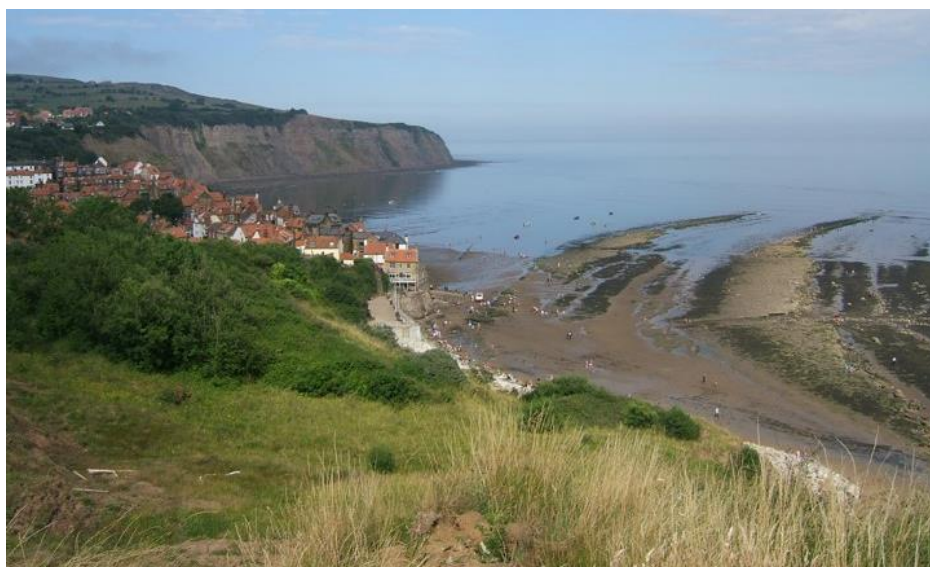
**Fig. CS1.2.23.** This present day photograph looks north-west towards the headland, which offers little protection from north-easterly and easterly waves. As a result, the original coastal defences have been strengthened with rock armour.

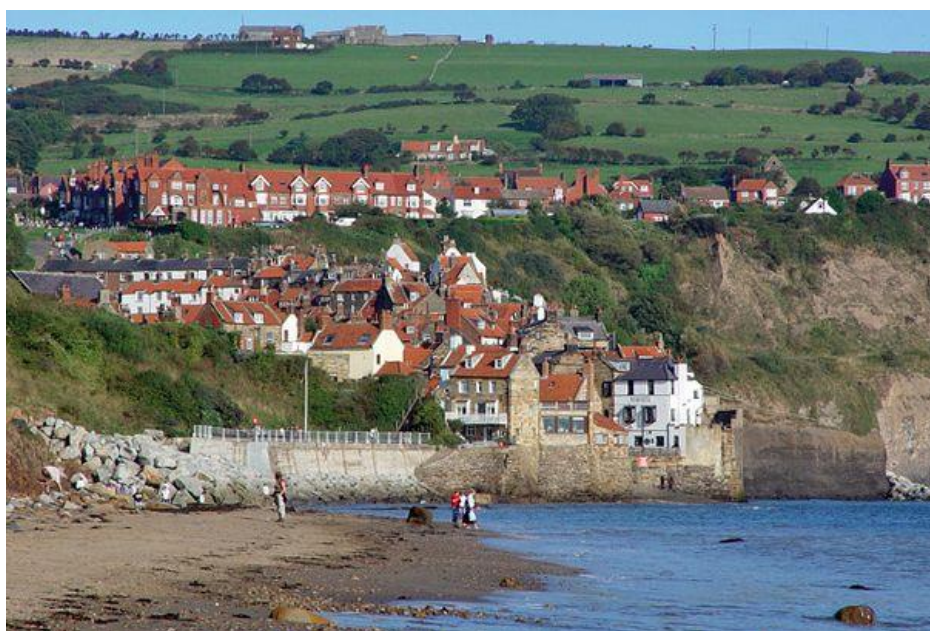
**Fig. CS1.2.24.** This photograph shows the village of Robin Hood's Bay from the sea. The steep cliffs on the right are now protected by rock armour as is the frontage to the left of the seawall.

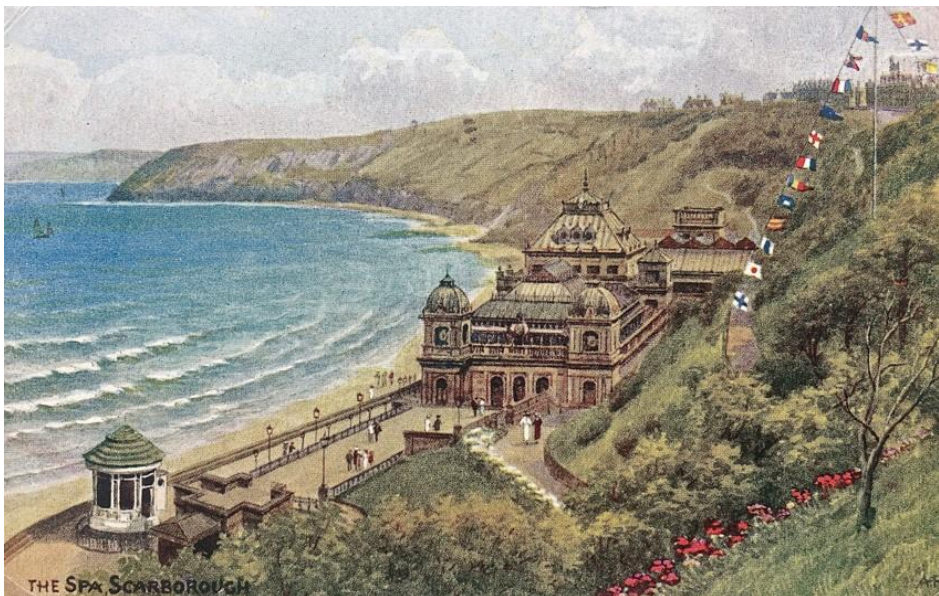
**Figs. CS1.2.30.-CS1.2.32.** These watercolours by Alfred Robert Quinton were painted in the 1920s and provided details on the nature of the Scarborough coastline at that time. The view top left shows North Bay looking south towards the Castle on the headland and its extensive sandy beach. The promenade and coast road runs round the foot of the cliff.

The view (middle) is of South Bay looking southwards with the grand Spa building overlooking the sea. The top of the coastal cliff/slope is lined with hotels and mansions. Beyond the Spa the unprotected cliffs show some signs of instability. The bottom view looks north towards Scarborough Castle and the harbour with the Spa and bandstand in the foreground. On the cliff to the left and beyond it stands the Grand Hotel, the largest brick-built structure in Europe.

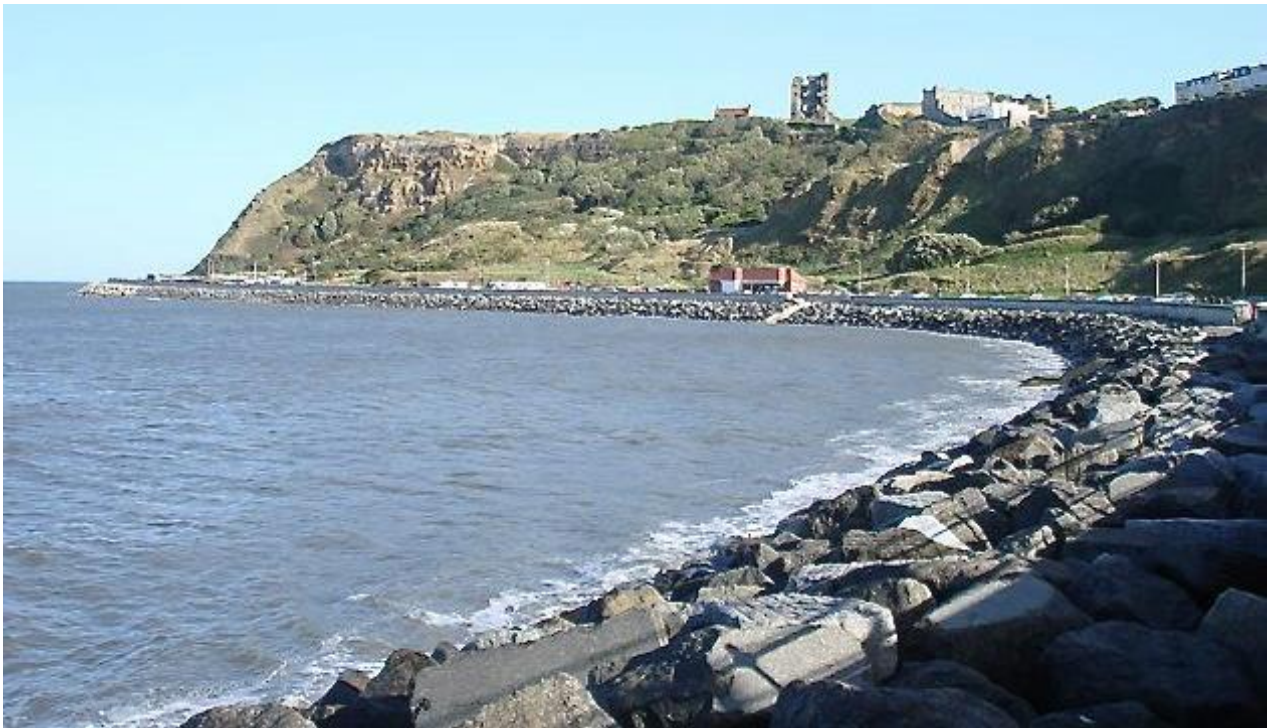
**Fig. CS1.2.33. (above)** shows the present day view of the coast at Scarborough North Bay taken at High Water. The existing seawall is now protected with interlocking concrete units and rock armourstone, which prevent coastal erosion and safeguard the highway and slopes behind, including the Castle headland. The Bay is fronted by a very extensive sandy beach at Low Water.

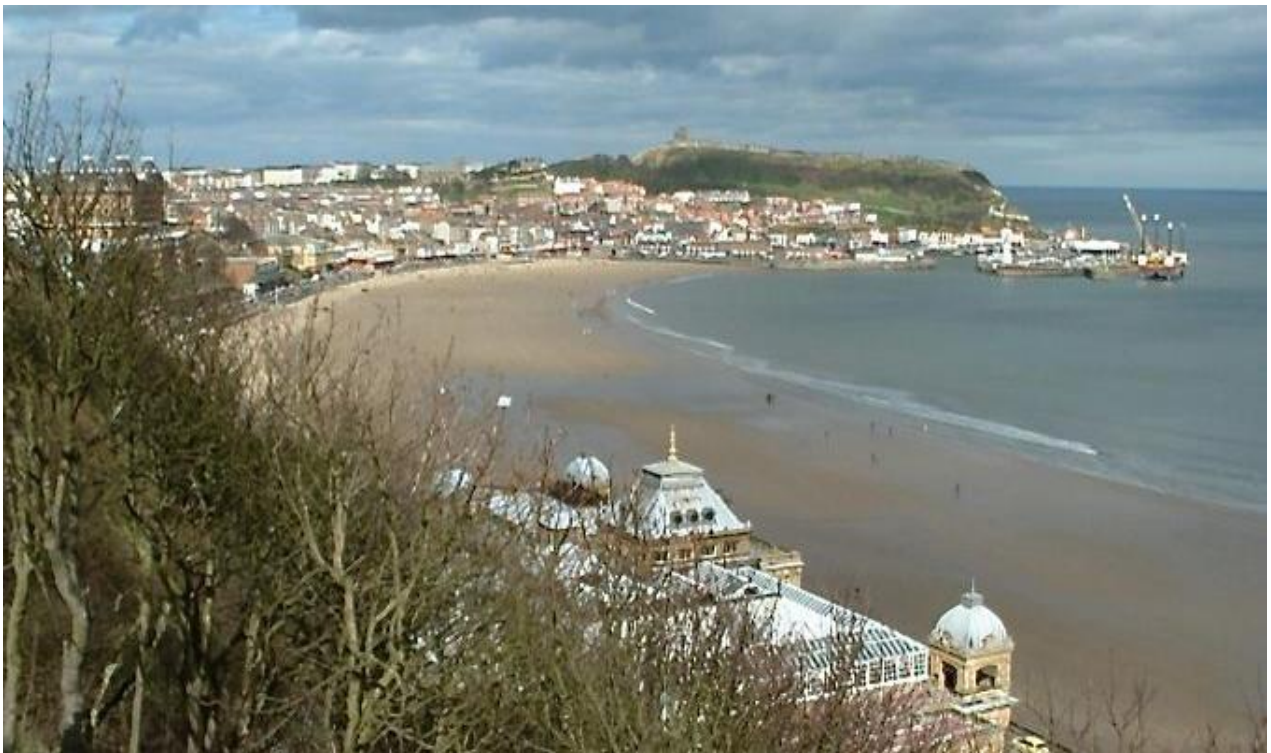
**Fig. CS1.2.34. (below)** shows South Bay looking northwards from above the Spa and, like Quinton's view, shows the extensive sandy beach. The whole of the Scarborough frontage has been the subject of extensive study since the Holbeck Hall Hotel landslide in 1993. This has resulted in a substantial investment in coastal protection and slope management measures, together with comprehensive coastal monitoring.

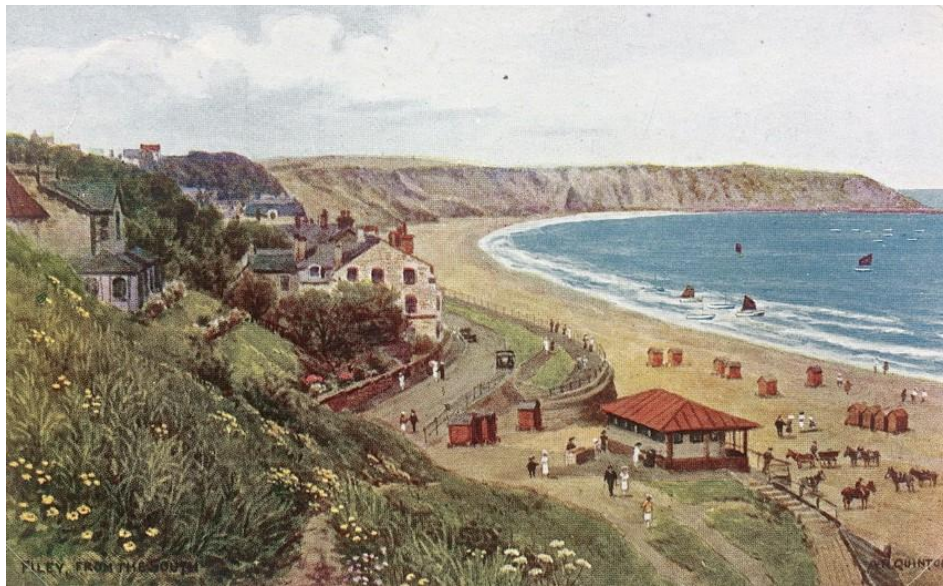
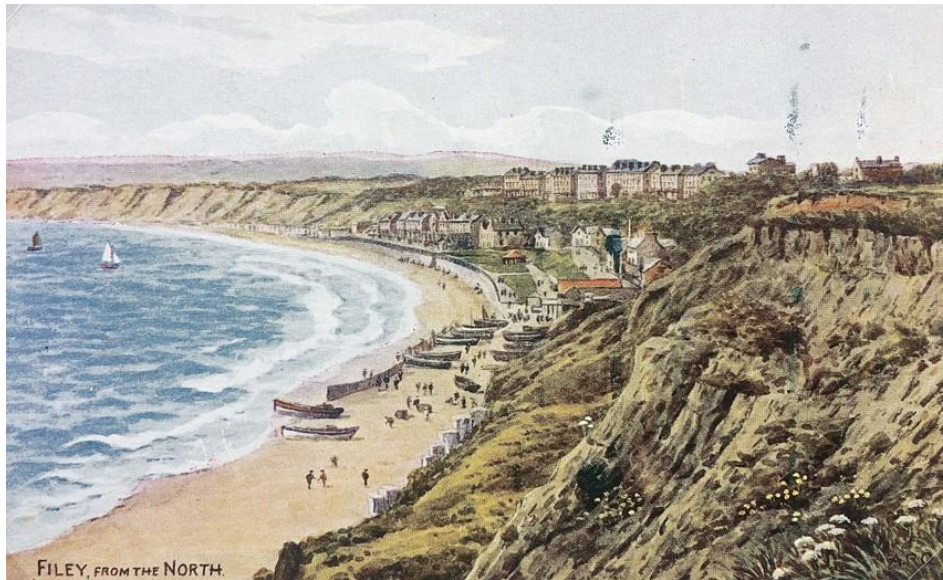
**Figs. CS1.2.35.-CS1.2.37.**

These three early twentieth century watercolours by A. R. Quinton show views of Filey Bay, which lies between Scarborough and Flamborough Head. The watercolours provide a detailed appreciation of the coastal geomorphology including the wide sandy beach which is backed by an eroding, unstable cliffline composed of clays and sandstone of the Cretaceous Wealden Group overlain by Glacial Till. Most of the cliffline is undefended retaining a very natural appearance, whilst a seawall protects the seaside promenade and cliff top developments in the centre of the Bay. The undefended cliffs south of Filey are affected by a range of erosional and instability types.

**Fig. CS1.2.38. (above)** This photograph looking north towards Filey Brigg matches Quinton's view (**Fig. CS1.2.35.**) and appears to show little change. The wide sandy beach and the cliffline are comparable, although the cliff to the left appears more vegetated; the general rate of cliff retreat on the headland ranges from 0.25-0.5mpa (Royal Haskoning, 2007<sup>2</sup>).

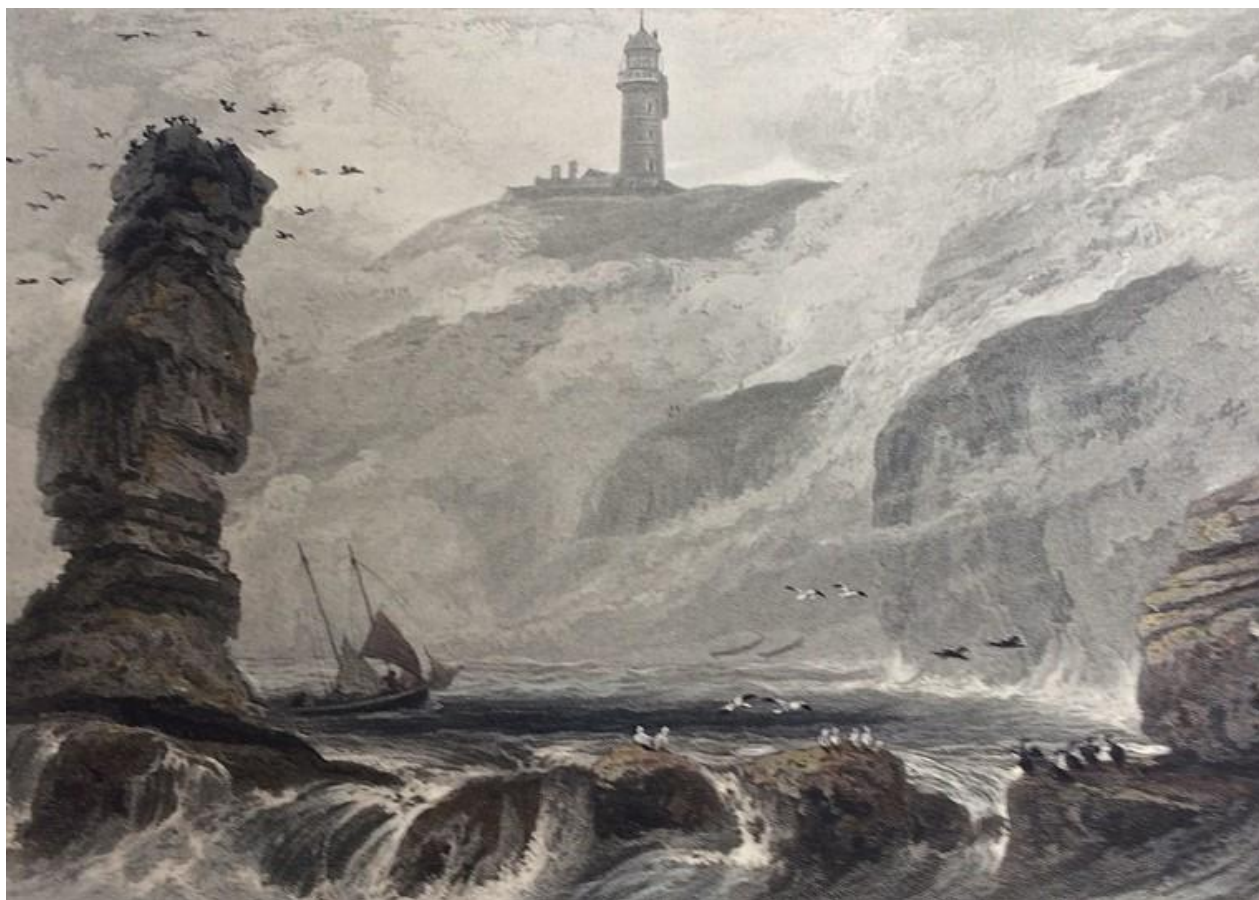
**Fig. CS1.2.40. (above)** shows William Daniell's view of Flamborough Head with the lighthouse in 1822; the sea stack still exists today.

**Fig. CS1.2.41. (below)** This watercolour of North Landing at Flamborough Head was painted by A. R. Quinton in about 1910. It shows the vertical chalk cliffs that have been eroded to form caves, arches and stacks. The oldest lighthouse, a Listed Building, dates from 1669 with a further lighthouse built in 1806. These cliffs are designated as a SAC (Special Area of Conservation) and a SSSI (Site of Special Scientific Interest) for their geology and natural species.

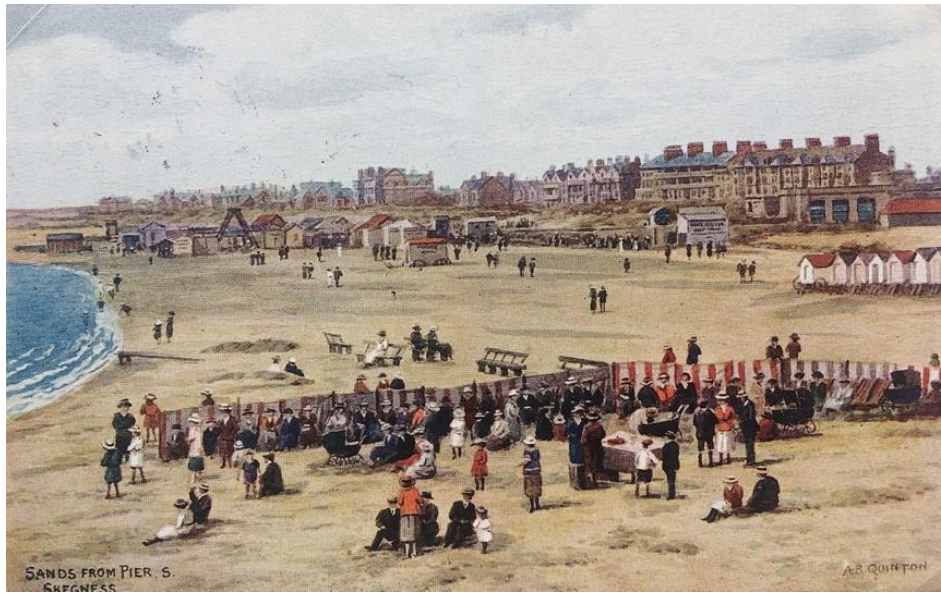
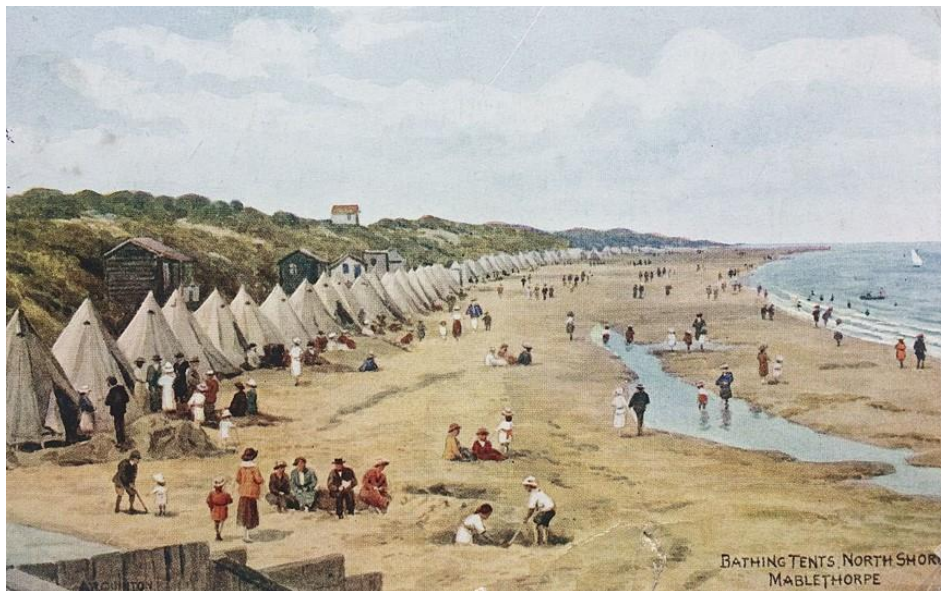
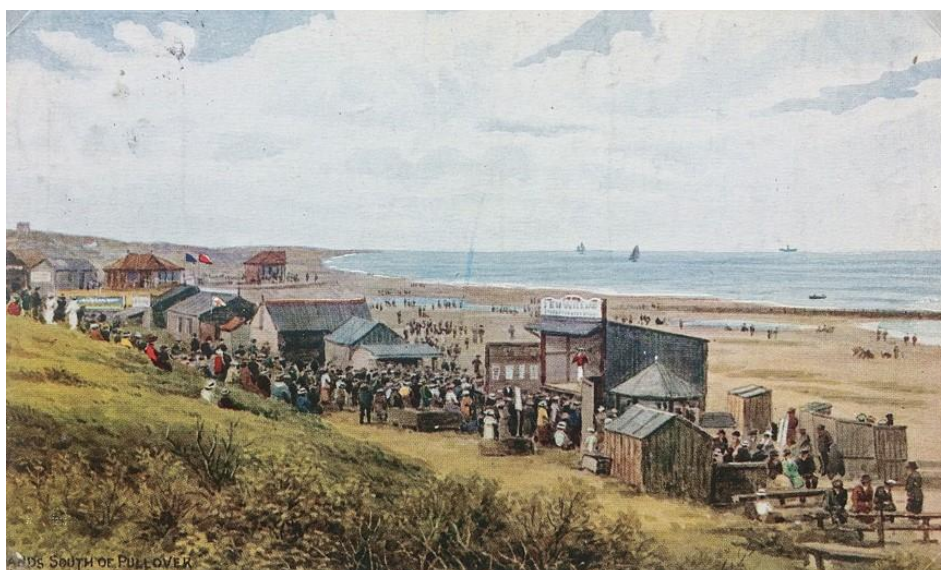
**Fig. CS1.3.1. to CS1.3.3.** These three detailed watercolours by A. R. Quinton (c.1920s) show beach scenes at Skegness (viewed from the pier) and of Mablethorpe (Middle and Bottom).

The view of Skegness shows its wide sandy beach backed by rows of elegant Edwardian hotels and residences.

The views also show how tourism has developed along these wide, flat sandy beaches which are backed by dunes and marshes.

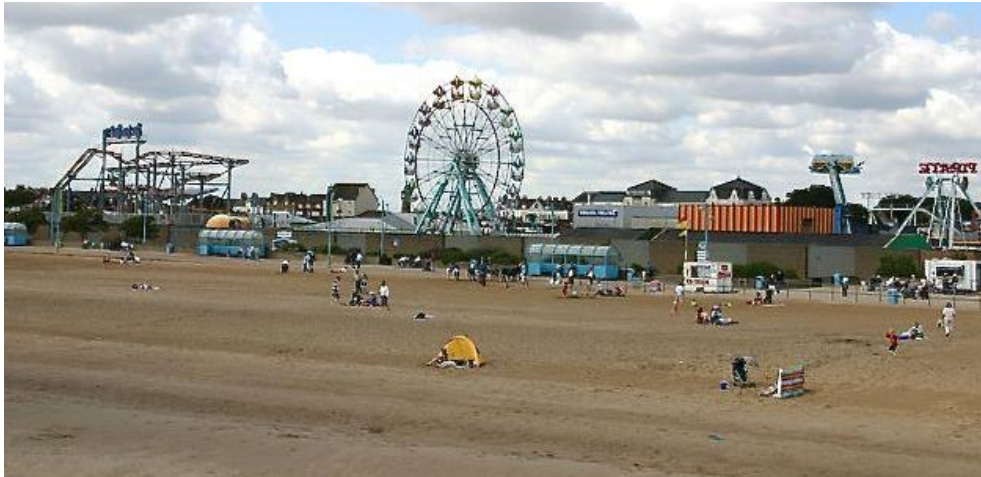
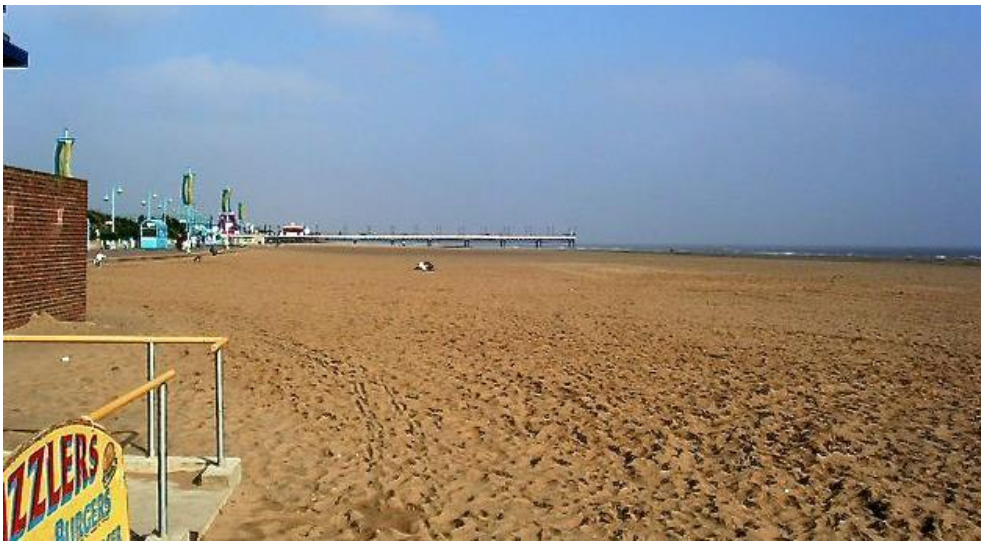
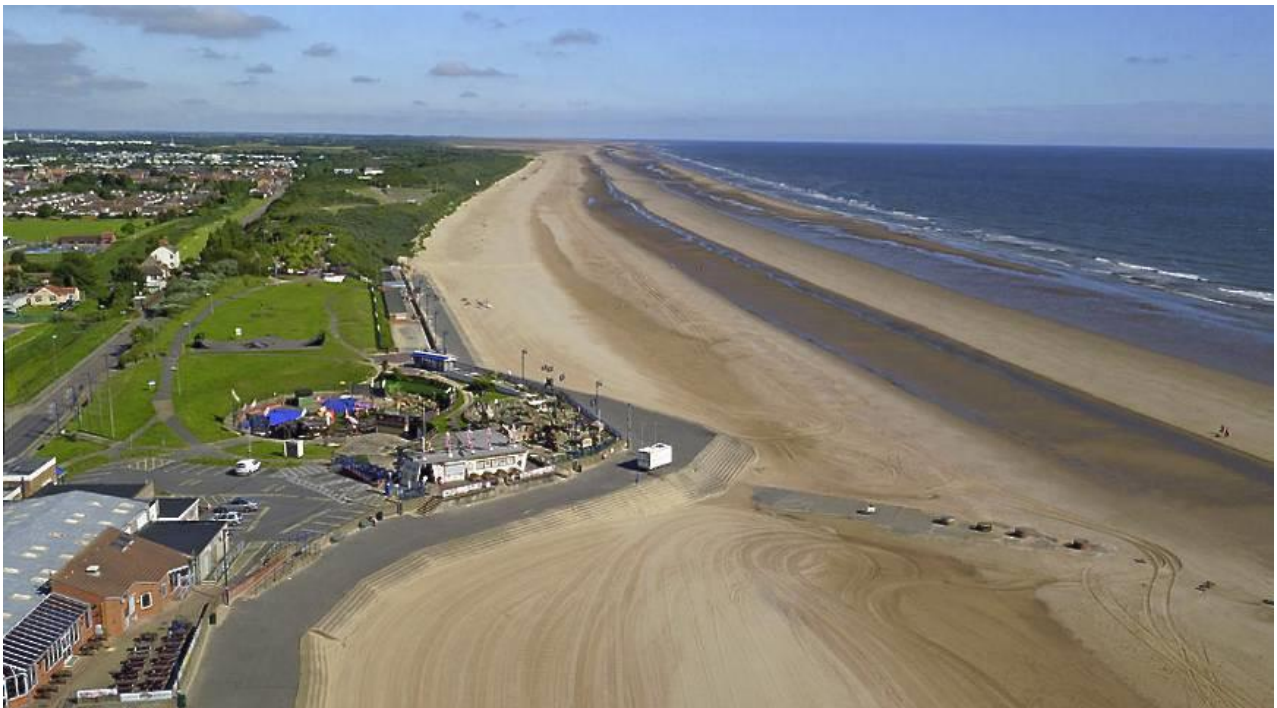
**Fig. CS1.3.4.-CS1.3.6.** show present day views of the beaches and defences at Skegness (Top and Middle) and at Mablethorpe (Bottom). The healthy beaches today are a result of both natural processes with longshore drift carrying sediments from north to south from the Holderness coast, as well as artificial replenishment.
