Case Study 2 - East Anglia

Case Study 2.1 – Cromer, North Norfolk Coast

Case Study 2.2 – Lowestoft to Orford Ness

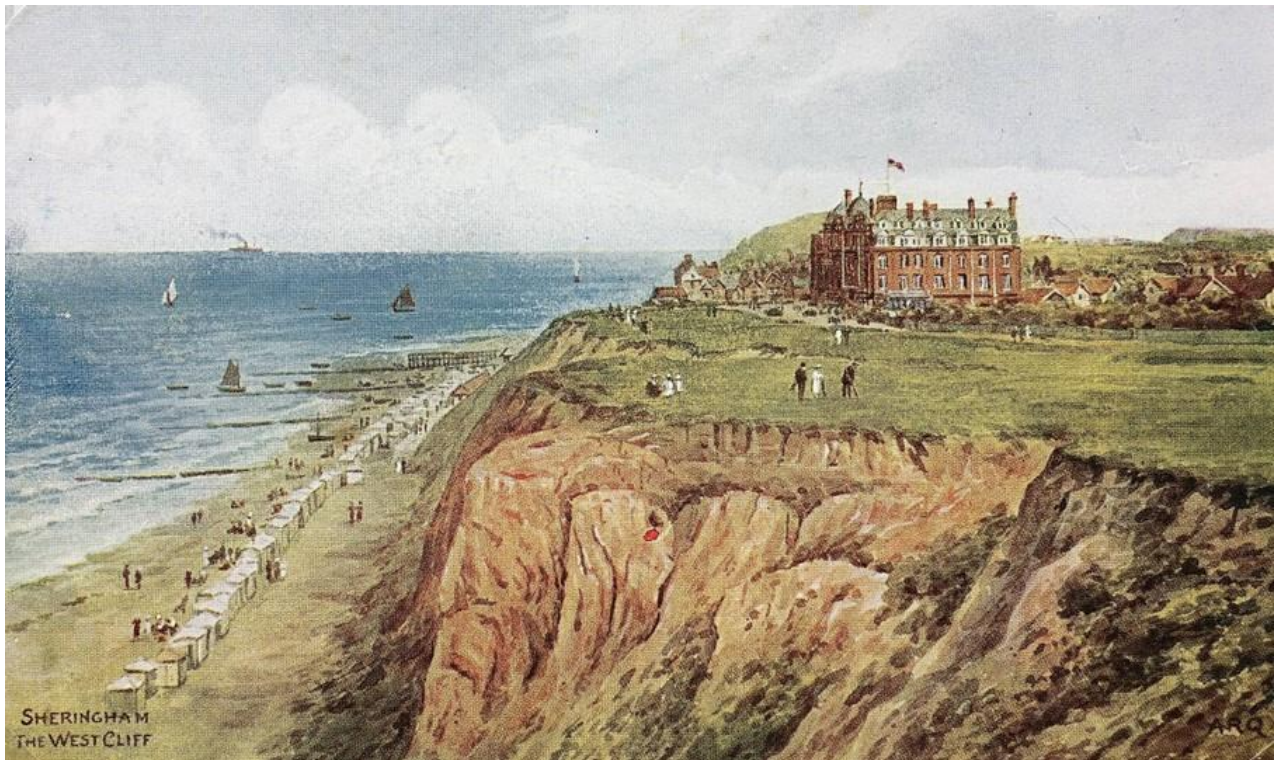
Fig. CS2.1.7. (above) The North Norfolk coastline between Sheringham in the west and Overstrand to the east, and centred on the important resort of Cromer, is characterised by high eroding cliffs of weak sands and clays. Whilst the town frontages are protected by a range of coastal defence structures the less developed cliffs continue to erode naturally. The eroded sediments are transported south-eastwards down the coast and contribute to the maintenance of beaches downdrift. This watercolour (c.1920) by Alfred Robert Quinton shows the undefended and unstable cliffs at West Cliff, Sheringham at that time.

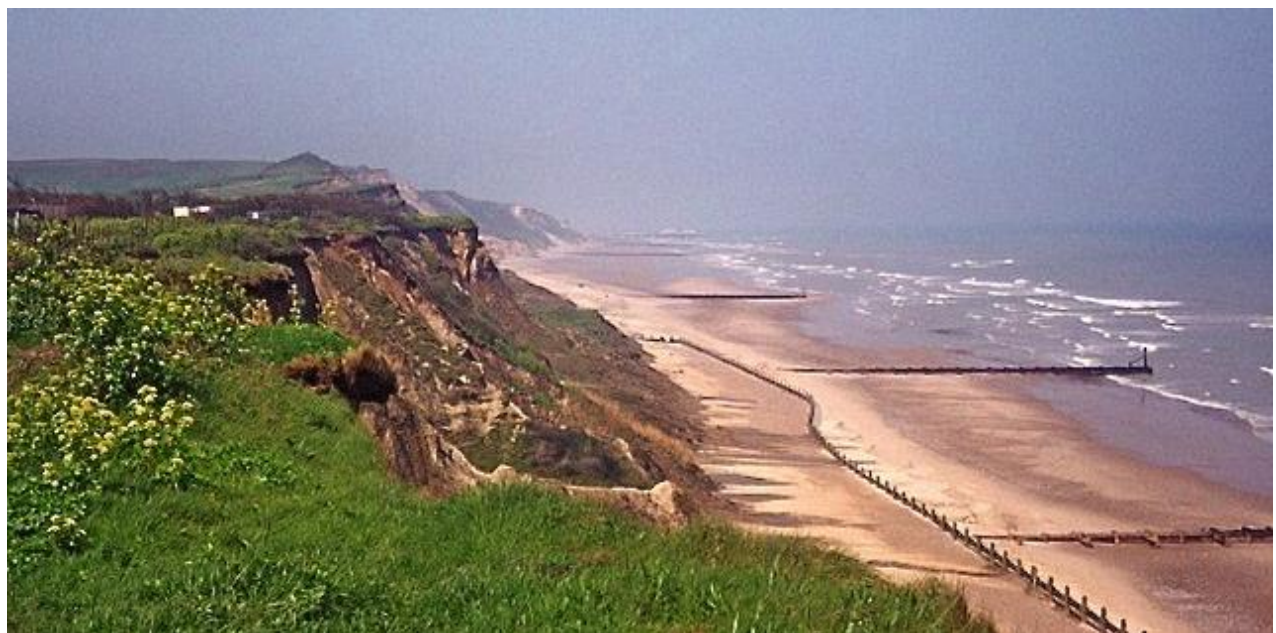
Fig. CS2.1.8. (below) is a photograph of the coastline looking towards Cromer from Overstrand. It shows the extensive timber defences, which aim to reduce the rate of cliff retreat.

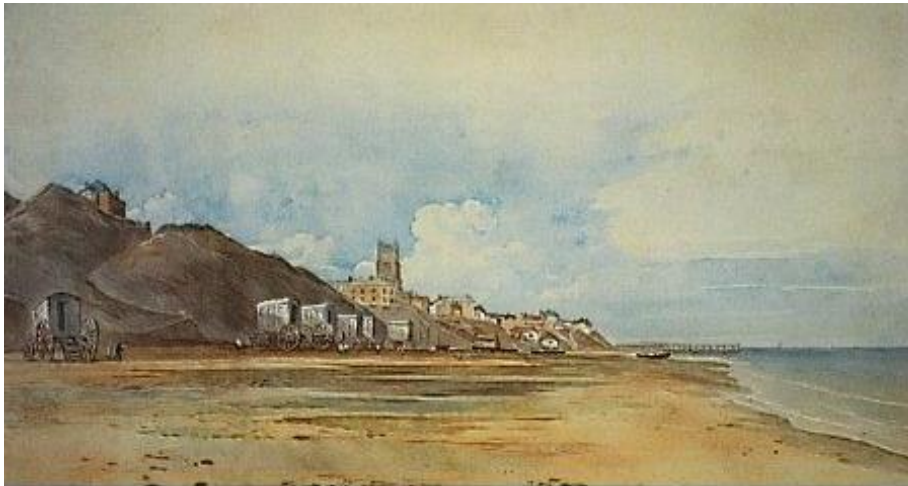
Fig. CS2.1.9. (top) 'Cromer' by John Varley. 1802.

The watercolours and paintings also show the nature of past beach conditions, and these are described in some detail in the watercolours painted by John Varley in 1802 (**Fig. CS2.1.9.**) and in c.1830 (**Fig. CS2.1.10.**). Beach conditions today compare favourably with the extensive beaches that existed in the early nineteenth century.

These watercolours by Varley are of interest because they provide details of the condition of the beach at the beginning of the nineteenth century, as well as the state of the cliffline. The beach is composed of sand and appears to be in a healthy state with a slight crest towards the centre of the beach, witnessed by the pool of water trapped at the back of the beach in the left foreground of the watercolour.

The cliffs can be seen in their natural state before coastal defences were constructed and the proximity of the development to the cliff top is clearly visible. The level of the beach against the piles of Cromer pier can be seen to the right.

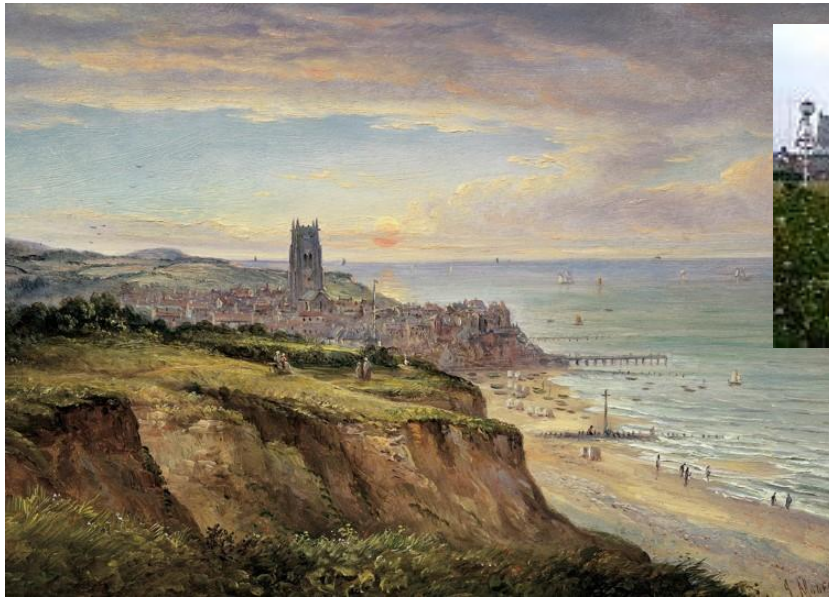
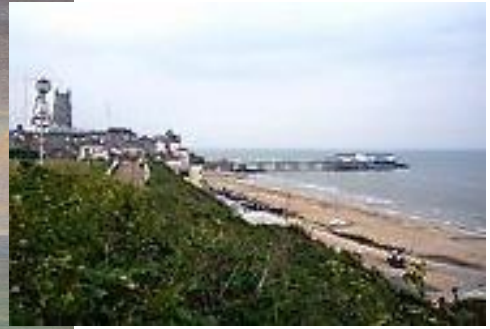
Fig. CS2.1.12. (left) and CS2.1.14. (below) were painted in oils by John Moore of Ipswich in 1850.

For this case study there are two paintings viewing the town of Cromer from the west and from the east. In the case of the cliffs, the natural processes of cliff erosion and weathering can be clearly seen. Large sections of the 30-35m high cliff can be seen spalling away by a process known as mass wasting, particularly in the painting from the west (left). The indentations in the face of the cliff shown in the two paintings suggest that the cliff conditions are influenced strongly by the local geology and groundwater conditions. The back scars of small slides and slips can be seen at the top of the cliff adjacent to the grassy land in front of the church. These processes will have been speeded up

through a lack of toe support, which is resulting in removal of support for the cliffline above by marine erosion. The artworks also illustrate how the steep clay cliffs are attempting to re-grade naturally to a more stable angle of repose by the processes of slope failure. The accumulation of slope debris at the foot of the sea cliffs is, however, being quickly removed by coastal erosion and, as a result, the cliff face is unable to achieve equilibrium and, therefore, remains actively unstable.

Also of interest is the depiction of the beach, which shows the extent of the sand and shingle ridges running along the beach parallel with the cliffline. The careful painting of the groynes and the pier also give an indication as the extent of the beach and the way the sediment is being retained by the groyne, particularly in the view from the east, at that particular time (top). This pair of paintings can, therefore, provide useful indications of conditions prior to coastal defences being constructed. The present day views (**Fig. CS2.1.13. & CS2.1.15.**) illustrate how the cliff face has become almost completely vegetated over the intervening period, largely as a result of protection at the toe by nineteenth century seawall construction. Along part of the town coastal frontage a large car park has been constructed, which has had the effect of advancing the coastal defence line seawards, and this provides additional support for the previously unstable cliffline.

The artwork describes very clearly the conditions that were being experienced before parts of the frontage was defended. It suggests what conditions might be experienced in terms of the re-activation of cliff instability problems if coastal defences are not maintained or are removed at some time in the future. This would lead to significant toe erosion of the cliffline and instability problems, which would impact upon people, property and assets in town.

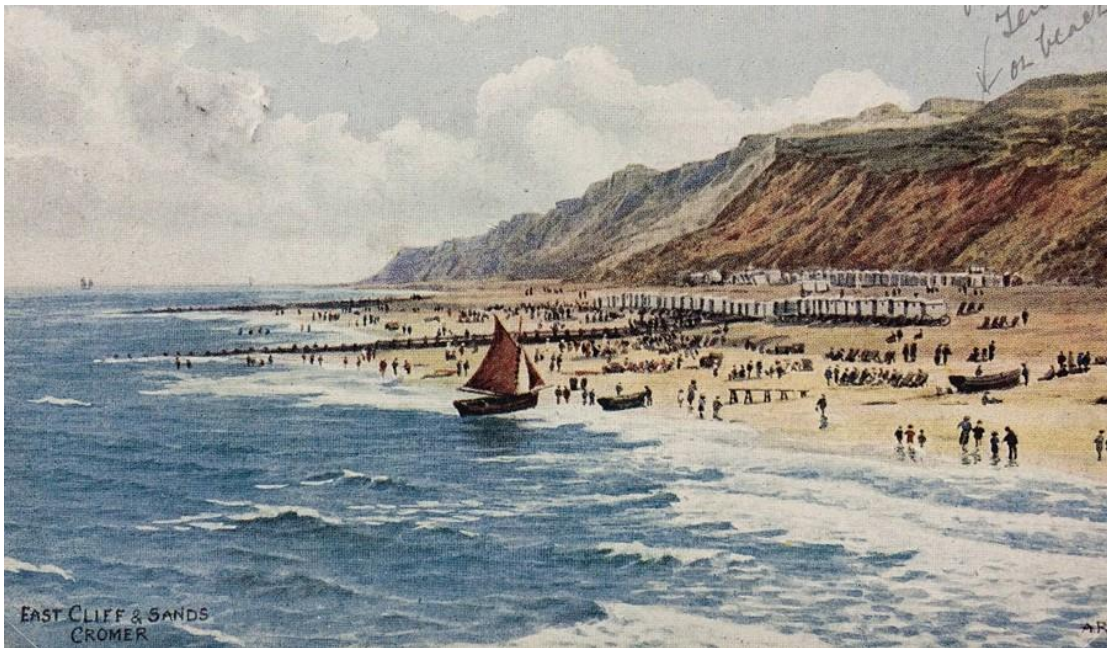
Fig. CS2.1.16. (left) shows the Eastern Cliffs and beach at Cromer c.1920 and was painted in watercolour by A. R. Quinton. Image courtesy of Salmon's.

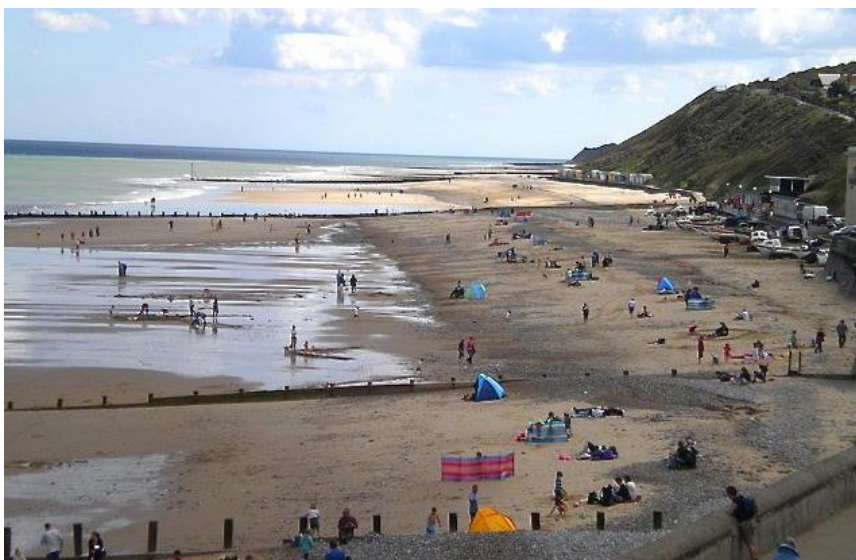
The present day view, **Fig. CS2.1.17.** (middle), shows a healthy beach retained by timber groynes and a more stable, vegetated cliffline. No doubt a result of the seawall constructed along the foot of the cliff.

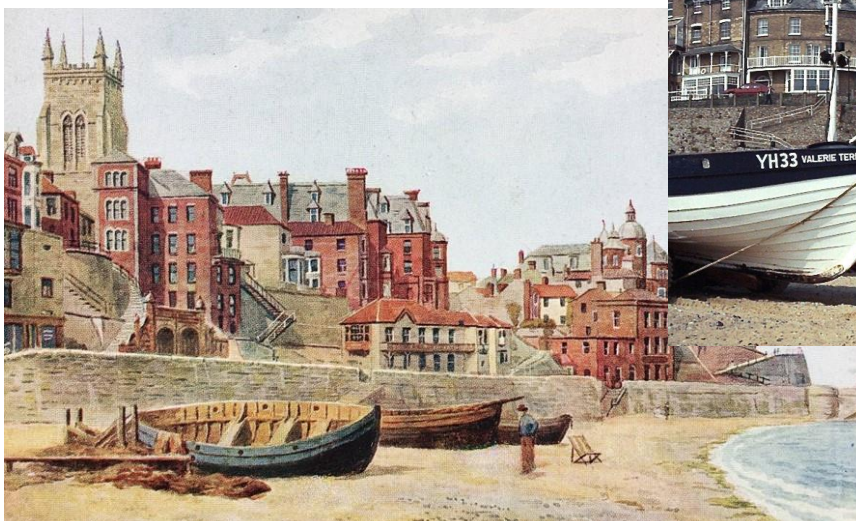
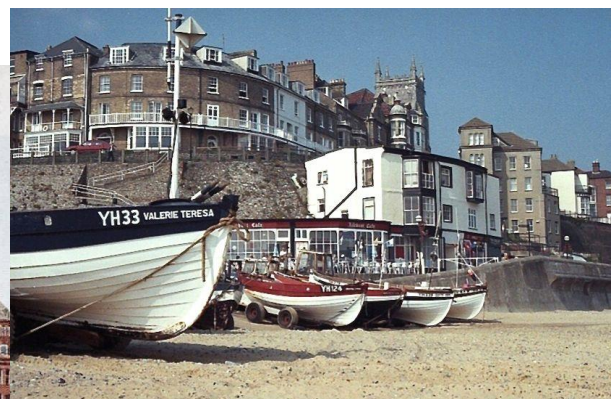
Fig. CS2.1.18. (bottom left) and **CS2.1.19. (bottom right)** show the seawall and seafront properties with the church above and behind. A. R. Quinton's watercolour accurately describes the architecture of the resort and much of its character has been carefully retained.

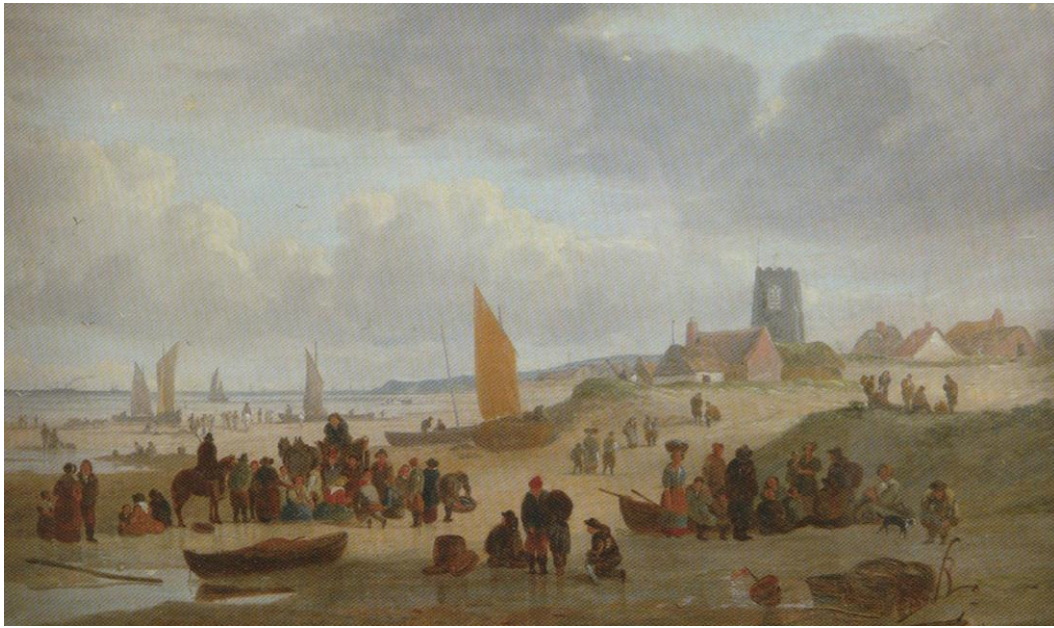
Fig. CS2.2.2. (left) shows a fish sale at 'Pakefield Beach, Suffolk' to the south of Lowestoft and was painted in 1882.

This painting informs us of the changing beach conditions at Pakefield since the 1880s. In particular, the beach appears more extensive today and the backshore and coastal cliffs appear to be extensively vegetated. This appears to be supported by evidence from coastal surveys since the 1990s, which show significant rates of accretion at the northern (Lowestoft) end, although there has been some erosion at the southern end.

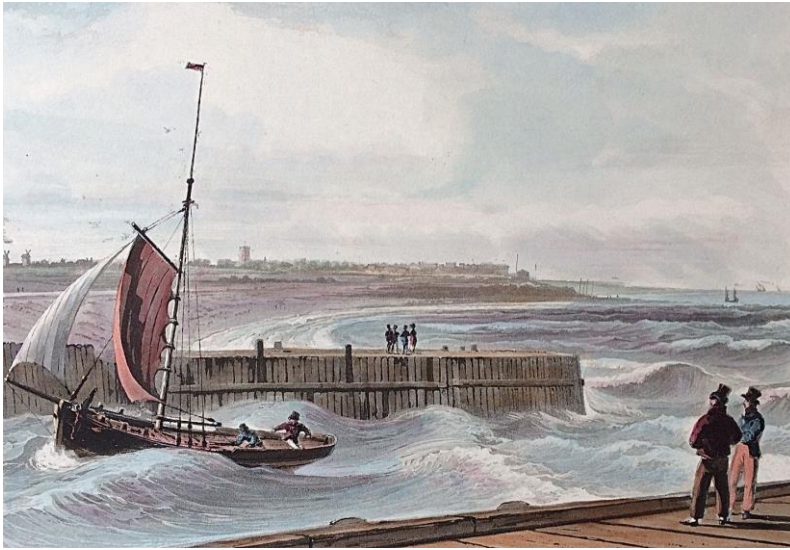
Fig. CS2.2.4. (top) shows Southwold Harbour engraved by William Daniell RA in 1822.

Southwold is situated on the open Suffolk coast. The town is almost an island as, on its north side, it is cut off from the hinterland by Buss creek, and on the south by the river Blyth. Southwold is an important historic coastal town containing many listed buildings, as well as being a popular seaside resort.

To the north of Southwold a small community at Easton Bavents is located along an undefended cliff frontage, whilst the town of Southwold itself is defended by a concrete sea wall with an extensive natural beach to the south. The boundary is the mouth of the Blyth Estuary with its estuary mouth being channelized with hard defences.

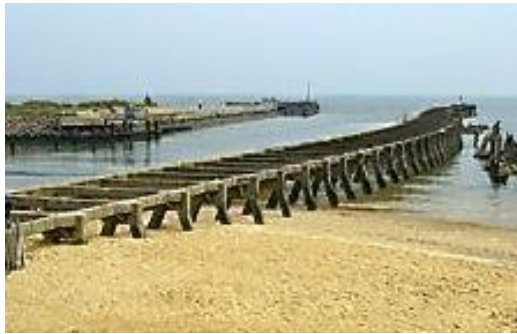
Southwold harbour lies at the mouth of the River Blyth to the south of the town of Southwold, and separates Southwold from the village of Walberswick to the south. The site was chosen because it allows comparison with the present day (**Fig. CS2.2.5. (middle)**) with an early nineteenth century image of the harbour infrastructure. The key coastal risk management issue for the location is the maintenance and management of the harbour and harbour mouth for the future, and to ensure that properties in the vicinity of Southwold and Walberswick receive a sufficient standard of protection from the risk of flooding.

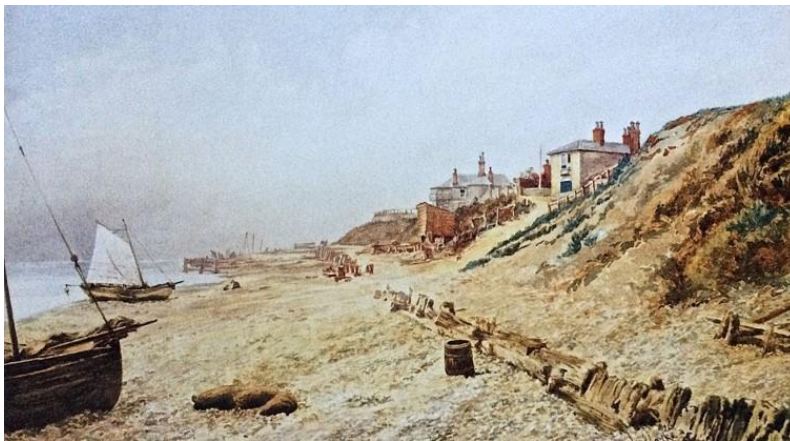
Fig. CS2.2.6. (bottom) shows 'Southwold Beach' painted by Helen Clarke in 1899.

This view provides a detailed illustration of the conditions on the cliffline and the beach at that time. Rudimentary coastal defences line the foot of the cliff and the beach appears to be of shingle; although the more vegetated cliffs appear relatively stable in the foreground they are more susceptible to active erosion beyond. Some further coastal defences and a groyne can be seen

The watercolour shows the form of the beach, which appears more stable and steeper than in the present day photograph. The vegetation on the cliff in the foreground suggests that waves are not undermining the cliff at this location compared with further along the coast. The picture illustrates how the coast might look if defences were not maintained.

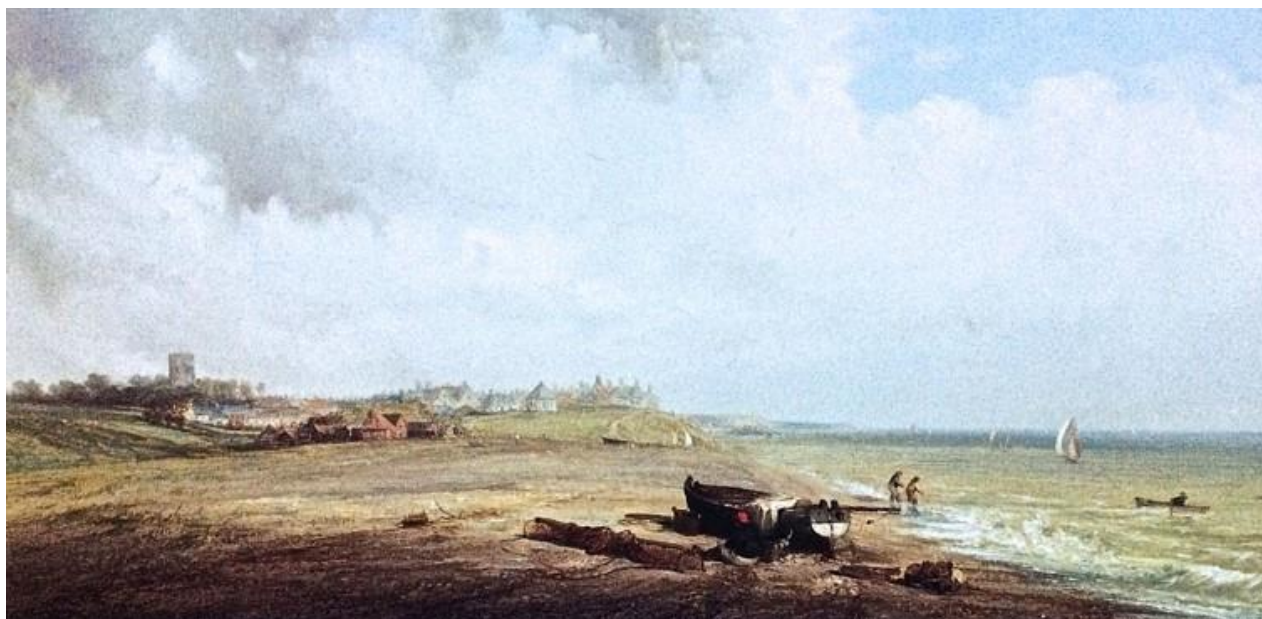
Fig. CS.2.2.7. (above) shows the beach immediately south of Southwold painted by Thomas Smythe c.1860.
Private Collection.

This oil painting illustrates conditions on an extensive open beach facing the North Sea. It contrasts with the narrower beach to be found abutting the town to the north.

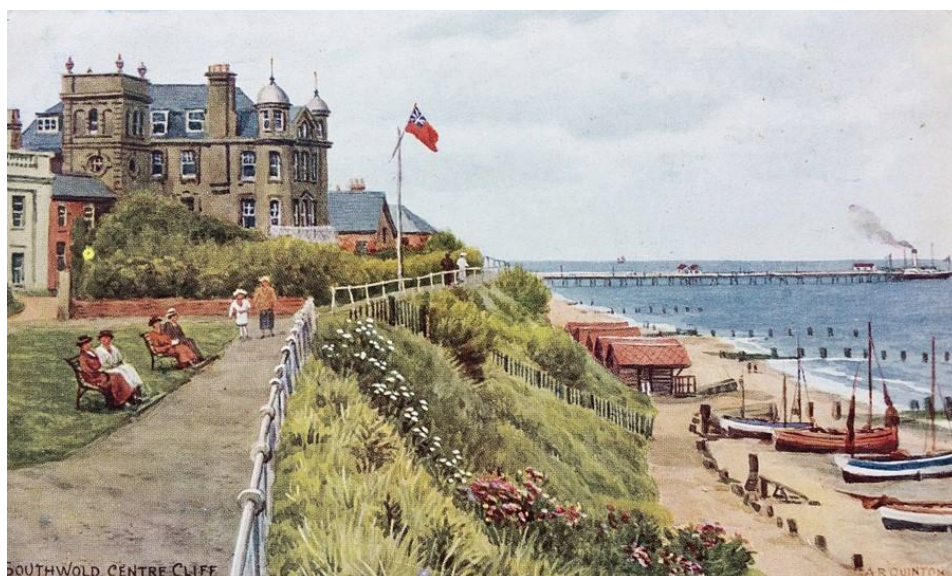
Fig. CS2.2.9. (left) and Fig. CS2.2.11. (bottom) show views of Southwold by Alfred Robert Quinton painted in watercolour c.1920.

Watercolours by Quinton painted between 1900-1934 show the patterns of development of coastal towns such as Southwold alongside architectural detail and information on coastal defences and beach conditions.

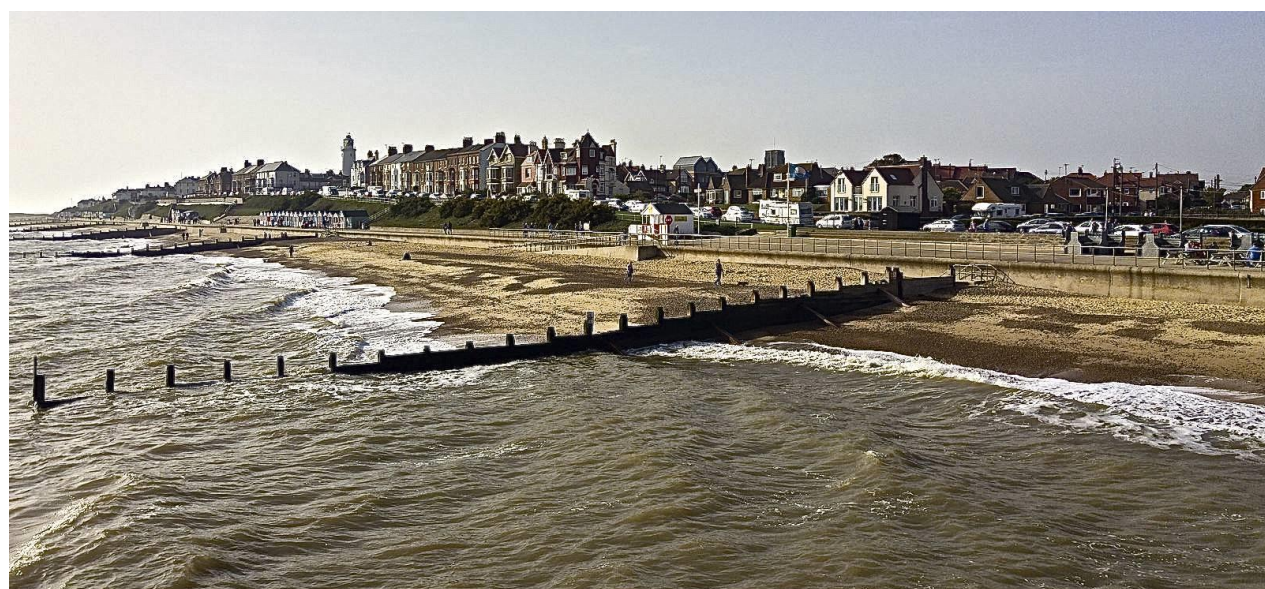
Fig. CS2.2.10. (middle) Coastal protection measures have been upgraded with an increased standard of protection provided by the concrete seawall.

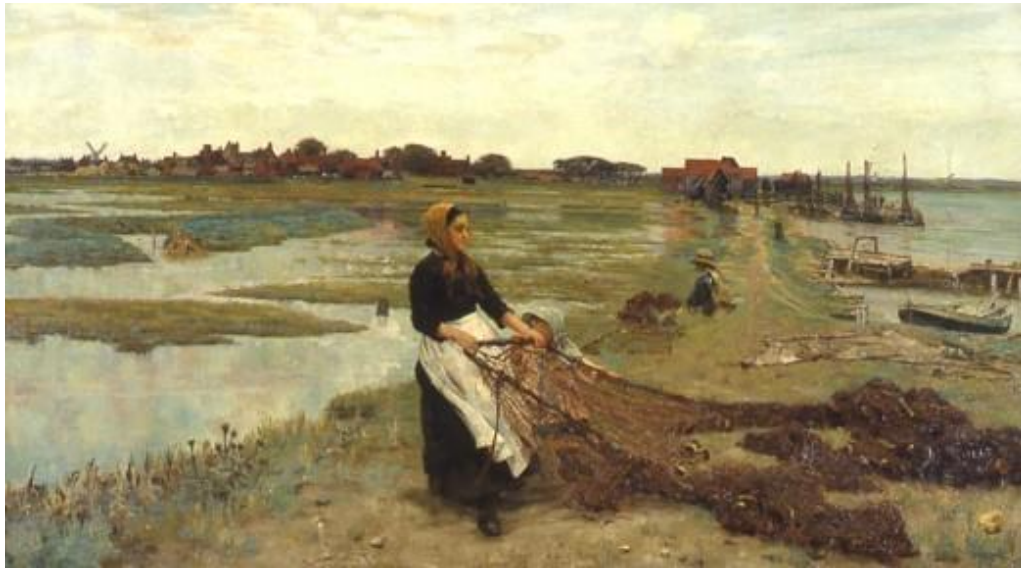
Fig. CS2.2.12. is a painting by Thomas Benham at Walberswick to the south of Southwold in 1878 (Private Collection).

Essentially a genre painting, the artwork also provides good topographical detail in terms of the conditions of the low-lying land behind the shallow embankment with the village beyond.

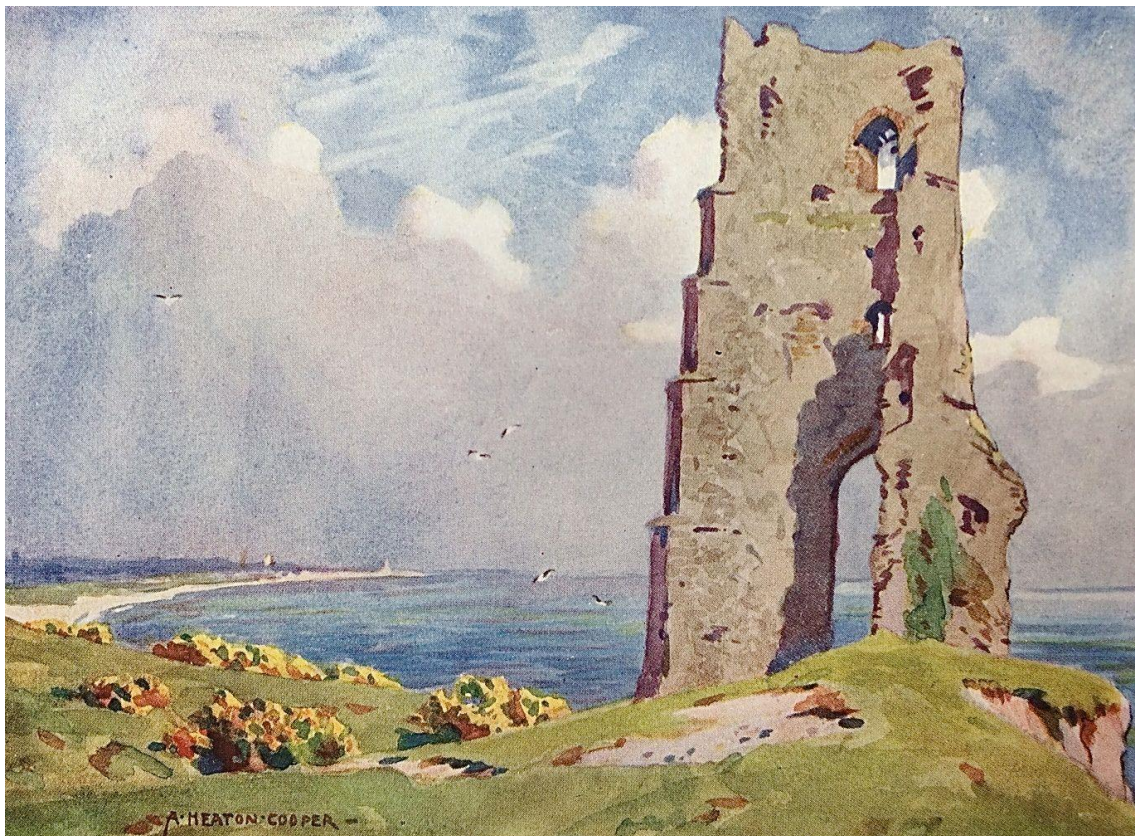
Fig. CS2.2.16. (below) by Alfred Heaton Cooper (1921) shows the relic of the church on the cliff edge.

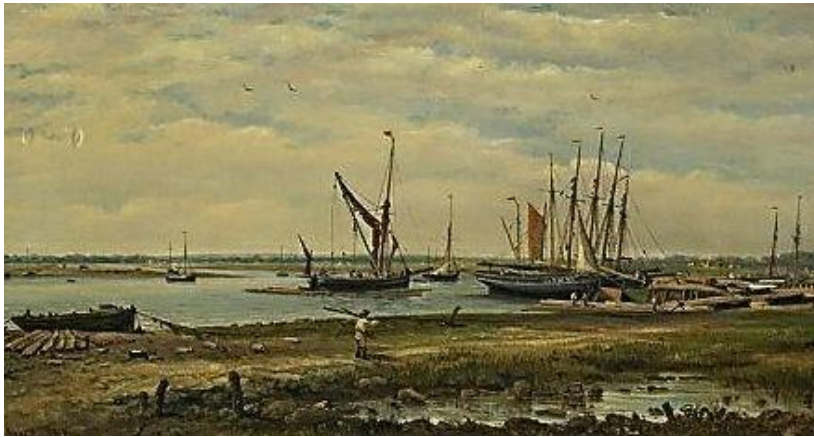
Fig. CS2.2.17. (top) of *'Slaughden Quay'* near Aldeburgh, Suffolk, was painted by John Moore of Ipswich in 1883.

The site is typical of the low-lying saltmarshes and mudflats to be found on the southern part of the Suffolk coastline.

Slaughden Quay is located on the River Alde and is situated on a massive shingle spit, which extends for some 16km south of Aldeburgh to Orfordness and Orford Beach. The shingle spit is separated from the hinterland by the River Alde, which flows eastwards, through Snape, before broadening into a wider estuary and narrowing again and turning sharply south as a result of longshore drift.
