Case Study 3 - South-East Coast of England

Case Study 3.1.1. – Reculver Church, North Kent

Case Study 3.2 – Hastings

Case Study 4 – Central Southern England

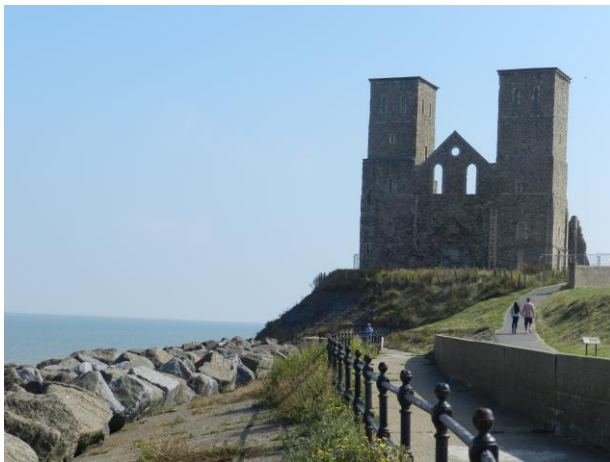
Fig. CS3.1.2. 'Reculver Church', North Kent coast by William Daniell, RA engraved in 1824. Some rudimentary coastal defences can be seen, which were helping to preserve this important landmark for navigation. A substantial rock revetment now protects the site (Fig. CS3.1.3. above left).

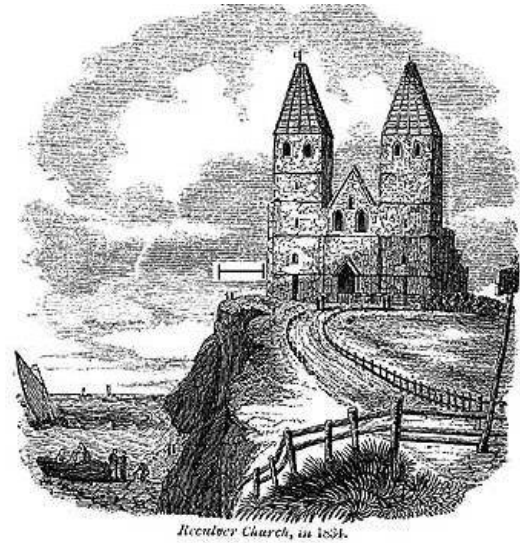
Fig. CS3.1.5. Lyell's view of 1834 shows the significant retreat of the shoreline since the previous engraving (left) was made in 1781.

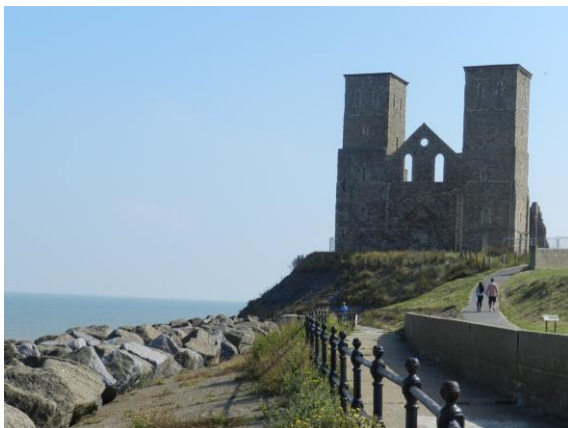
Fig. CS3.1.6. *'The Reculver'*, commonly called *'The Two Sisters'* by James Malton, 1798. Malton's watercolour drawing shows a building existing between the seaward side of the church and the cliff edge. Image courtesy of Bonham's. Private collection.

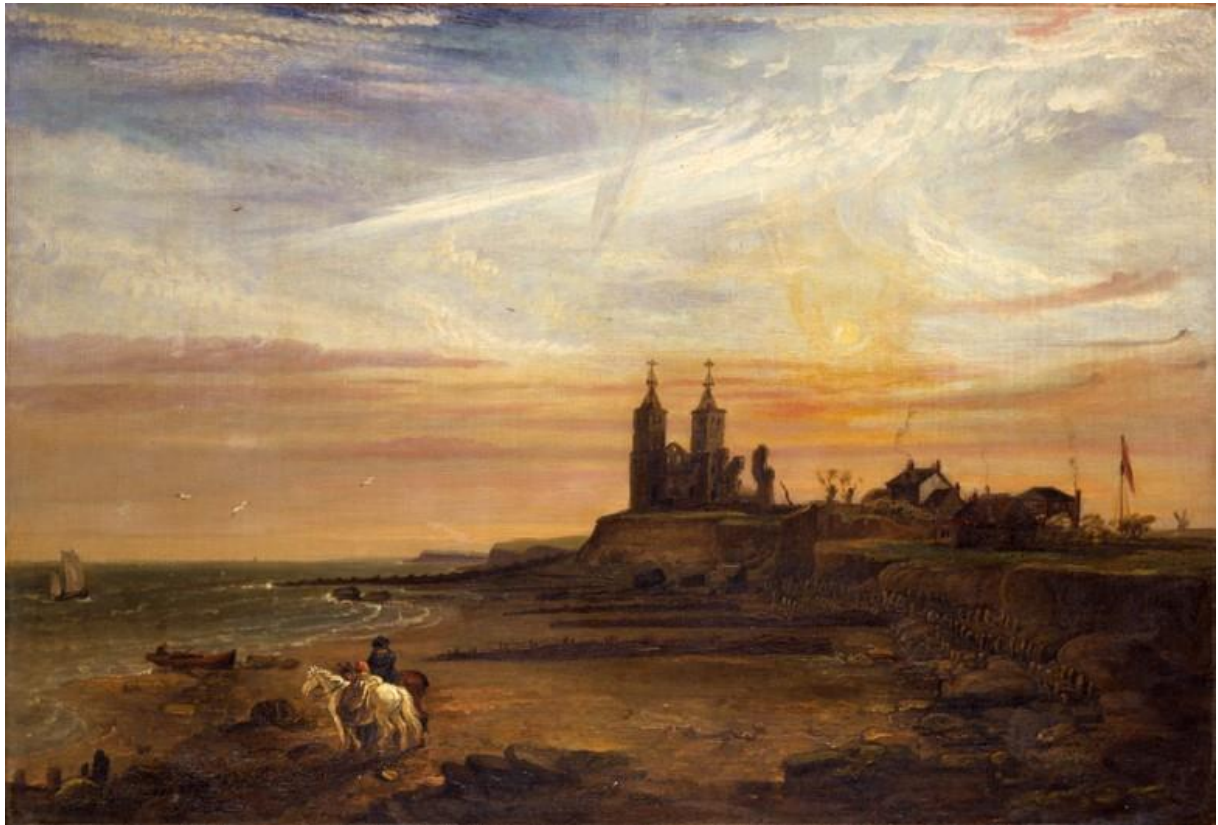
Fig. CS3.1.9. In this view of Reculver by James Ward painted in 1818 a range of coastal defences can be seen at the foot of the soft cliffline. Image courtesy of Canterbury City Council Museums and Galleries.

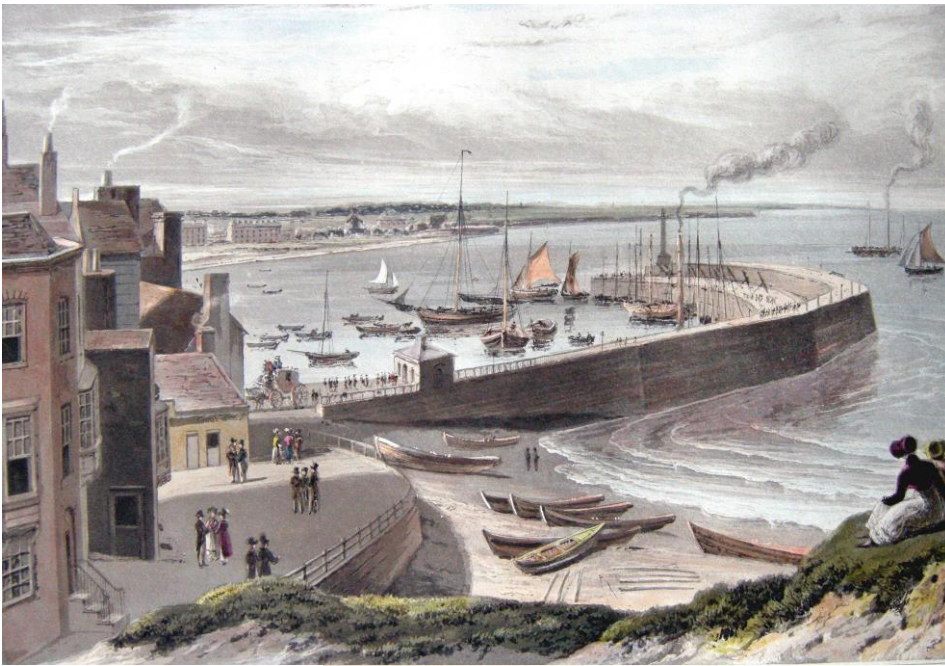
Fig. CS3.1.13. (top) 'Margate' by William Daniell engraved in 1823. His view illustrates how artworks can depict how just physical change but also the history of coastal development and sometimes the modes of construction used.

The view of Margate harbour (**Fig. CS3.1.13. overleaf**) and engraved by William Daniell in 1823, illustrates the growing resort taken from a vantage point just to the west of the harbour arm. An advantage of Daniell's work was his architectural and geographical accuracy including the form of the small beach in the foreground, the shape of the harbour arm, showing its proximity to the seawall and seafront properties, and the view looking along the coastline in an easterly direction beyond. Works of art, which depict seawalls and harbours can be particularly useful to designers who are having to replace or improve these structures. Often the original harbour structure may have been covered by concrete or other later additions and alterations. It is, therefore, useful to understand the nature of the original construction, which could help reduce costly investigations and studies that might otherwise be deemed necessary. This view is typical of the meticulous observation and eye for detail in William Daniell's aquatint engravings.

This view by Daniell was selected to illustrate the role that art can fulfil in terms of understanding not just physical changes on the coast but also the history of coastal development and construction. Not only are features such as harbour arms influential in terms of interruption of sediment transport but an understanding of their form can be particularly helpful to designers and coastal engineers who may wish to repair or replace these structures. It can be seen from Daniell's view and from the present day view that the harbour wall has stood the test of time and remains unaltered. Part of the former beach is now occupied by a dinghy park and the Turner Contemporary Art Gallery can be seen on the left. It can be seen that artwork such as this can inform not just coastal risk management but integrated coastal zone management more widely as the view encompasses a range of features and issues relating to the coastal zone.

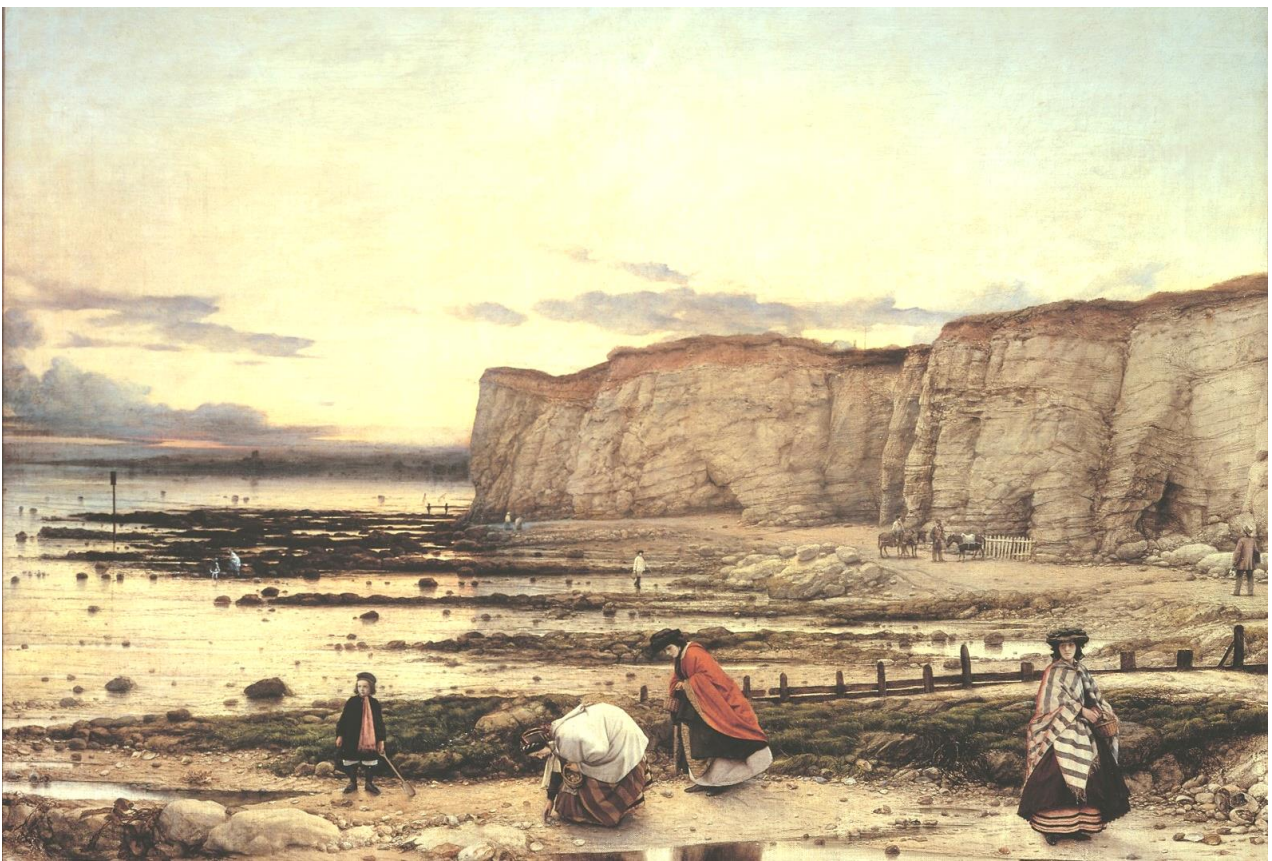
Fig. CS3.1.17. *'Pegwell Bay – Recollections of 5th October 1858'* by William Dyce, RA demonstrates the precise detail that could be achieved by the Pre-Raphaelite artists. Dyce has achieved a depiction that has the appearance of a photograph.

The oil painting of Pegwell Bay by William Dyce provides an excellent example of how artists of the Pre-Raphaelite Brotherhood and their Followers could depict the coast in a truthful and highly accurate manner. The portrayal of the chalk cliffline, the sea caves and the eroding beach is almost photographic,

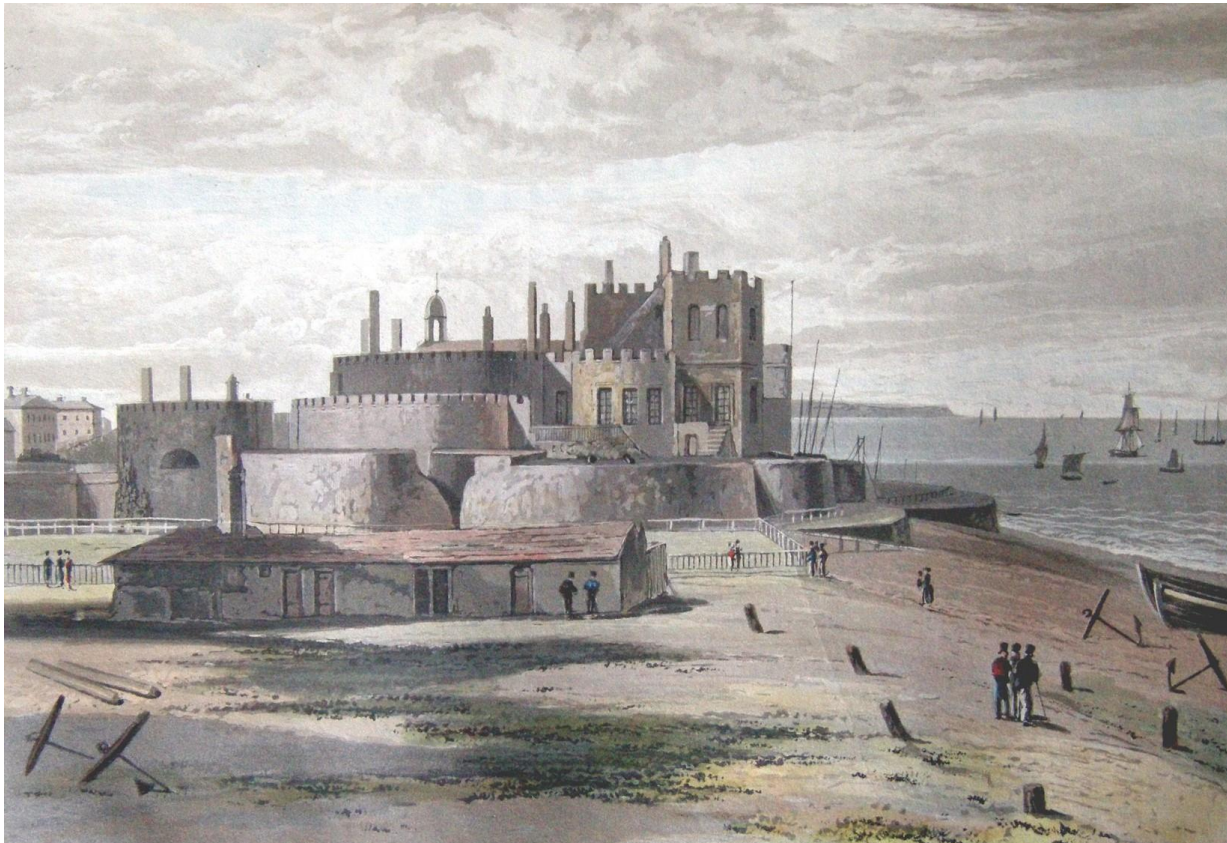
Fig. CS3.1.20. 'Deal Castle' by William Daniell RA, engraved in 1823. His fine draughtsmanship shows us the relationship between the structure and the shore at that time. David Addey's watercolour as **Fig. CS3.1.21.** (1988) shows the castle adjacent to the beach, whilst **Fig. CS3.1.22.** depicts the scene thirty years later. A substantial beach now provides flood defence for this low-lying coastline.

The coloured aquatint engraving illustrates coastal conditions in the early nineteenth century and contrasts significantly with the present day situation where the beach appears much more stable, with the upper beach being vegetated. Whereas, in the view by Daniell, the Castle appears vulnerable to erosion and demanded the provision of a seawall, the present structure appears much more secure. The frontage could become increasingly vulnerable in the future as a result of coastal erosion promoted by rising sea levels, and so it is likely that the defences will be maintained for the foreseeable future, but may require replacement in the long term.

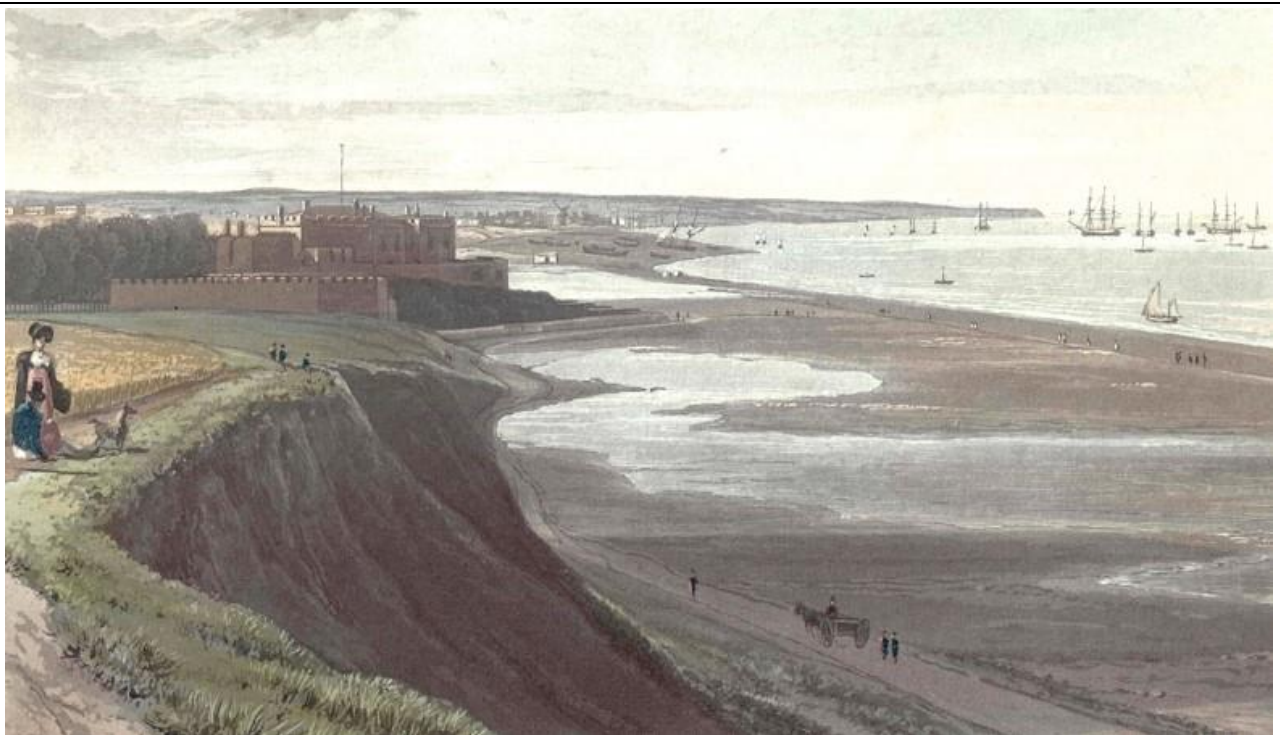
Fig. CS3.1.23. In his view of 'Walmer Castle' (1823) Daniell provides us with an extensive and detailed depiction of the shoreline and cliffs. The form of the beach at low water can be seen clearly. Some defences have been put in place around the frontage of the castle, which forms a hard point along this relatively soft coastline.

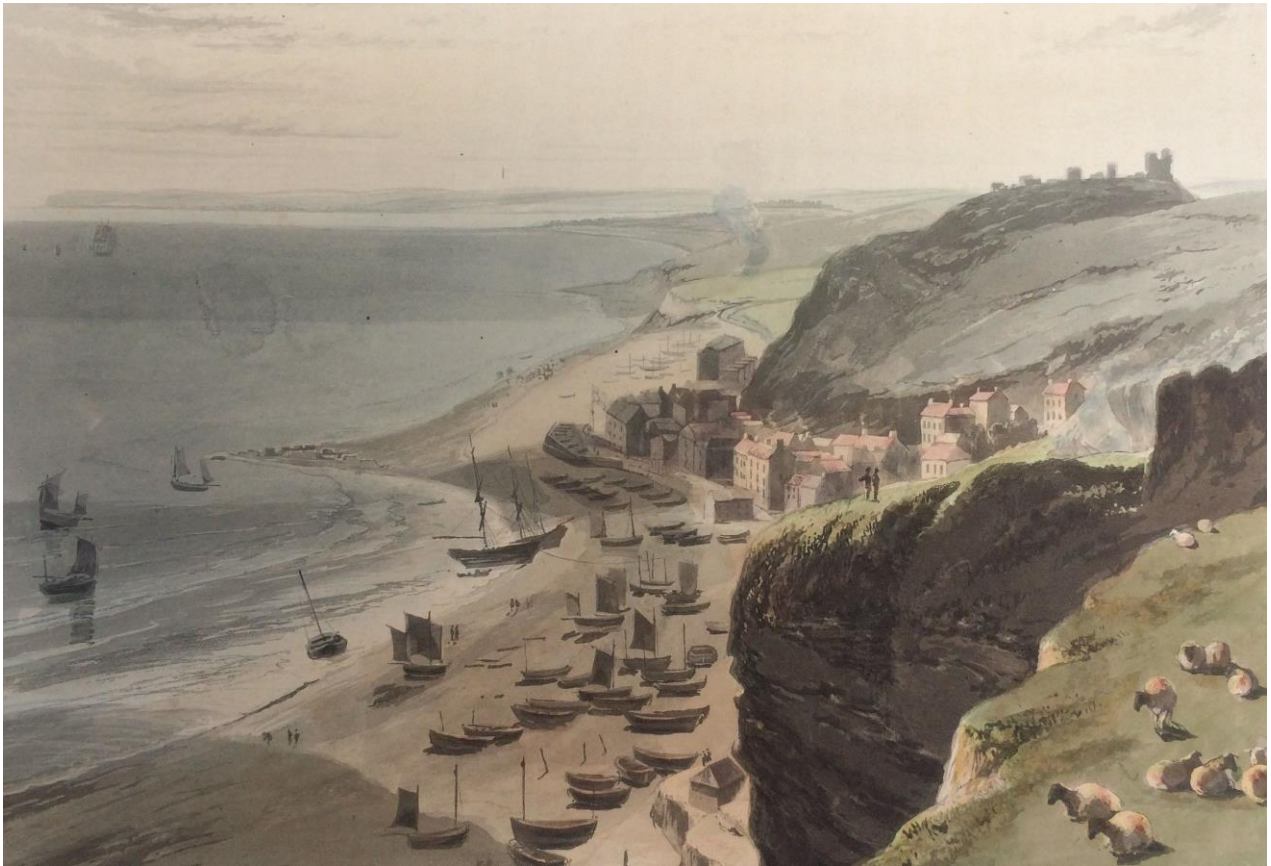
Fig. CS3.2.2. This extensive view of Hastings by William Daniell RA in 1823 looks westwards towards the town frontage and shows the fishing fleet on the shore below the line of rugged sandstone cliffs. The image by David Addey (**Fig. CS3.2.3. below**), who visited Daniell's vantage point in 1989, shows the extensive tourism development, although some of the original architecture remains, as does the character of the fishing village (The Stade) just below Daniell's vantage point.

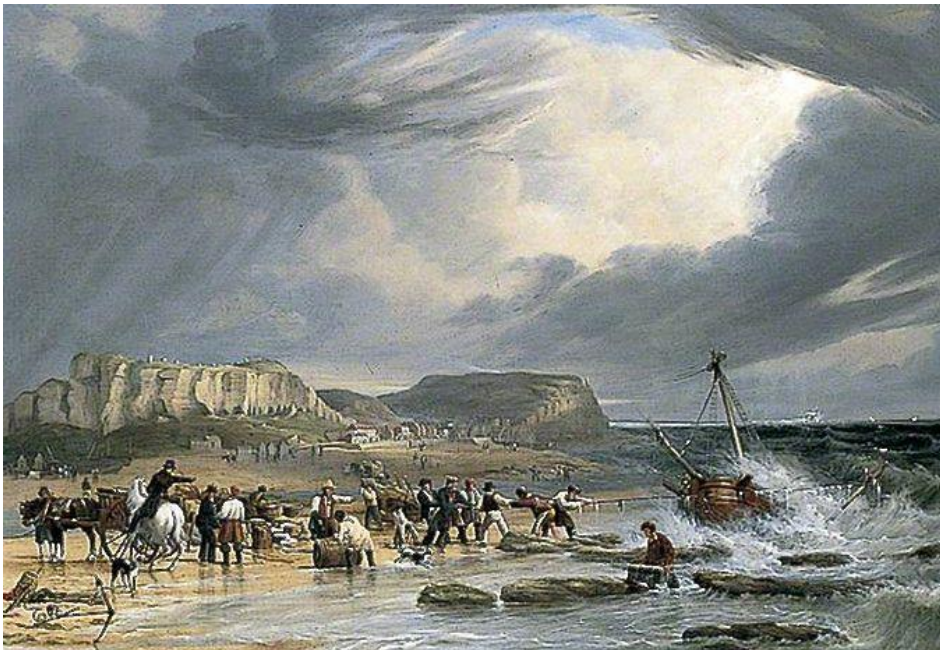
Fig. CS3.2.4. *'Rescue at Hastings'* by William George Moss, 1814. This oil painting shows the Hastings frontage from Low Water Mark, looking east along the extensive beach towards the town, and the high sandstone cliffline beyond.

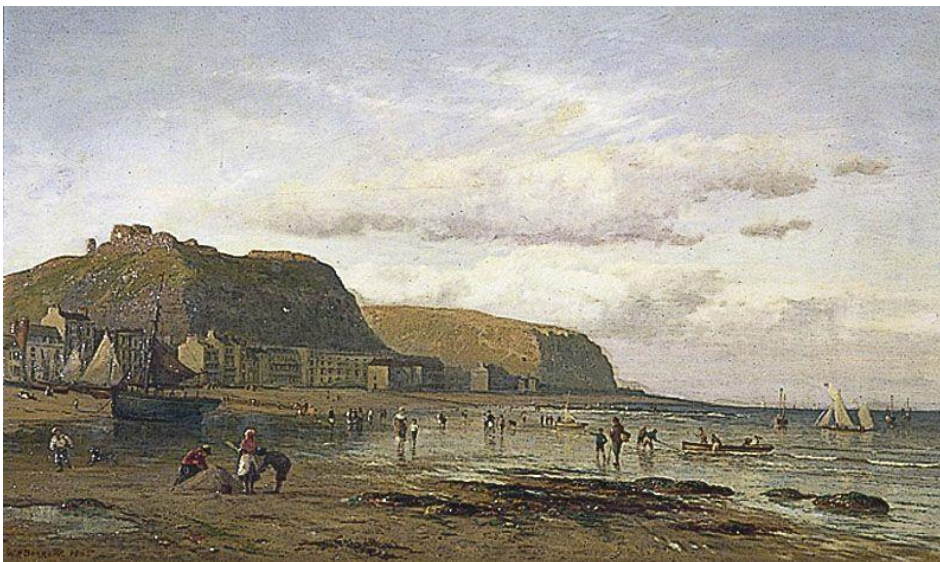
Fig. CS3.2.5. An oil by the prolific Hastings artist, William Henry Borrow, dated 1885. The relatively gentle sloping foreshore can be observed. Hastings Castle is on the top of the cliffs overlooking the expanding seaside resort.

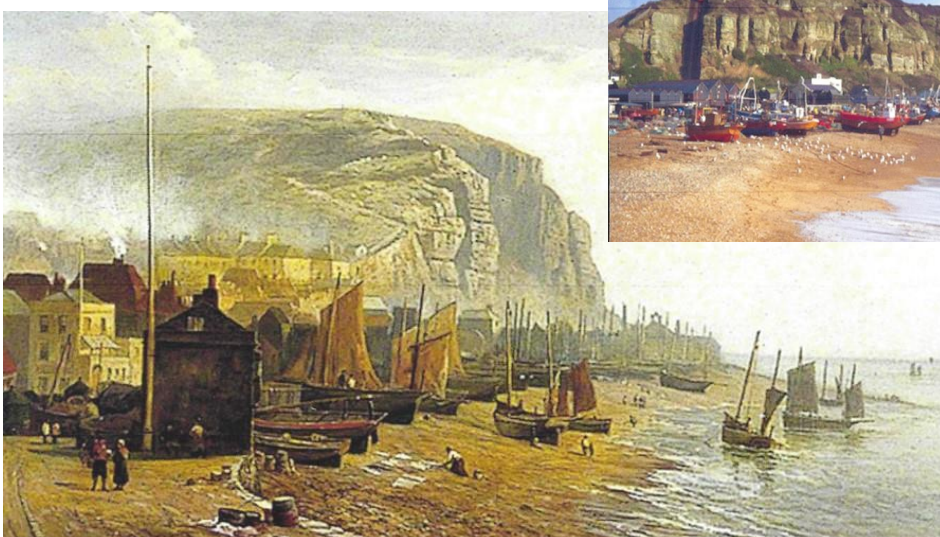
Fig. CS3.2.6. A further oil by W. H. Borrow, dated 1879, showing the steeper beach at the eastern end of the Hastings frontage; this is also reflected in the present day view (Fig. CS3.2.7.).

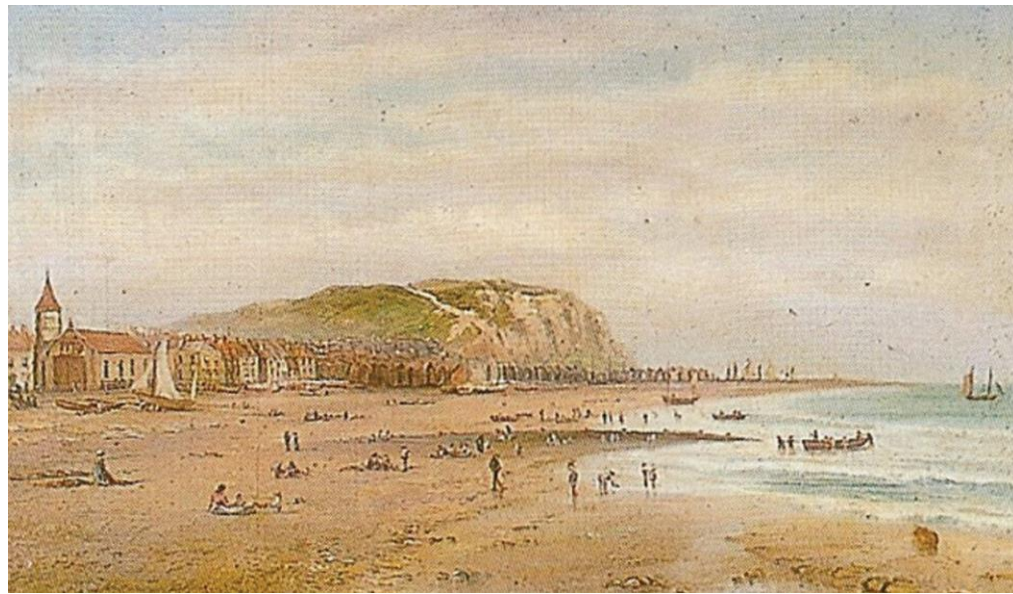
Fig. CS3.2.8. An oil by Edwin Hayes entitled '*Old Hastings*', 1880, taken from Low Water Mark, showing the considerable expanse of beach at that time.

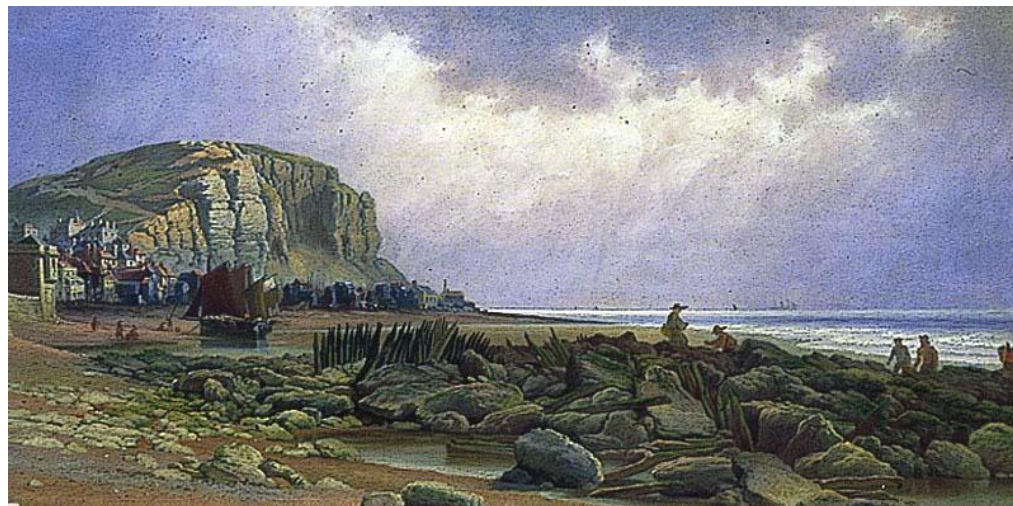
Fig. CS3.2.9. '*Remains of the Elizabethan Harbour at Hastings*' by Charles A. Graves, 1901. This view shows the timber relics of the harbour. Beyond is the fishing village and behind it the jointing and mechanisms of failure of the rugged sandstone cliffs are particularly well painted.

The painting by Graves of the Elizabethan harbour (**Fig. CS3.2.9.**) is one of many examples of coastal landscape paintings, which include archaeological and maritime heritage evidence. Such images can provide evidence alongside archaeological fieldwork to help understand past coastal developments and activities around the English coast.

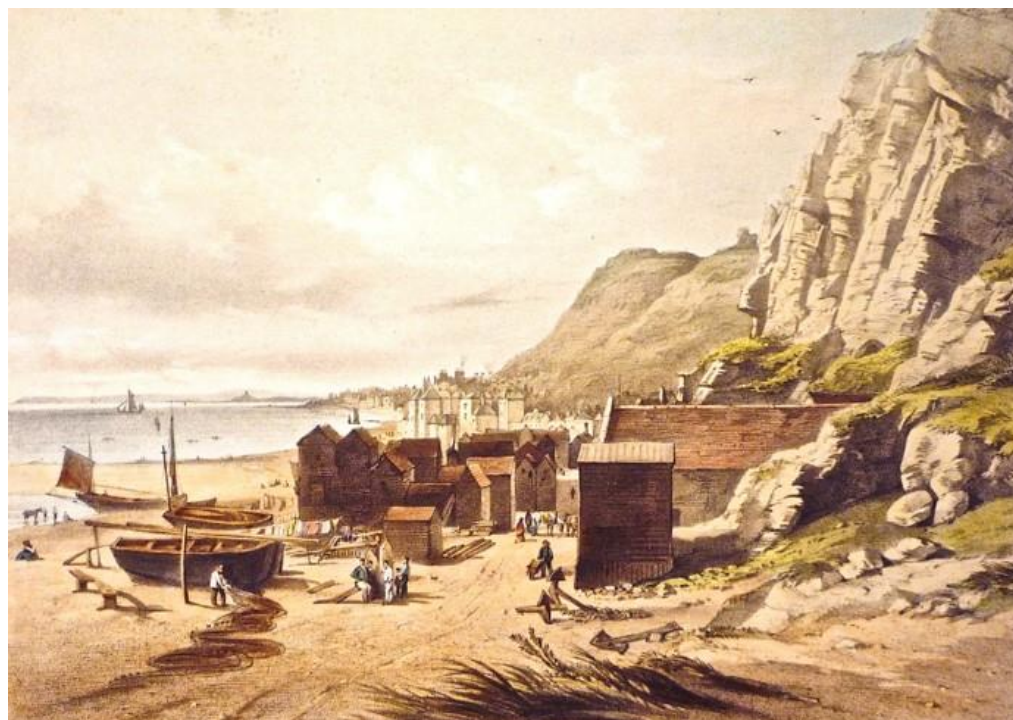
Fig. CS3.2.10. This mid-nineteenth century lithograph provides a detailed view of the character of the fishing village at the eastern end of the Hastings town frontage.

The lithograph of the eastern end of Hastings beach, **Fig. CS3.2.10.** shows the extent of the beach in the mid-nineteenth century. It has been increasingly recognised that it is necessary to take a long-term perspective when looking at coastal issues and to understand the processes of coastal evolution over time. By making decisions about coastal risk management policy, looking ahead for the next 100 years, it is important to understand the rate and scale of change over time, and images of this kind can help explain beach conditions in the past.

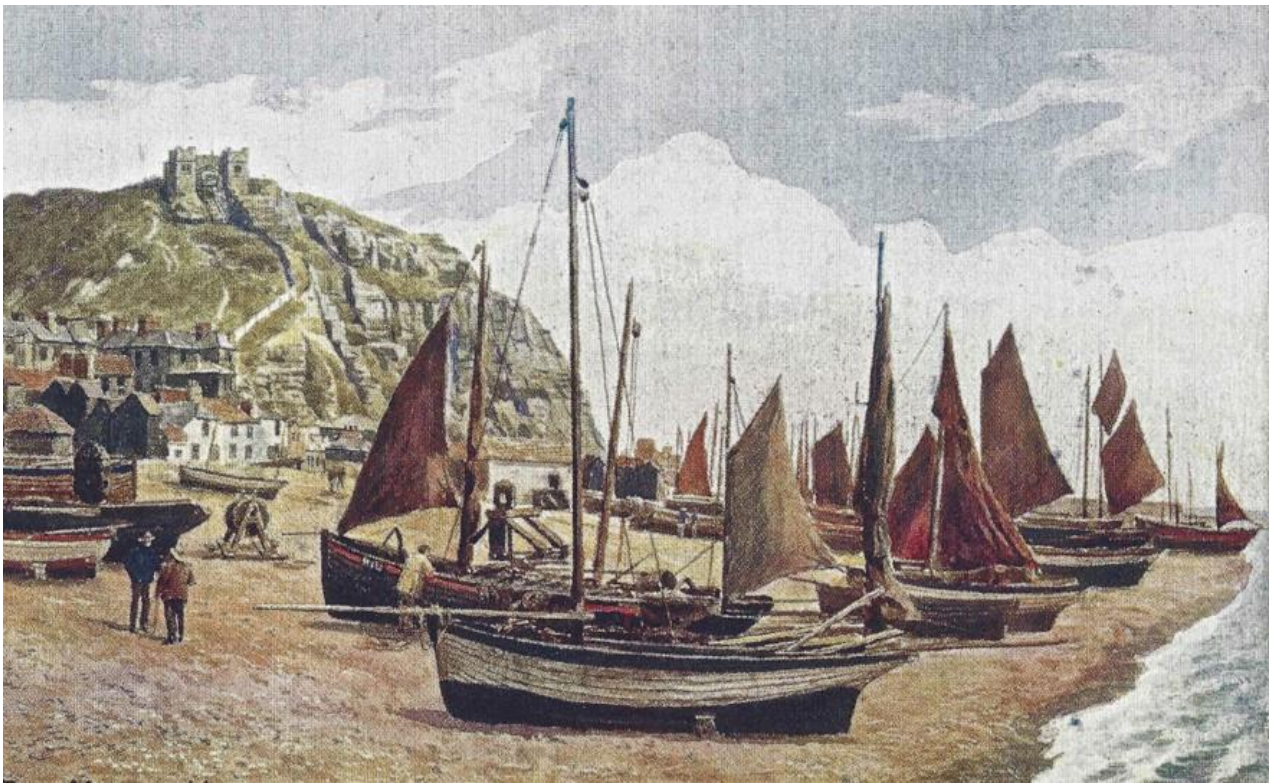
Fig. CS3.2.11. A detailed watercolour of the eastern end of Hastings beach in about 1920 by the prolific coastal artist, Alfred Robert Quinton. The boats are beached at the waterline below a change in the profile of the shore, which is still present today. The control room for the lift is visible on the cliffs behind.

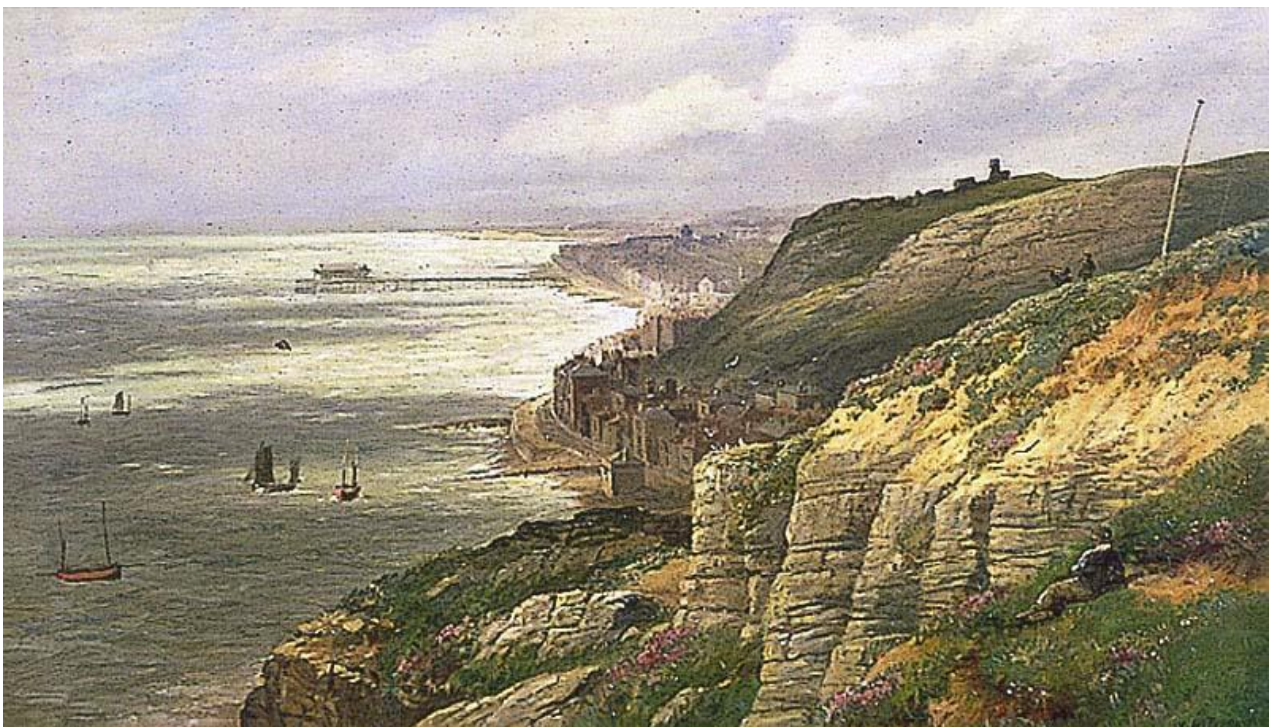
Fig. CS3.2.12. A panoramic view by W. H. Borrow from the top of the cliffs looking westwards in 1881. The geology is carefully painted and shows the dipping, jointed strata. The scene is painted at High Water as the sea abuts the promenade.

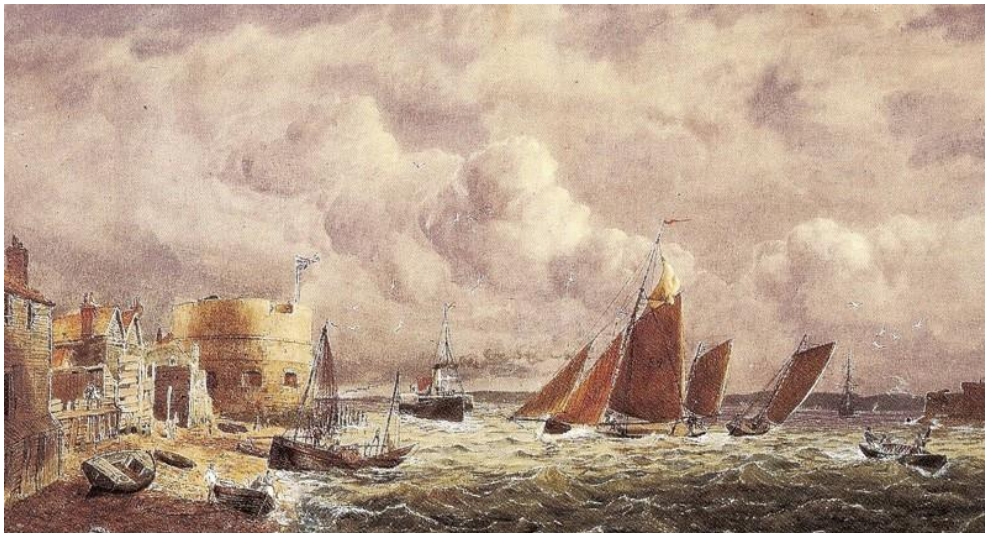
Fig. CS4.1.9. This watercolour by W. E. Atkins c.1890 shows the Round Tower at Portsmouth and was painted fifty years after Joy's view (above). The beach can be seen adjacent to the Tower. Vertical timber poles were designed to reduce the reflection of waves from the tower itself.

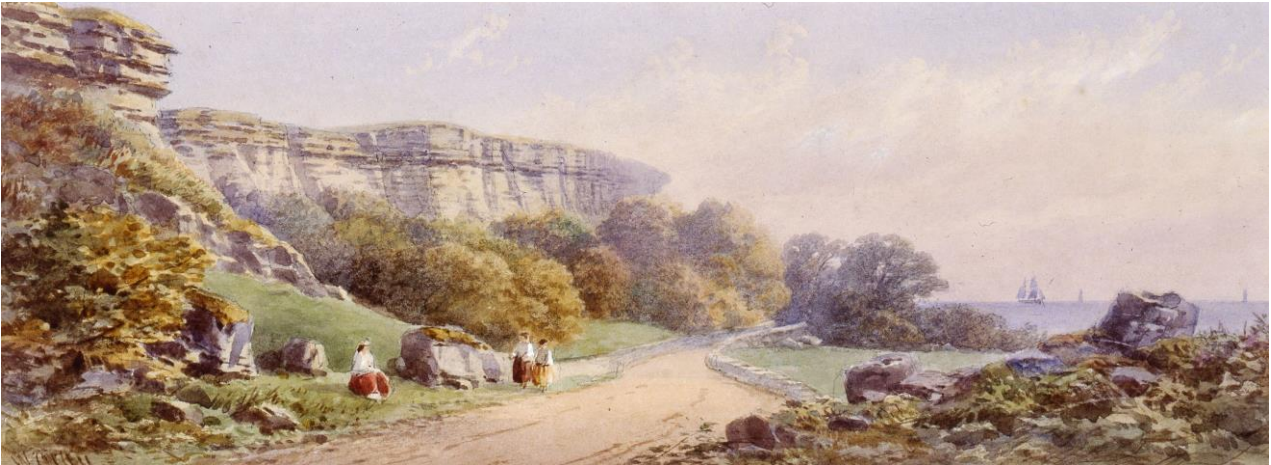
Fig. CS4.2.8. (top) This watercolour of Niton Undercliff c.1855 by William Gray shows the scenery when the coastal land was open and grazed. After grazing gradually died out the Undercliff has become covered by trees and undergrowth, which masks the striking cliffline.

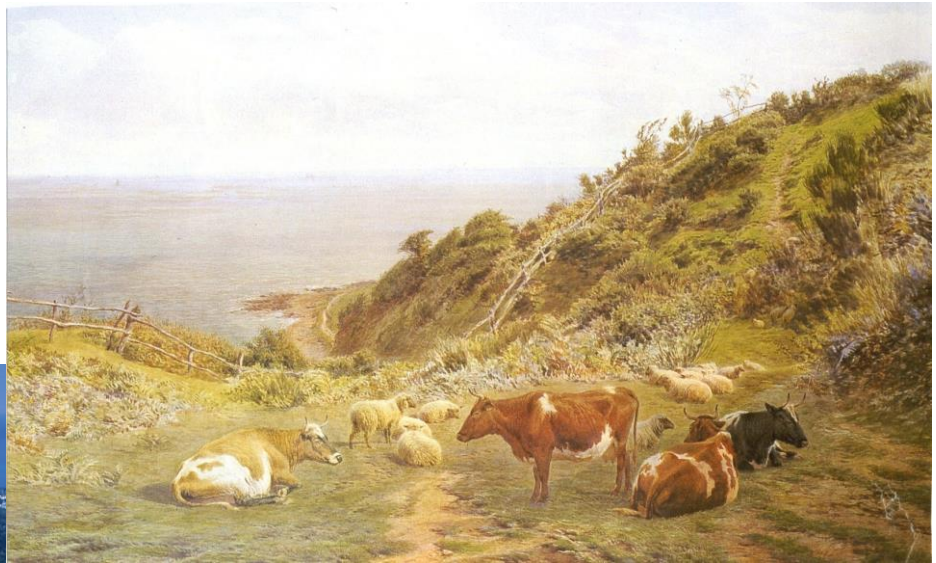
Fig. CS4.2.9. (middle) At Luccombe the open prospects enjoyed in this watercolour by Frederick Williamson (1878) are now obscured by tree growth.

Artworks also illustrate changing natural environments. A significant change in the Undercliff landscape occurred from the early 1900s and after the First World War, when grazing of the coastal fields and slopes effectively stopped. This led to the growth of scrub and trees throughout the Undercliff, which changed significantly the character of the landscape from an essentially open area backed by the dramatic rear cliff of the Undercliff escarpment, into a heavily wooded coastal zone (see Fig. CS4.2.8. & CS4.2.9.).

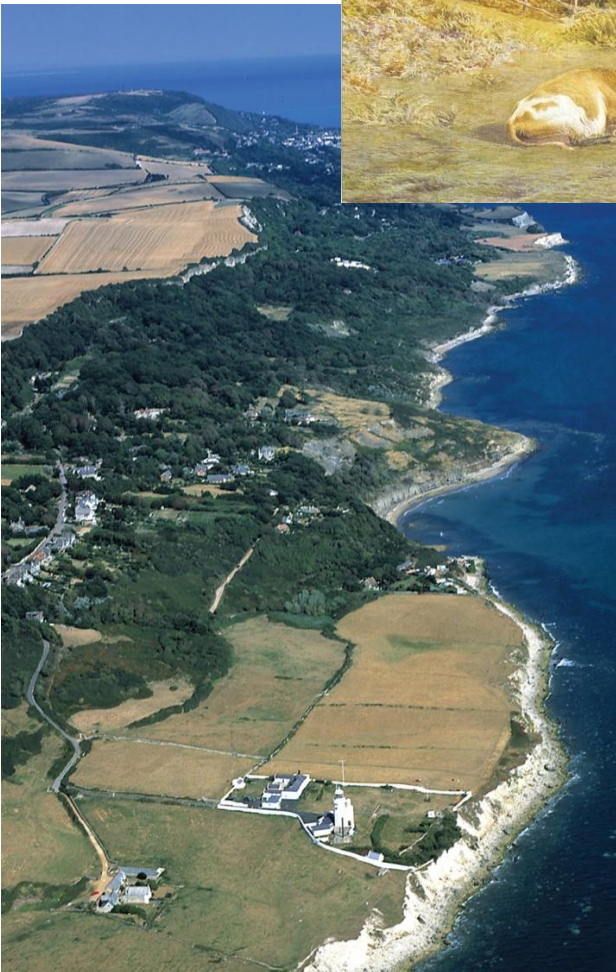
Fig. CS4.2.10. (left) shows the view looking eastwards along the Undercliff from above St Catherine's Point. In the early 1900s acorns of Holm Oak (Evergreen Oak) were planted on the chalk downs behind Ventnor and now form the largest forest of this kind in Northern Europe.

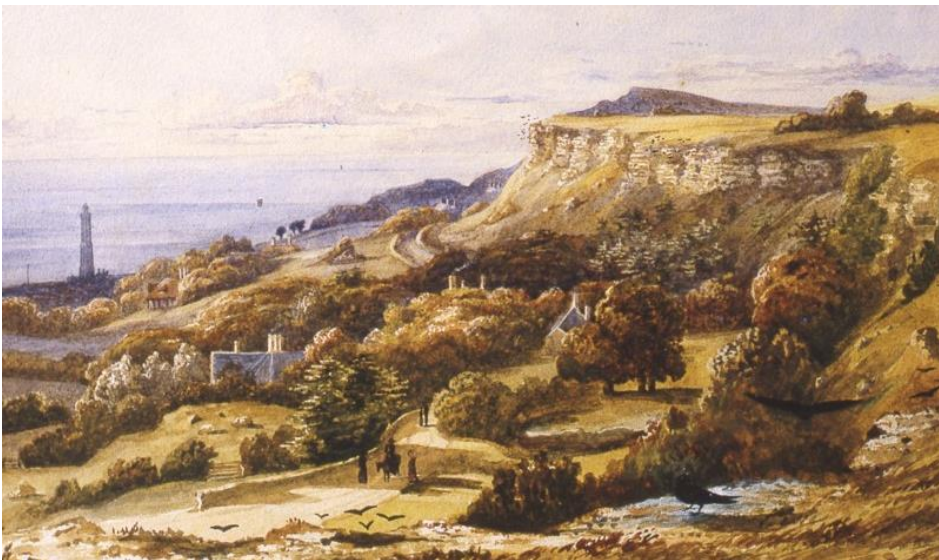
Fig. CS4.2.12. (middle) This extensive view of Niton Undercliff to the west of Ventnor was painted by Susan Kirkpatrick in 1864.

Beauchamp House (centre right) was destroyed by a landslip in 2001. The lighthouse at St Catherine's Point is shown at its original height and was later reduced because the light was obscured by sea mists. In the distance can be seen the Buddle Inn and, beyond, the Royal Sandrock Hotel, which was destroyed by fire in 1984.

Artworks also illustrated changes that have affected a range of buildings of architectural interest in terms of alterations, additions and losses, for example through landslip and fire, and there are numerous examples of changes or losses to historical structures along this part of the Isle of Wight coast (see Fig. CS4.2.11.-CS4.2.13.).
