## Case Study 5 - South-West Coast of England

### 5.1. Introduction

## Case Study 5.1 – West Bay, Dorset to Sidmouth, Devon

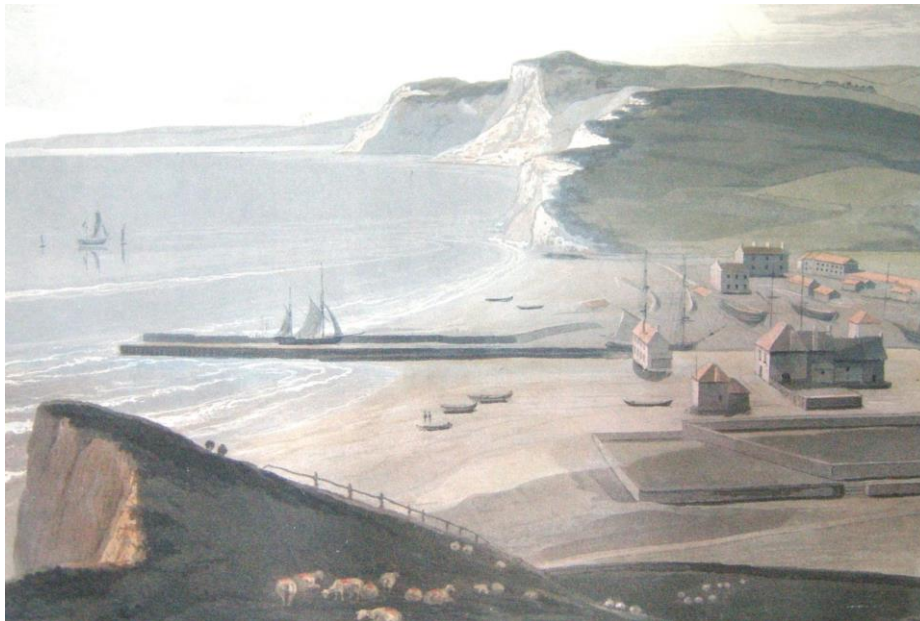
**Fig. CS5.1.4.** *'Bridport Harbour' or West Bay* by William Daniell RA. 1825. The aquatint engraving shows how the historic harbour arms cross the wide beach interrupting the west to east sediment transport along the coast.

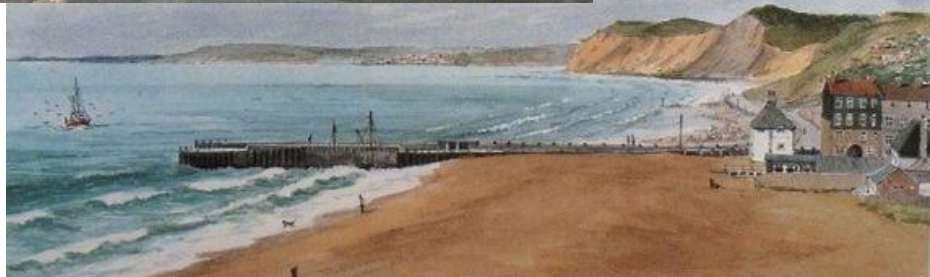
**Fig. CS5.1.5. (right)** This view of the same scene (but from a lower vantage point) was painted in watercolour by David Addey in 1990. The harbour and flood defences were improved ten years ago.

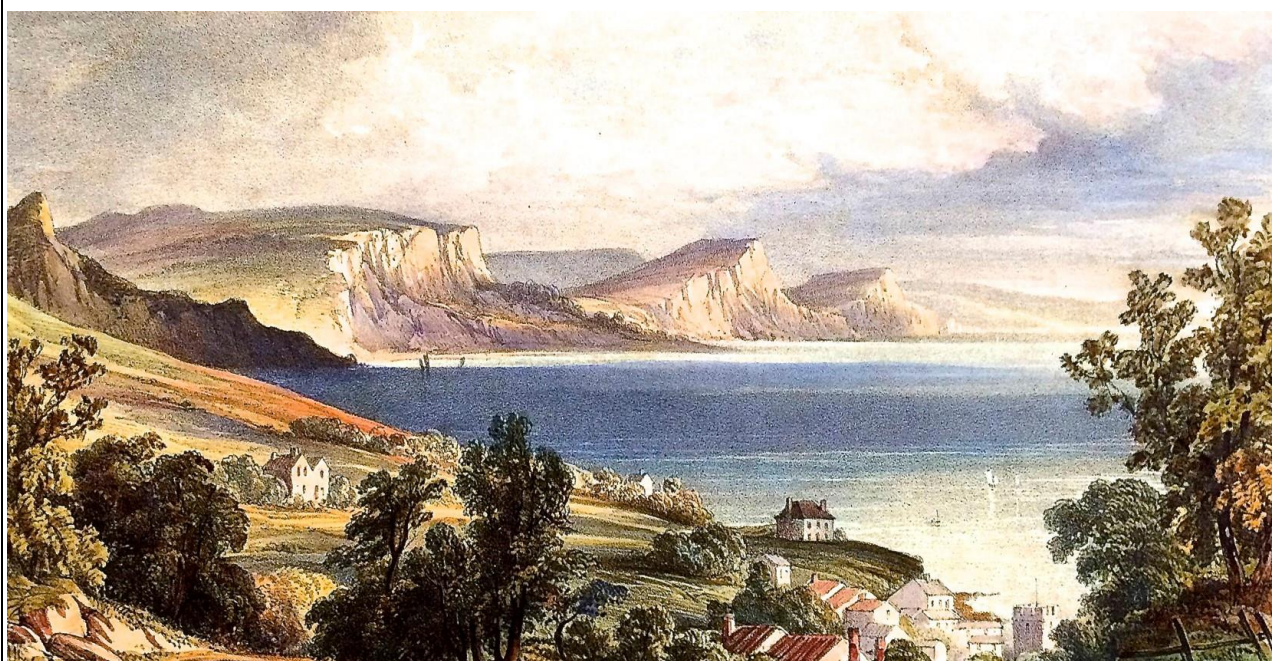
**Fig. CS5.1.11. (top)** The coastal geology and geomorphology was mapped and described by the Rev. W. Conybeare and William Dawson in 1840. They provided detailed maps of the landslips, as well as finely lithographed views of the major landslide events.

**Fig. CS5.1.12. (middle)** In addition to their maps and plates, Conybeare and Dawson produced detailed views of the coastline from the sea, which provide an accurate record of coastal conditions and developments along this part of the East Devon/West Dorset coast.

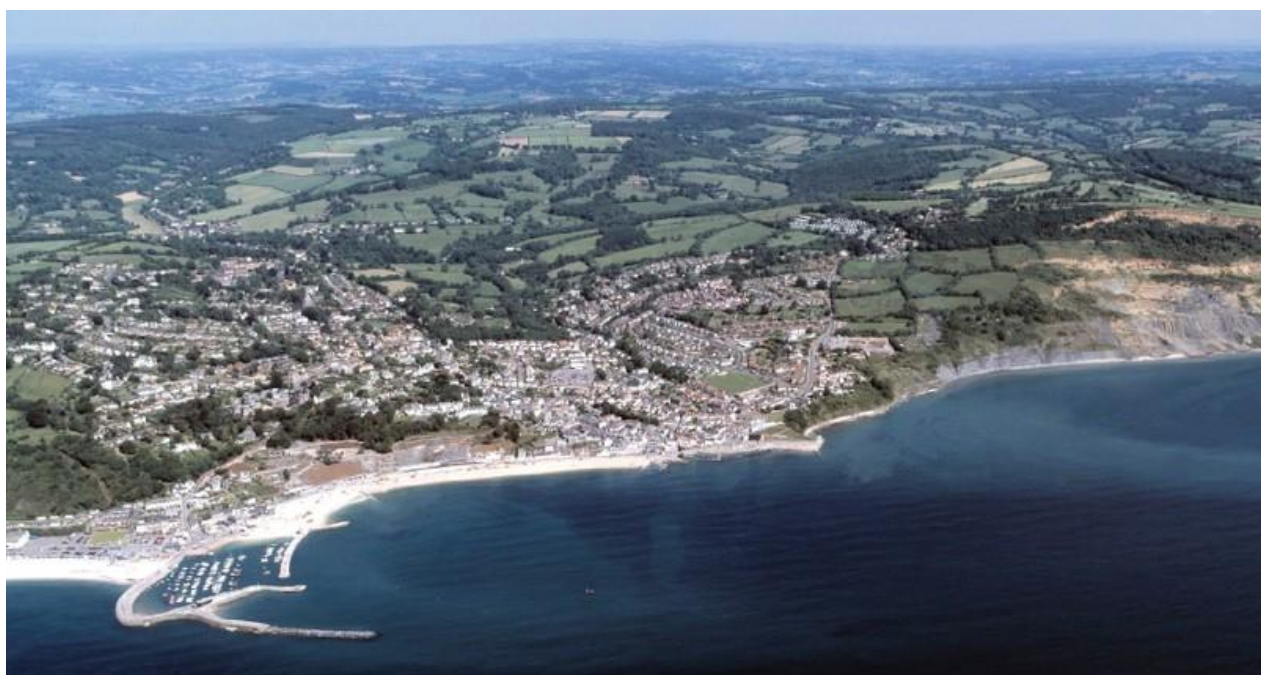
**Fig. CS5.1.16.** Lyme Regis has been protected progressively over the last 25 years with several phases of major coast protection and landslide stabilisation works. These have included the addition of rock armour at the end of the Cobb and, more recently, further works at the eastern end of the seafront below The Spittles.

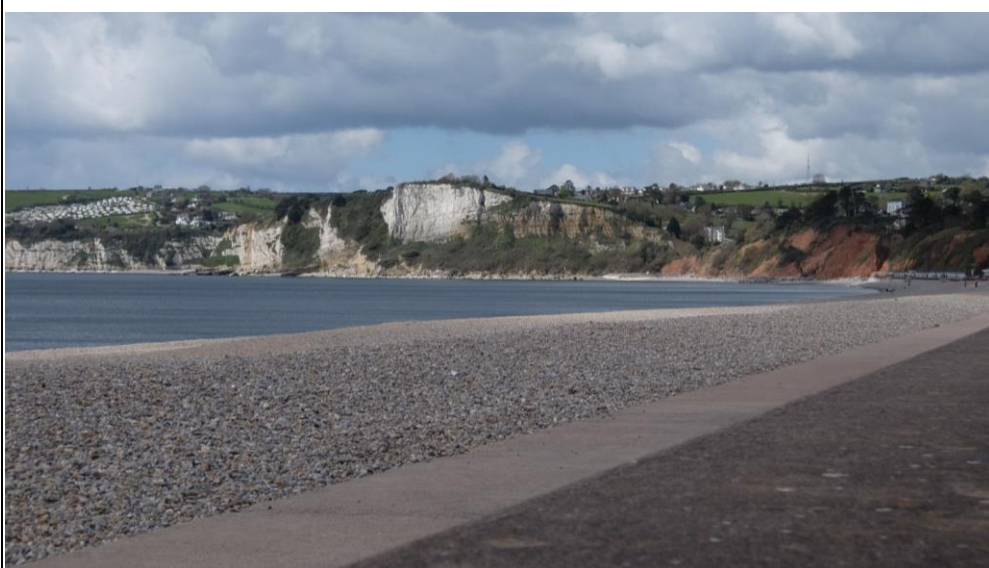
**Fig. CS5.1.20.** This photograph shows the headland on the left of Cooke's painting. The cliff tops contain heritage sites, which are being lost progressively as a result of coastal erosion.

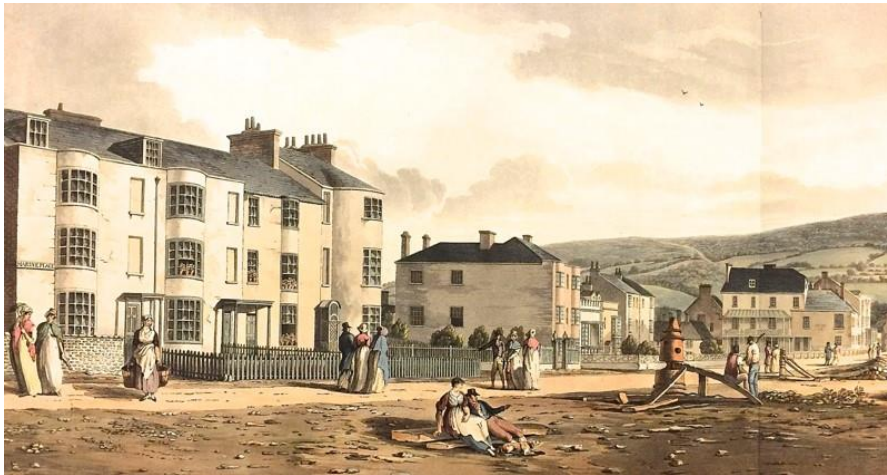
**Fig. CS5.1.28.** This view looks east along the coast from the shore. The seawall and Esplanade were yet to be constructed. The building on the left is Prospect Place with the York Hotel beyond.

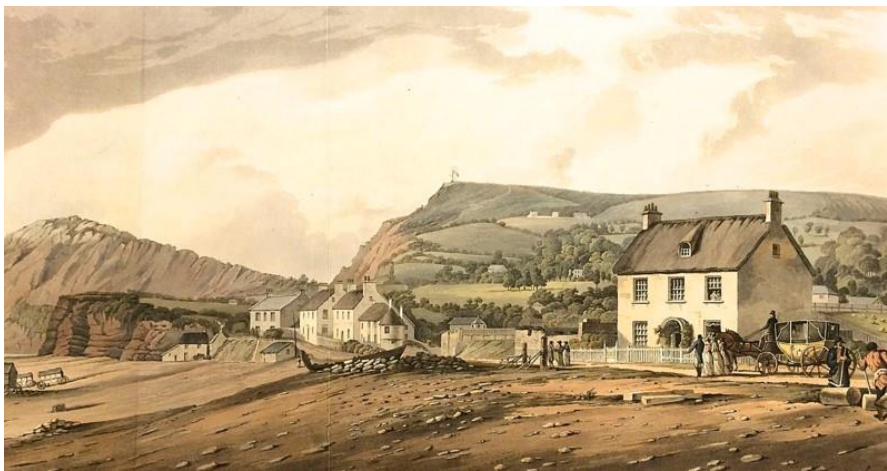
**Fig. CS5.1.29.** A second eastward view shows Marine Place and Portland Place. The entrances to the properties appear level with the back of the beach, which appears to be very extensive at the time.

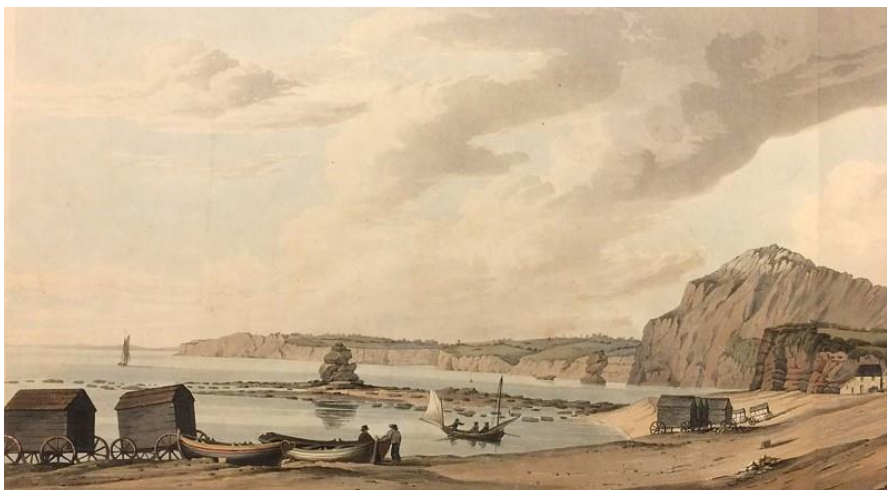
**Fig. CS5.1.30.** This detail from the 'Long Print' looks to the west and shows the thatched 'Fort Cottage' with the signalling mast on Peak Hill. The fishermen's cottages on the shore to the left were destroyed in the Great Storm of 1824.

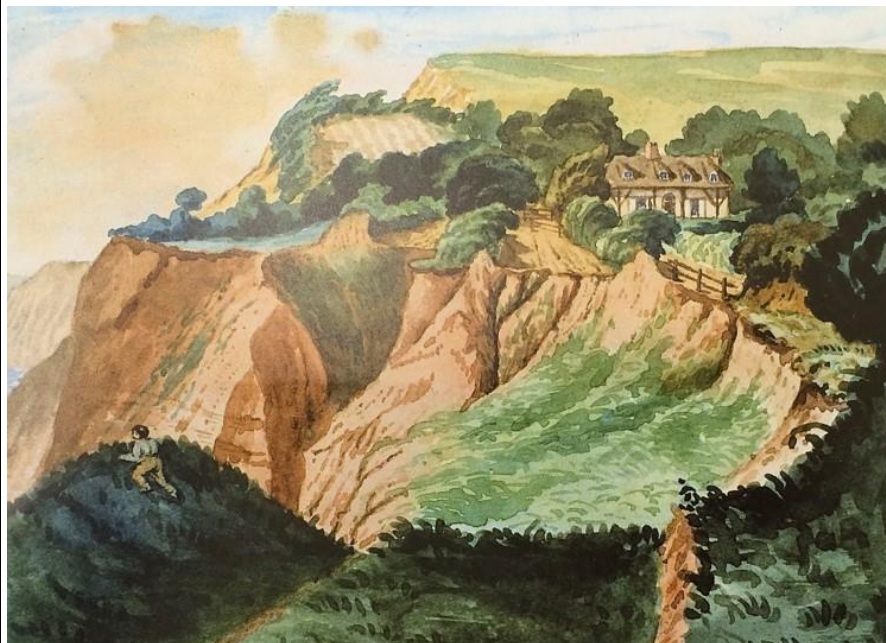
**Fig. CS5.1.32.** A failure of the cliff near Peak Cottage, Peak Hill, Sidmouth, on 31<sup>st</sup> August 1847. A watercolour painted on the spot by P. O. Hutchinson.

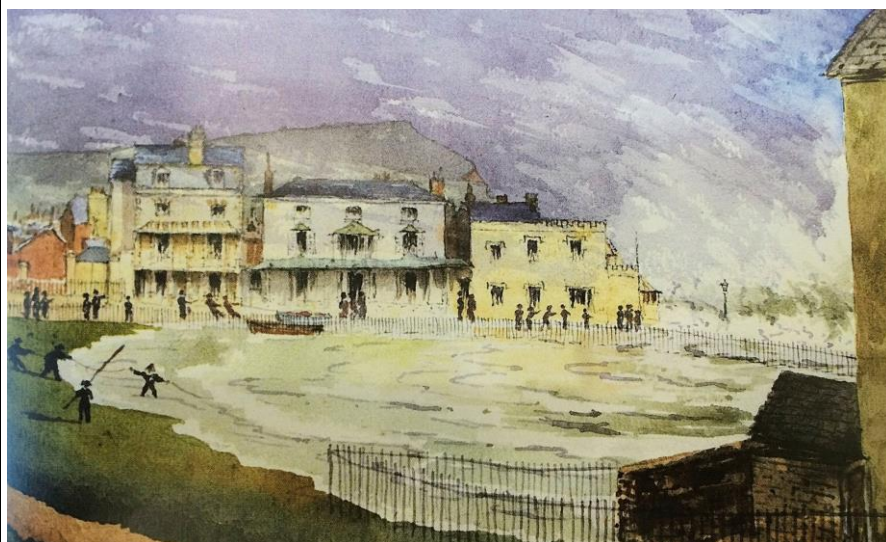
**Fig. CS5.1.33.** Serious sea flooding affected Sidmouth on 3<sup>rd</sup>/4<sup>th</sup> December 1876. The scene was captured in watercolour by P. O. Hutchinson and described in his diary.

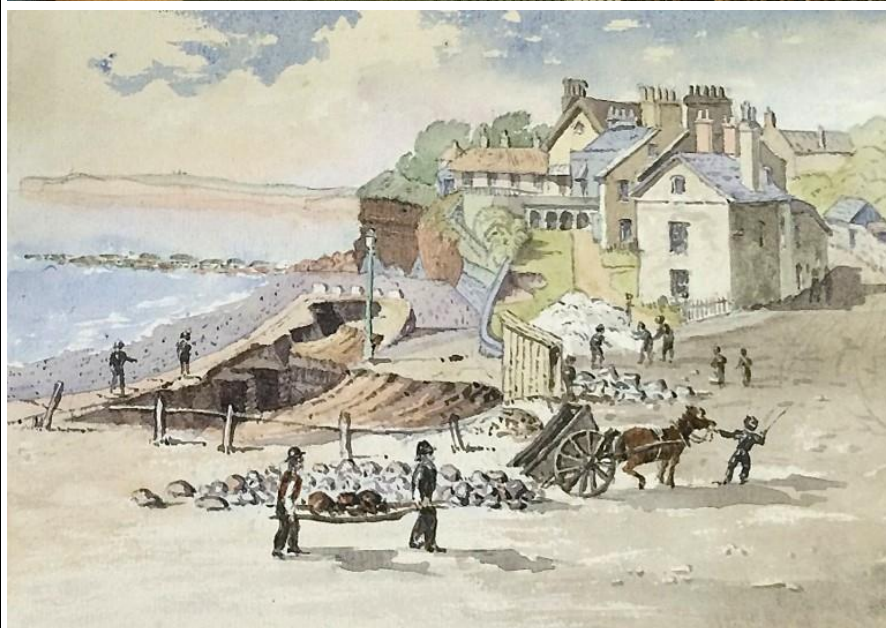
**Fig. CS5.1.34.** Sketch by P. O. Hutchinson showing repairing storm damage to the Esplanade near the bottom of Peak Hill, Sidmouth, in January 1873.

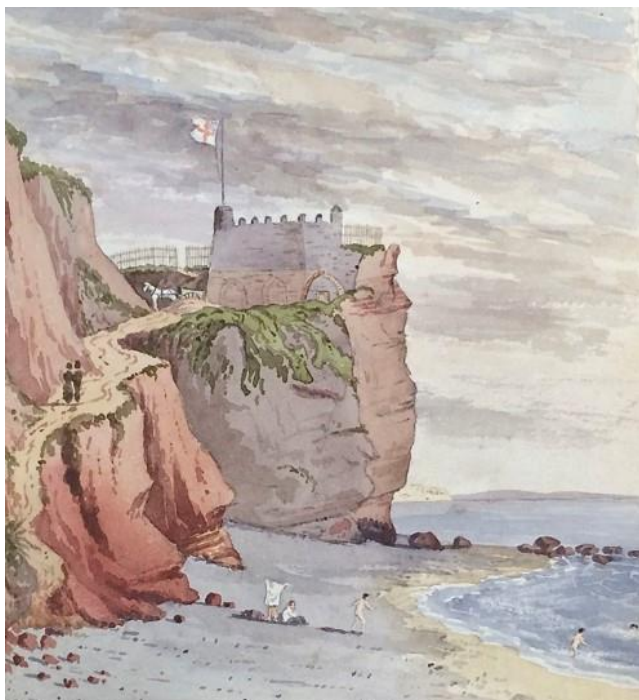
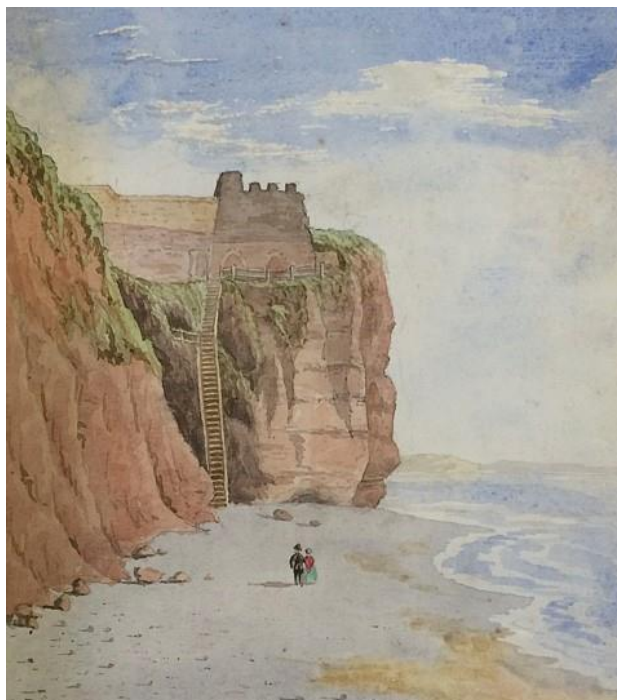
**Fig. CS5.1.35, CS5.1.36 & CS5.1.37.** These three views by Hutchinson depict the remains of the old lime kilns near the Chit Rocks at Sidmouth. The earliest view (top left) was painted on 4<sup>th</sup> December 1871, with a ladder providing access to the shore (top right). The view (left) was painted in May 1888 and, by now, the base of the cliff has been protected.

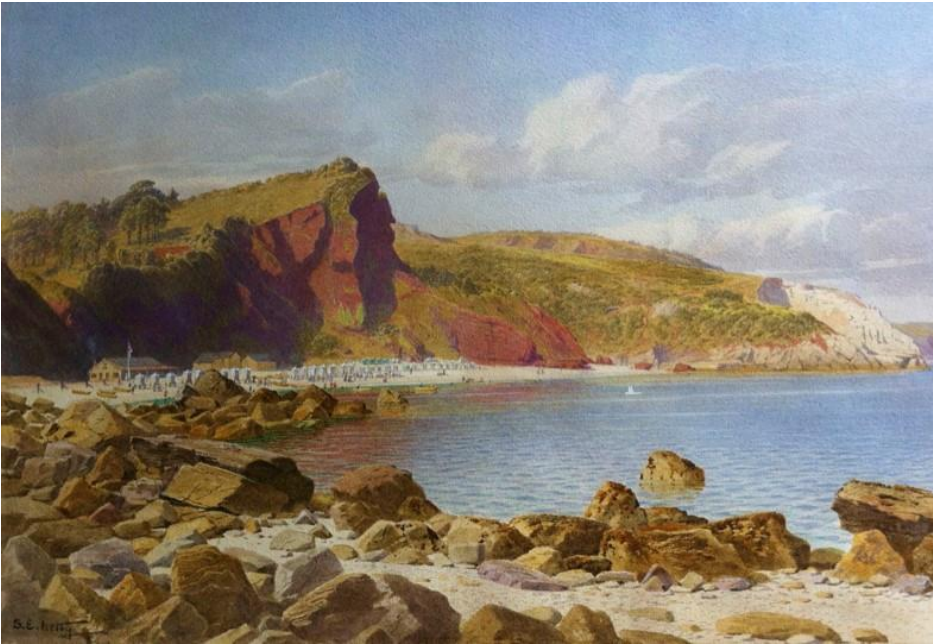
**Fig. CS5.2.15.** This detailed watercolour of '*Oddicombe Beach*' by Samuel Edward Kelly, c.1910, shows development beneath the precarious red sandstone cliffs. Debris from previous cliff falls litters the shore in the foreground.

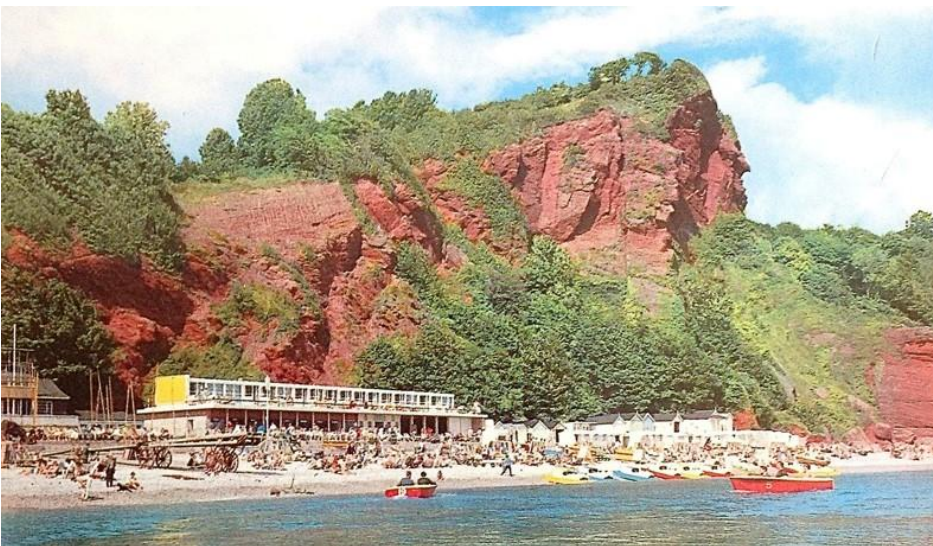
**Fig. CS5.2.16.** This postcard shows the beach and the cliff in about 1970. The jointing in the sandstone cliffs is clearly visible and suggests the potential for further cliff falls.

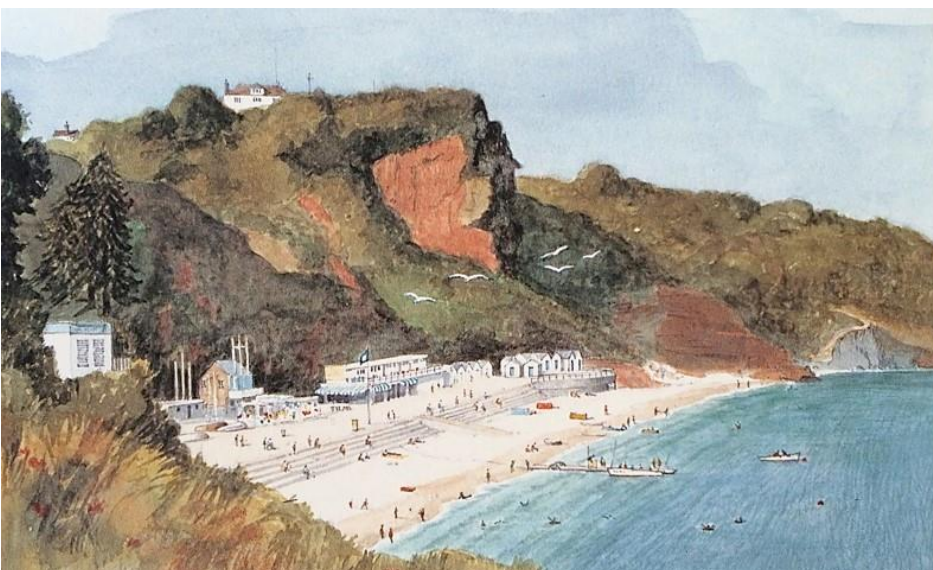
**Fig. CS5.2.17.** The watercolour by artist David Addey (1990) shows development on the cliff top and coastal defences in the bay below.

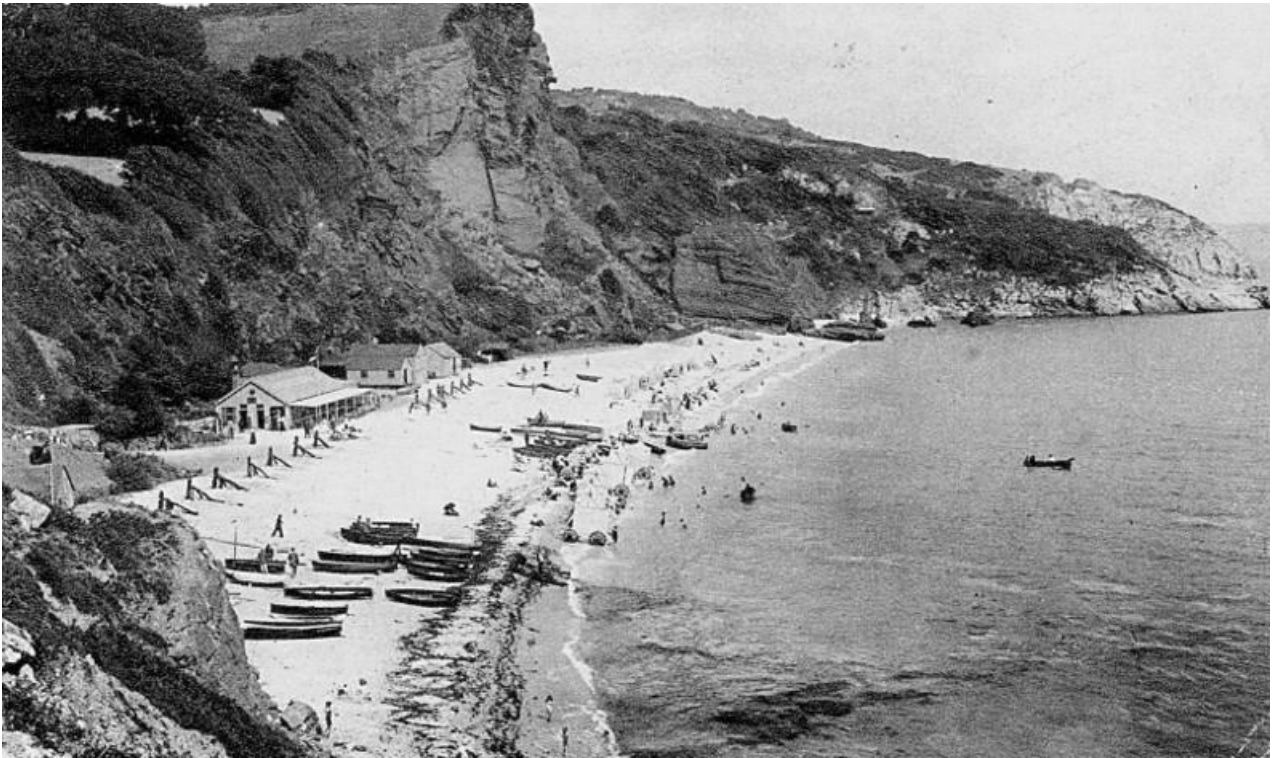
**Fig. CS5.2.18. (top)** A photograph of Oddicombe Beach c.1900 looking eastwards. A cliff fall has occurred from the face of the bluff in the centre of the view.

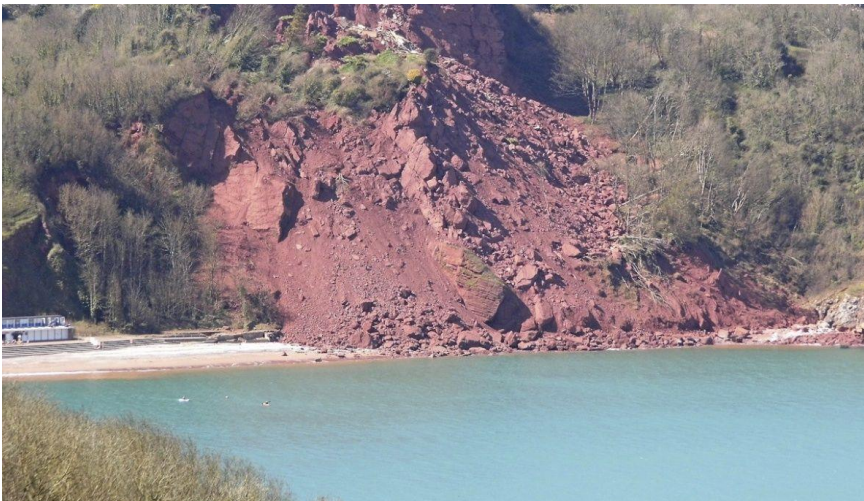
**Fig. CS5.2.19. (middle)** The massive cliff fall onto Oddicombe Beach on 3<sup>rd</sup> April 2013 at Ridgemont House.

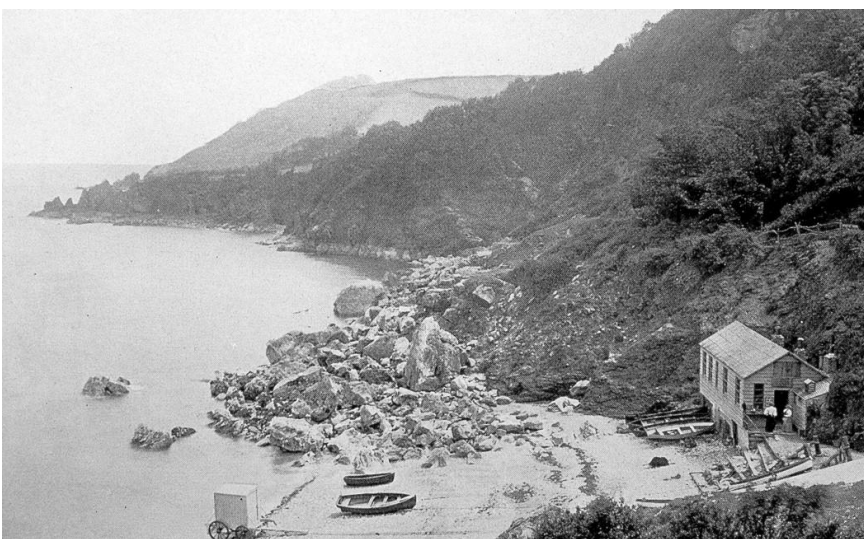
**Fig. CS5.2.20. (bottom)** Another massive rockfall at nearby Anstey's Cove is recorded in this photograph c.1900.
