Case Study 5.3 – Polperro to Penzance, Cornwall

Case Study 5.4 – Hartland Point to Ilfracombe, Devon

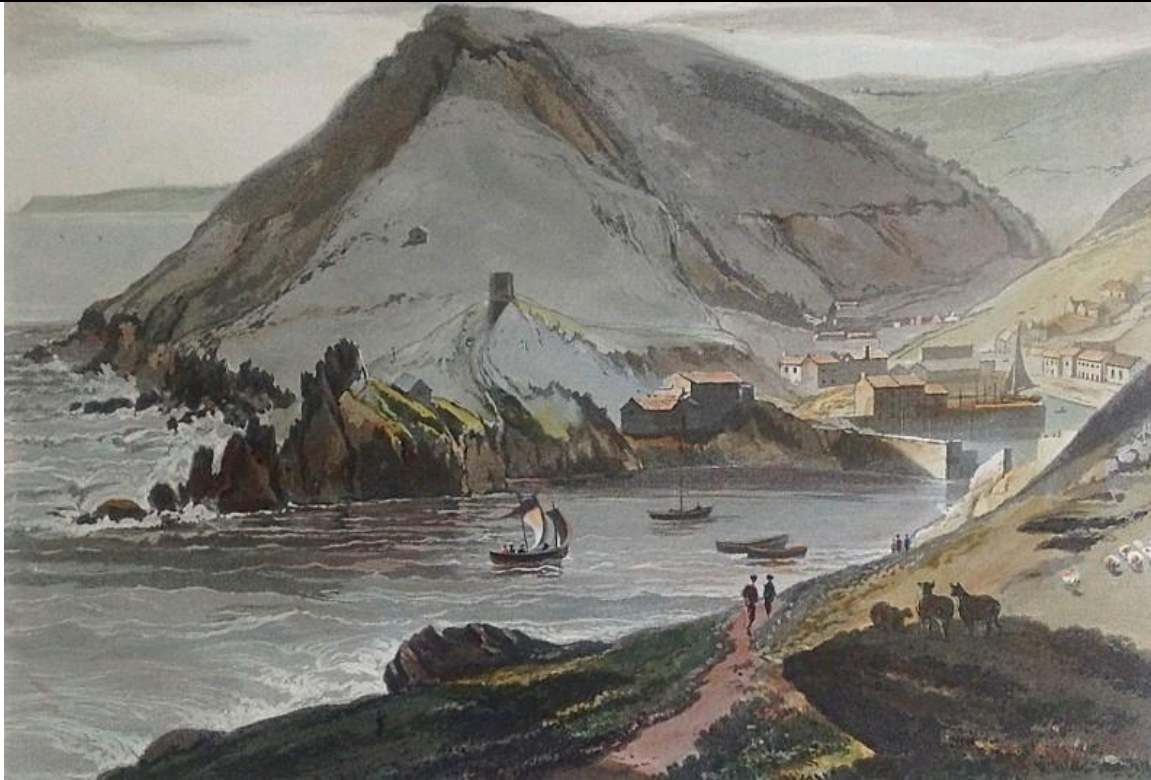
Fig. CS5.3.2. (above): 'Polperro' by William Daniell RA was engraved in 1825, near the end of his eleven year 'Voyage Round Great Britain'. Image courtesy of Grosvenor Prints.

It compares with the view by David Addey painted in 1988 (**Fig. CS5.3.3. below**). Daniell has foreshortened the western side of the entrance to the harbour, and has slightly exaggerated the height of the scenery. Daniell said of Polperro *"the town is very irregularly built; the inhabitants are mostly fishermen, and in the pilchard season, whatever inclination they may have for cleanliness, they cannot be otherwise than dirty. Of course, little can be said of the beauty, and nothing of the elegance of Polperro; but the environs abound in picturesque features, though of a humble kind, such as uncouth cottages, so strangely planted amongst the rocks, that they seem to have been dropped there and left to take their chance of a settlement"*. The harbour piers at Polperro were damaged in the late eighteenth and early nineteenth centuries, and nearly destroyed in 1824. A new pier was constructed in 1824 and improved in 1897, due to the growth of the fishing industry. It is possible that Daniell's aquatint engraving was produced as the new pier was being completed. The harbour and pier are listed Grade II. Today the village has become a major tourist attraction and its development is well illustrated in the series of views by Alfred Robert Quinton (below).

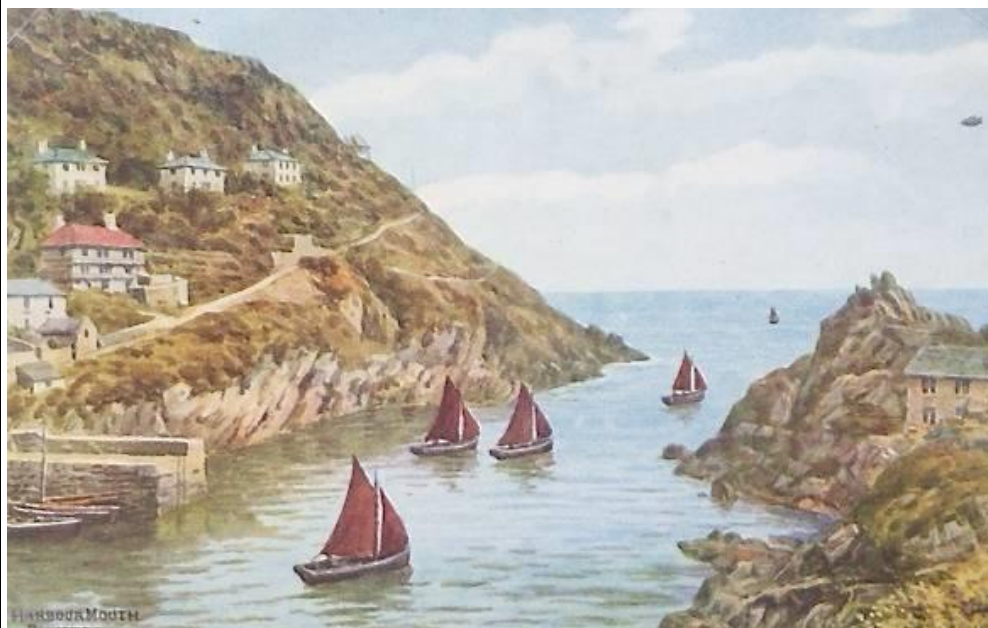
Fig. CS5.3.4. (top) and CS5.3.5. (middle) show two views of the entrance to the harbour at Polperro taken from the same spot. Figure 3 is a watercolour by Alfred Robert Quinton, painted in about 1920, and, for comparison, a photographic postcard (c.1930) shows an almost identical scene to that painted by Quinton, who was quite meticulous in his detail.

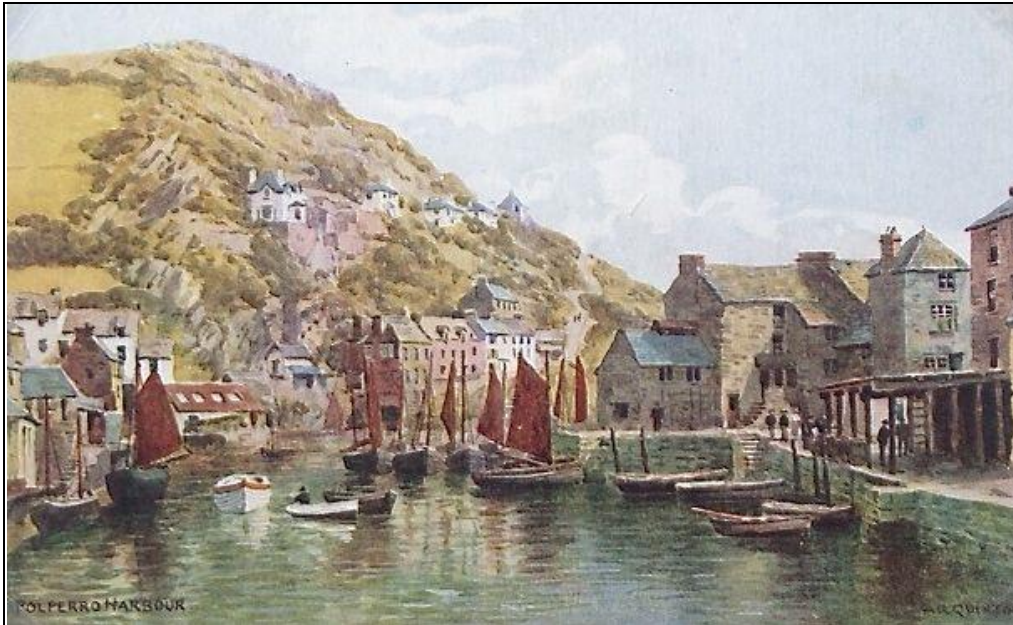
Fig. CS5.3.7.-CS5.3.9. (left) are a series of views, again, by Alfred Robert Quinton, which show the interior of the harbour, together with the harbour arm, painted in about 1915.

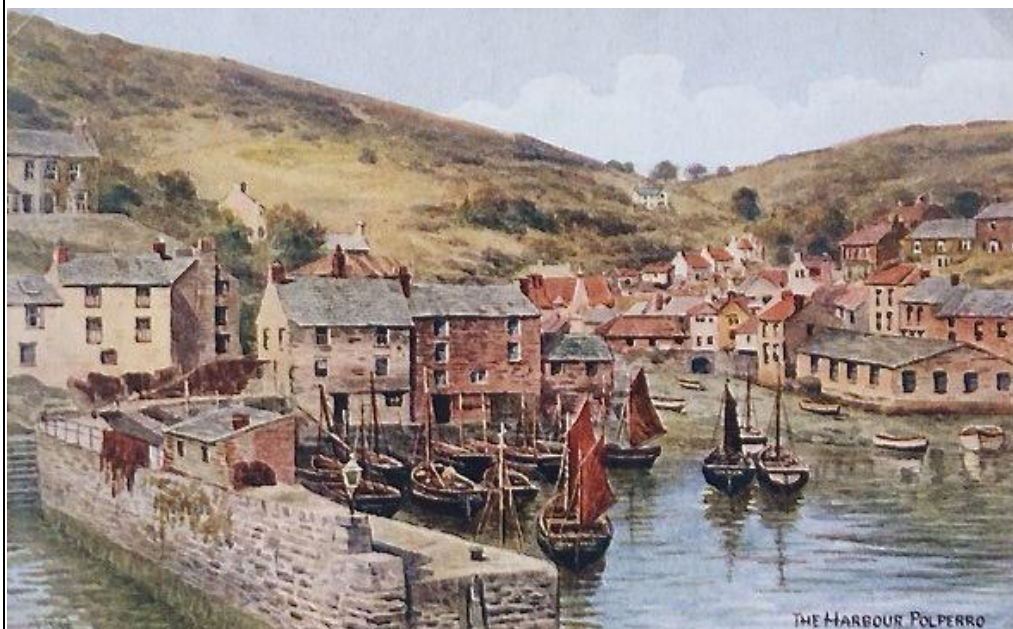
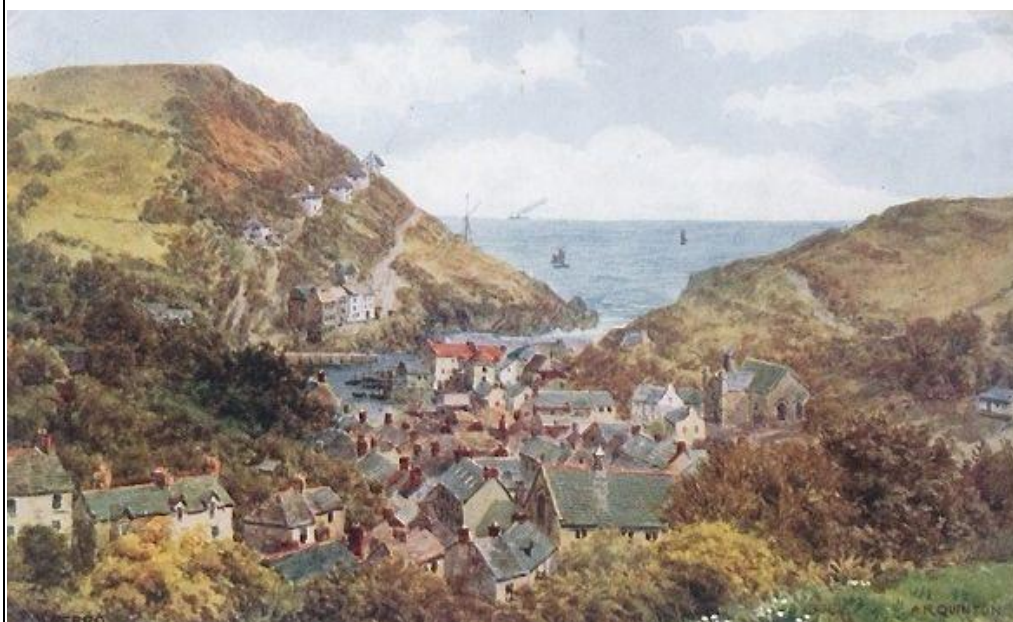
Fig. CS5.3.10. (bottom) shows the overall setting of Polperro, looking from behind the village, out towards the sea. Quinton's work allows us to examine the nature of the harbourside buildings and the structure of the harbour wall itself. This can be compared with the works of other artists who often painted from the same location.

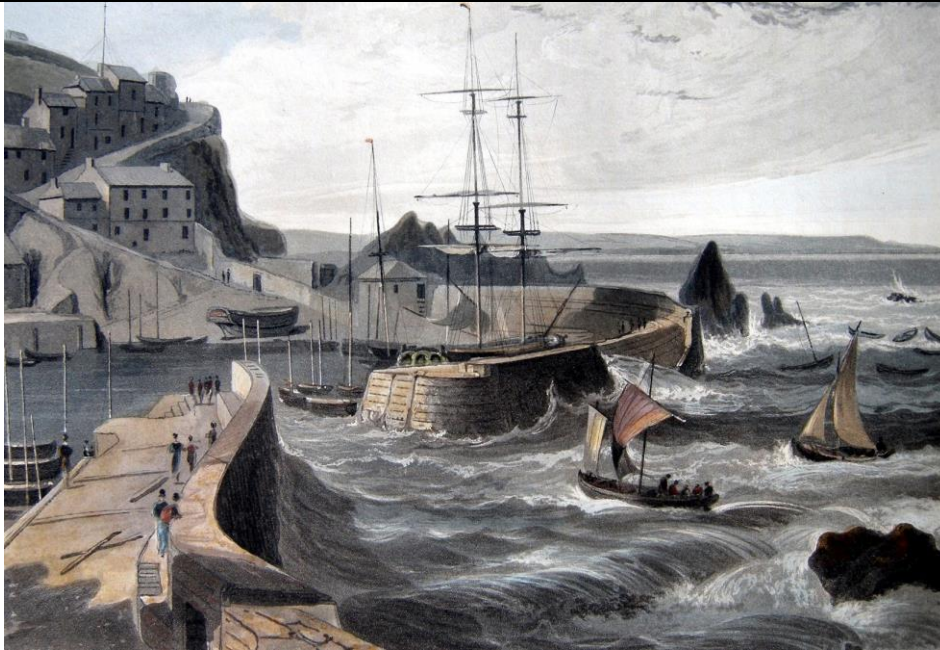
Fig. CS5.3.14. & CS5.3.15. show two views of Mevagissey Harbour by William Daniell, engraved in 1825. The nature of the harbour construction is clearly depicted in **Fig. CS5.3.14. (top)** and the conditions of the water appear rough outside and more tranquil inside the harbour.

It is believed that Mevagissey Harbour dates from as early as the fifteenth century, although, in 1775, a new pier was built enclosing the present day inner harbour, and additional wharfs and jetties were constructed in the late eighteenth century.

The harbour was enlarged in the 1880s with two outer enclosing breakwaters. These were destroyed in the Great Blizzard of 1891, necessitating the harbour to be rebuilt in 1897 (HER, Cornwall County Council, 2012).

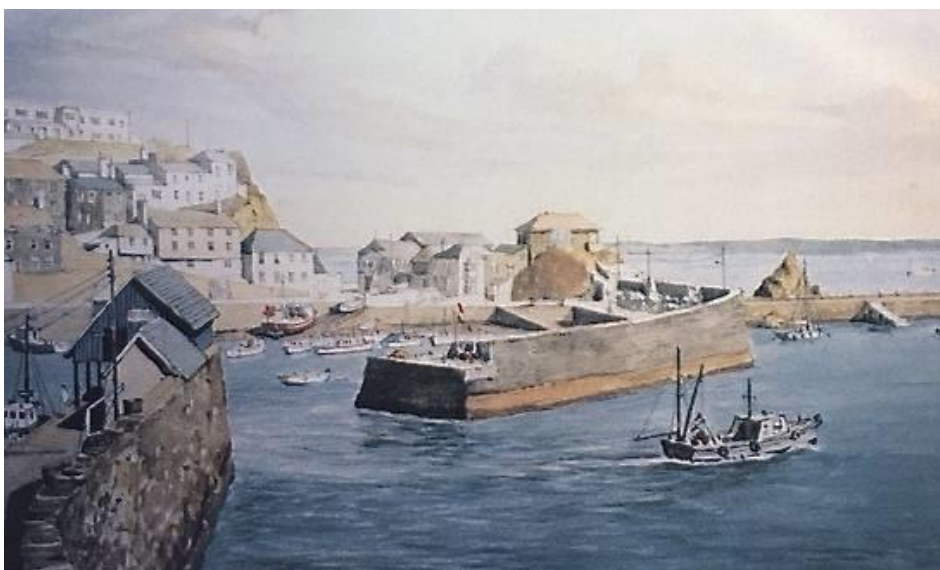
In David Addey's 1988 view (**CS5.3.16. bottom**) he observed that the two main piers are basically unchanged, although a building of pleasing architectural design had been added to the nearer pier on the left. The rounded end of the main harbour arm, as depicted by Daniell, has been squared off in Addey's view.

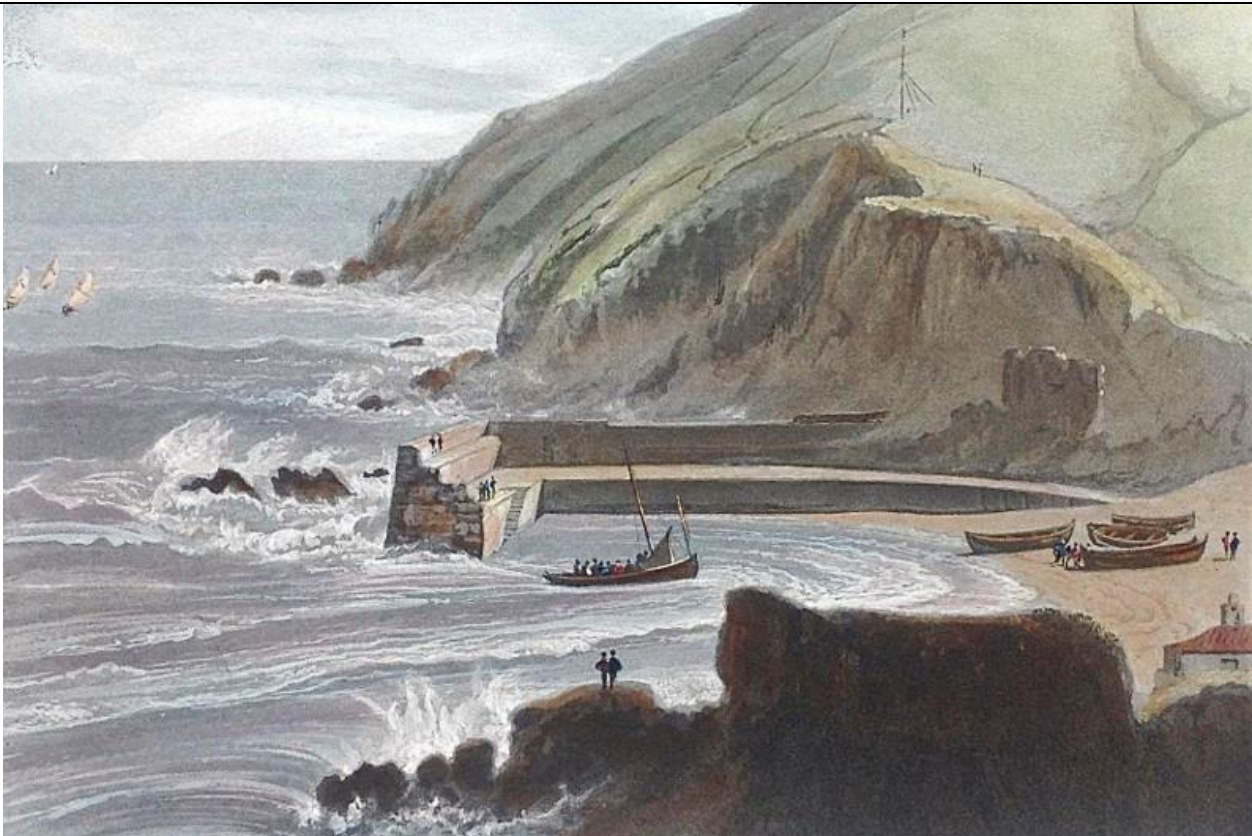
Fig. CS5.3.17. (above) shows Daniell's view of Gorrán Haven, a quay which has existed since medieval times. Daniell's 1825 engraving of the harbour arm appears very similar in design to that depicted by David Addey in 1988 (**Fig. CS5.3.18. below**). Daniell noted *"at Gorrán Haven there is a little pier for the shelter of the pilchard boats. The rocks here and in the neighbourhood are of a bold and picturesque aspect. On the high ground there is a signal post for the preventive service"*.

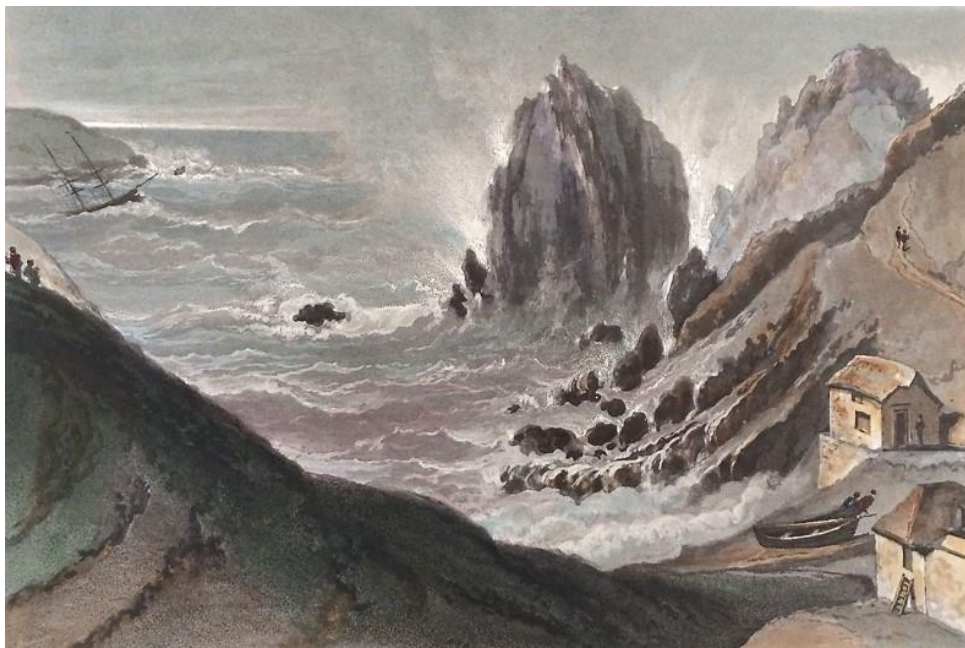
Fig. CS5.3.19-CS5.3.21. show the dramatic physical location of Mullion Harbour. At the time Daniell visited the location a harbour did not exist, and he says *"the scenery around Mullion Harbour is rocky and as wild as possible. In heavy gales from the south-west the cave affords safe shelter for small vessels, whilst the Gull Rock protects them from the sudden and dangerous influence of the ground swell"*.

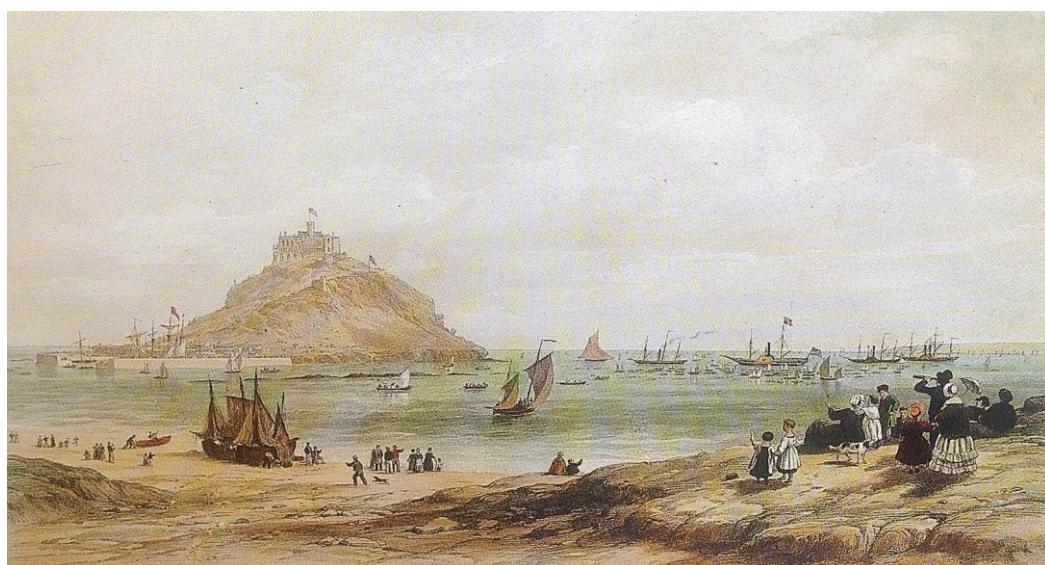
Fig. CS5.3.24. This fine lithograph was produced to mark the occasion of the visit of Queen Victoria and Prince Albert to the Mount in 1846. The landward end of the causeway can be seen on the left of the picture.

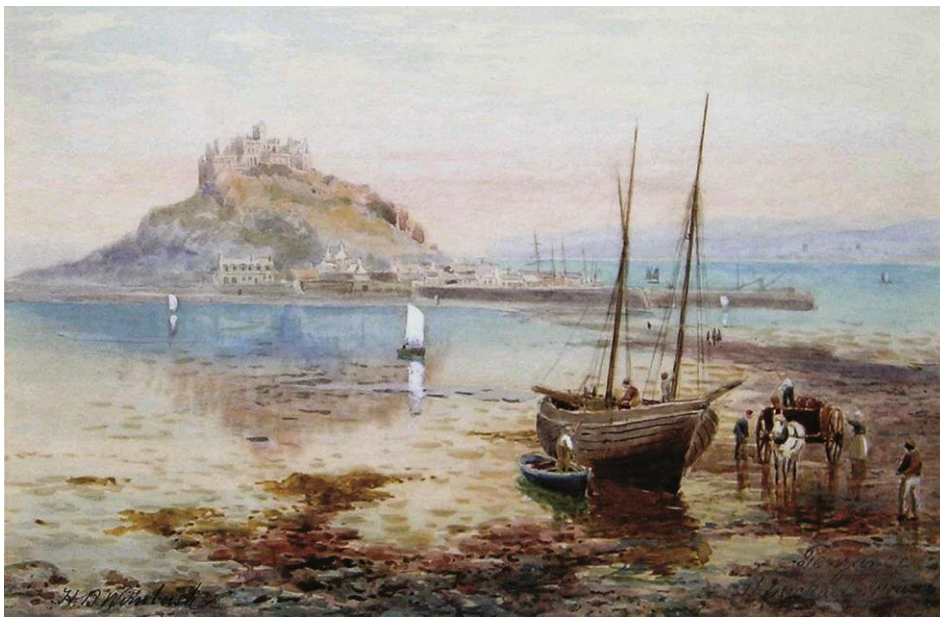
Fig. CS5.3.25. 'St. Michael's Mount' by Henry B. Wimbush. This watercolour (c.1895) shows the scene towards Low Water as the tide recedes to expose the causeway. Image courtesy of Elford Fine Art of Tavistock.

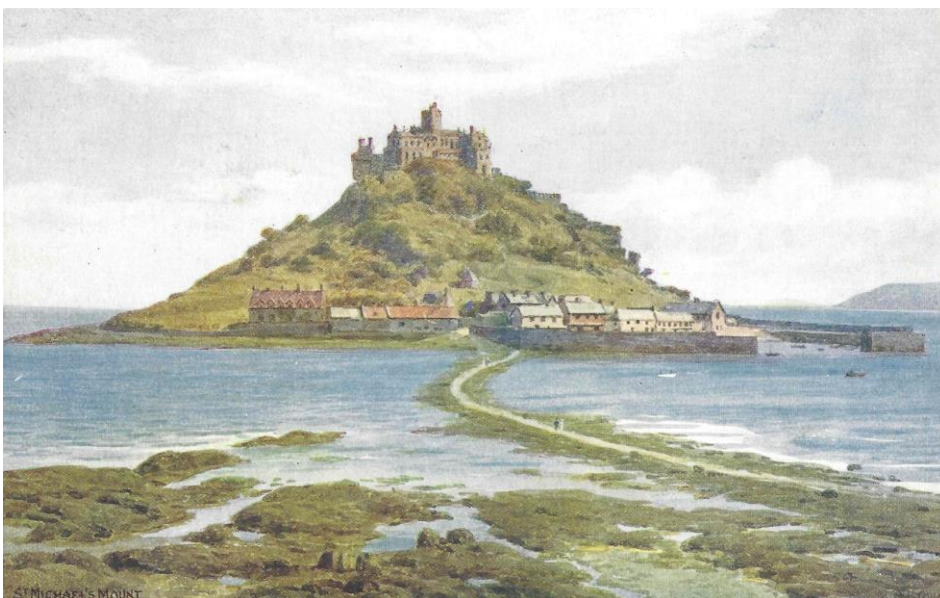
Fig. CS5.3.26. 'St. Michael's Mount' by Alfred Robert Quinton. Watercolour. C.1915. Quinton's view provides a detailed, almost photographic, image of the Mount showing the full extent of the causeway. Image courtesy of Salmon's.

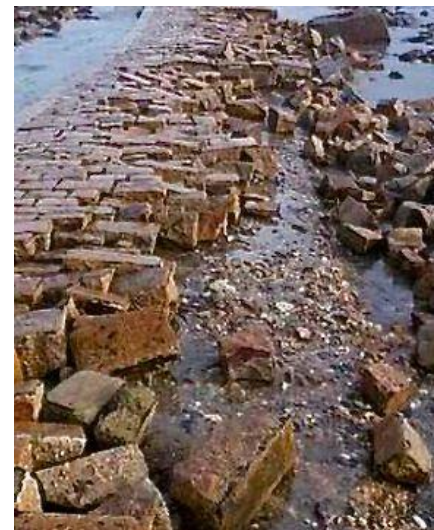
Fig. CS5.3.27. (below left) & Fig. CS5.3.28. (below right) show the granite setts of the causeway before and after the severe storms of 2013/14.

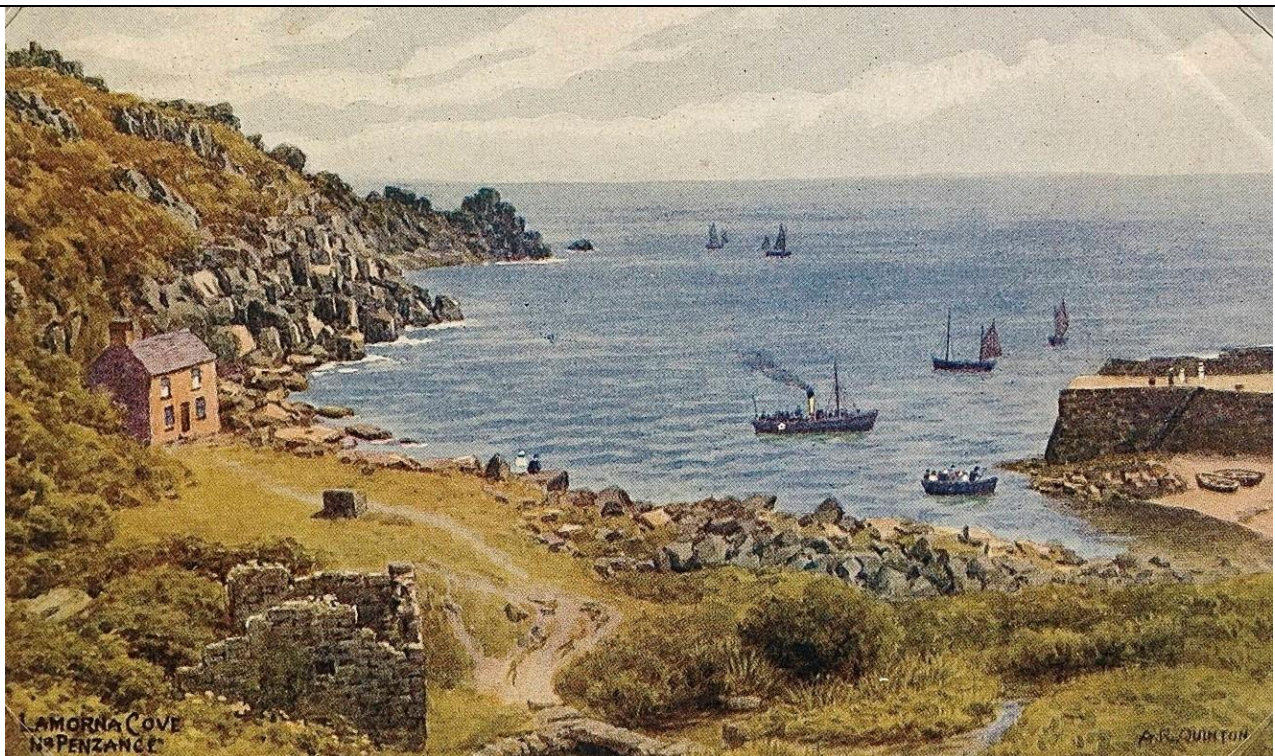
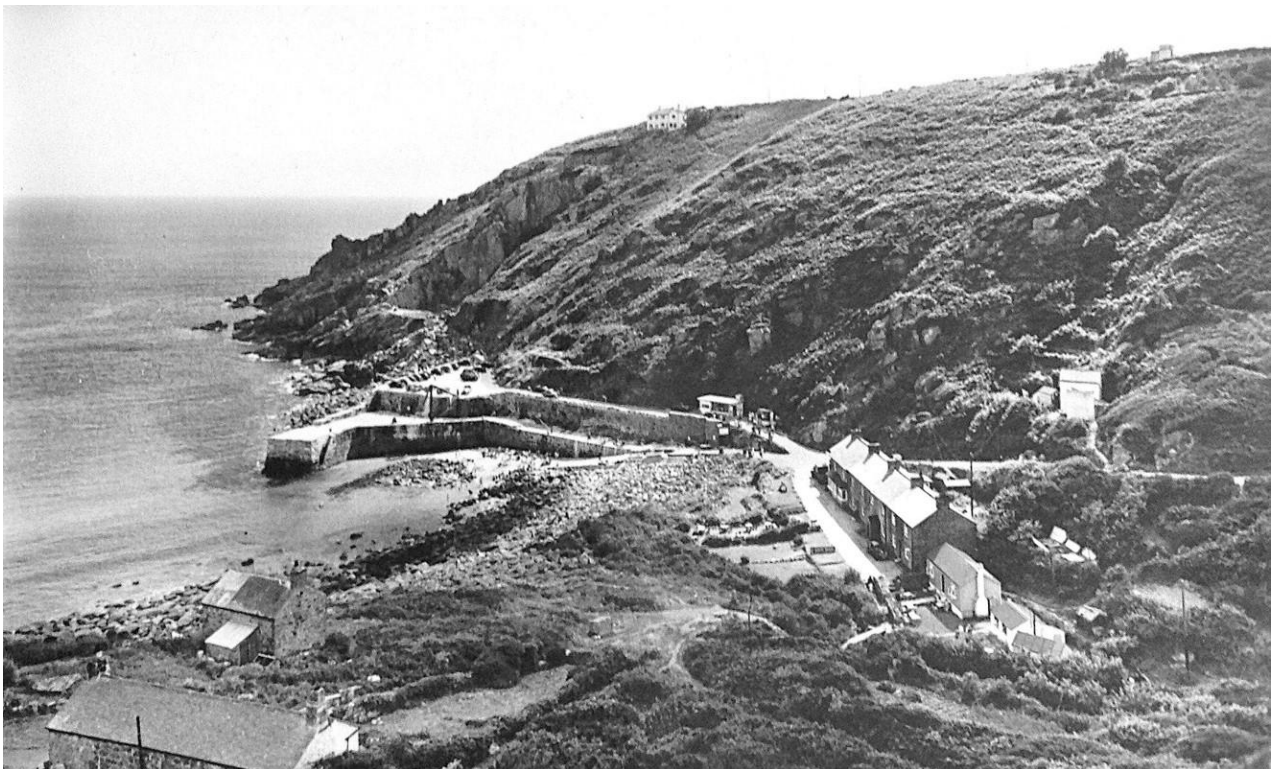
Fig. CS5.3.35. (above) & CS5.3.36. (below) show two views of Lamorna Cove, which is located in the parish of St Buryan. The old quay dates from about 1540 and was used for the shipment of granite. In the severe storms of January and February 2014, Lamorna Quay suffered severe damage and has partly collapsed into the sea.

Fig. CS5.3.36. (below), a postcard dating from about 1920, shows the view from the east and condition of the harbour at that time, together with the cottages in the Cove.

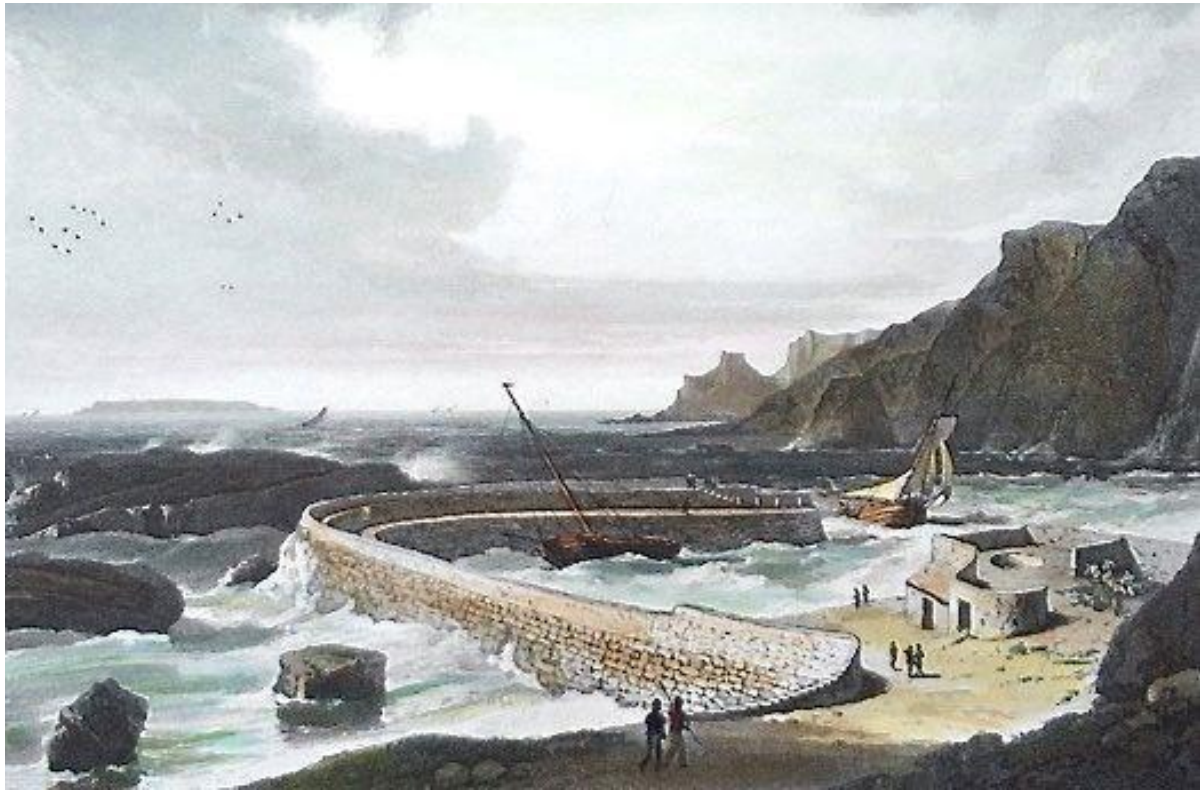
Fig. CS5.4.2. 'Hartland Pier' by William Daniell RA. Aquatint Engraving. 1814. This view was produced by Daniell at the start of his eleven year 'Voyage Round Great Britain' (1814-25) and shows the stone arm/pier in sound condition. The rocky, hazardous coastline and exposure of the location to Atlantic storm waves are obvious in Daniell's view.

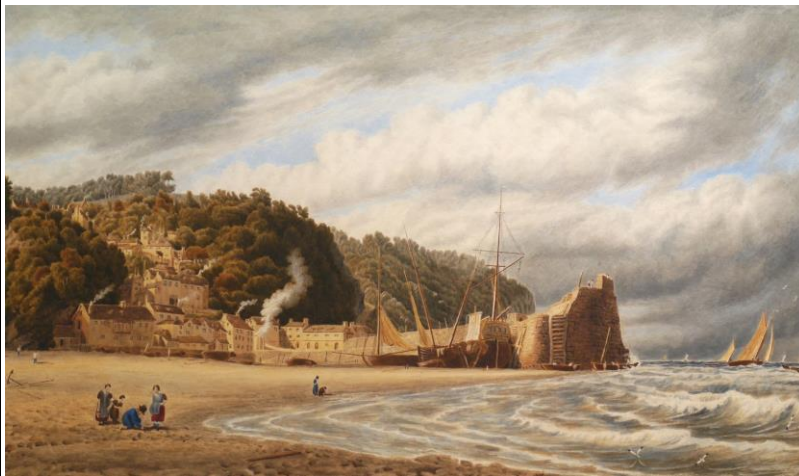
Fig. CS5.4.6. 'Figures on the Beach at Clovelly' by William Turner of Oxford. Watercolour. c.1840. The massive harbour wall is well illustrated in this view. The cottages in Daniell's view (above) are on the left of the harbour.

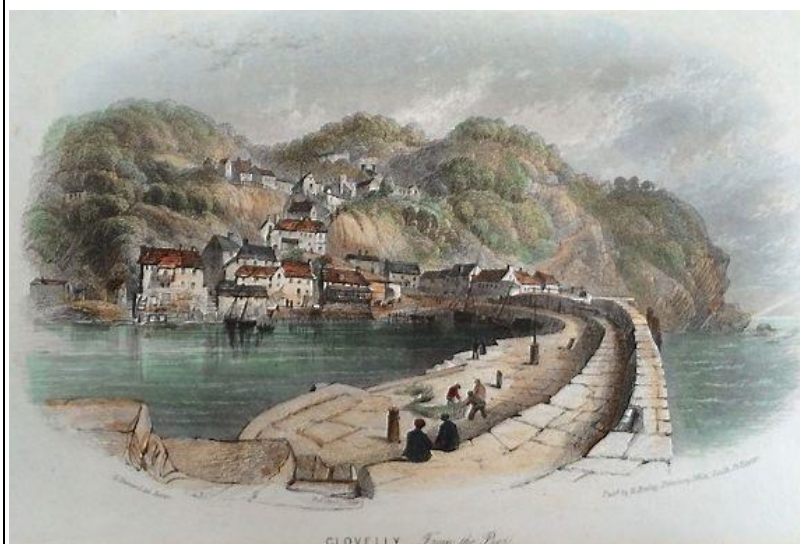
Fig. CS5.4.7. 'Clovelly from the Pier', a mid-nineteenth century steel engraving taken from the end of the harbour arm. The steep street leads down to the quay from above with cottages clustered round the waterfront.

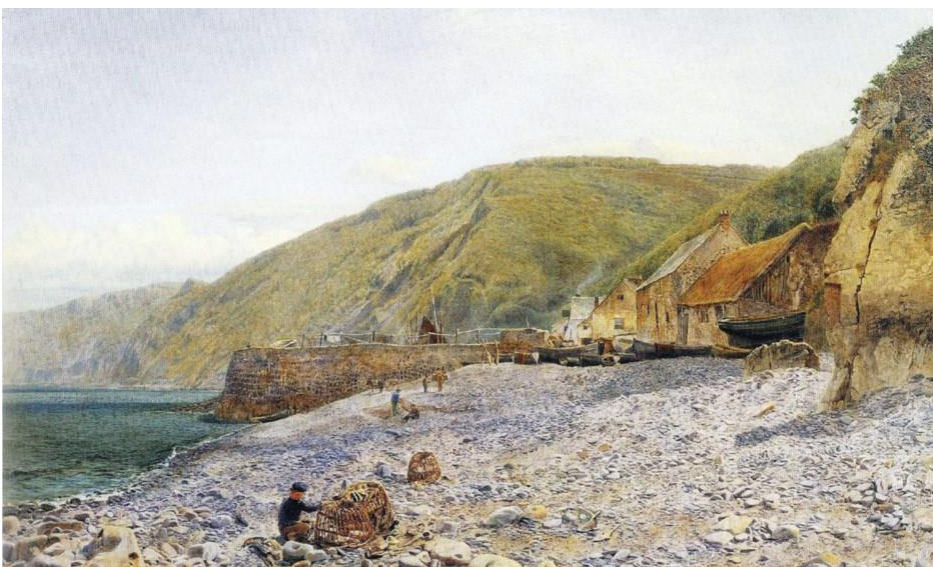
Fig. CS5.4.10. This watercolour entitled *'Among the Shingles, Clovelly'* is by Charles Napier Hemy (1864). Painted in Pre-Raphaelite photographic detail every stone on the beach can be seen together with its height and profile as well as the nature and condition of the harbour wall. Artworks of this kind equal a colour photograph of today in their detail. Image courtesy of the Laing Art Gallery, Newcastle Upon Tyne.

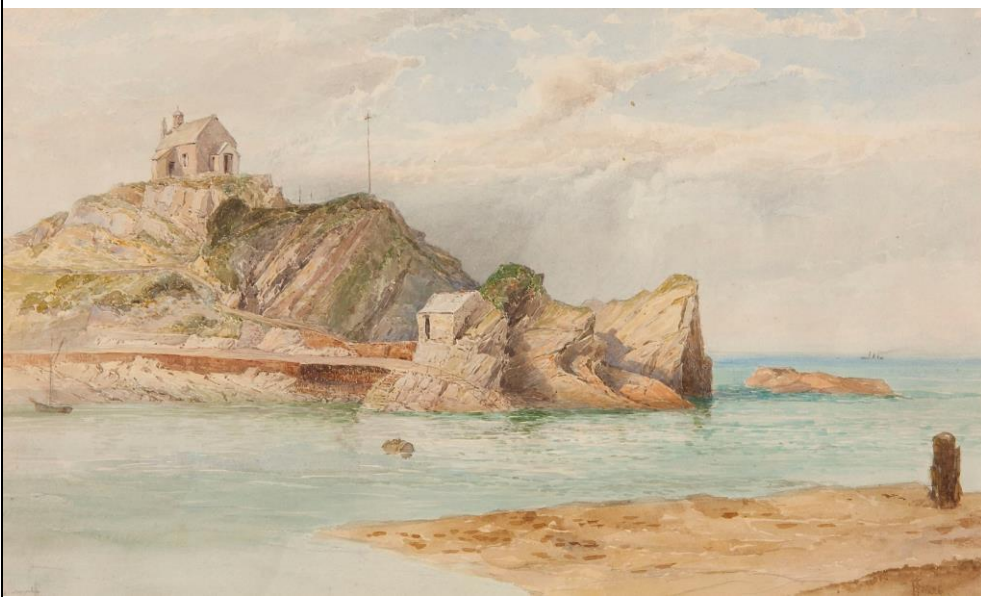
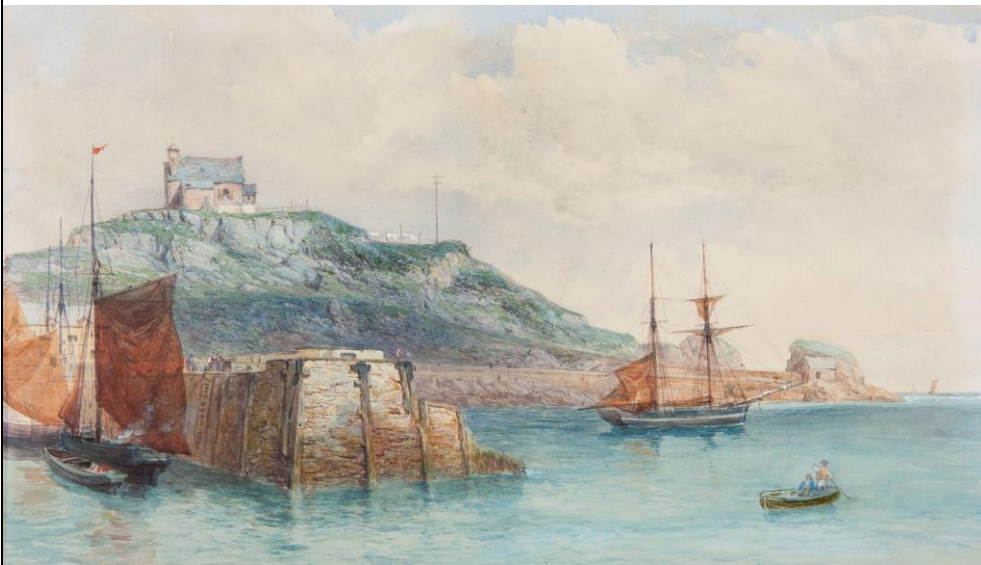
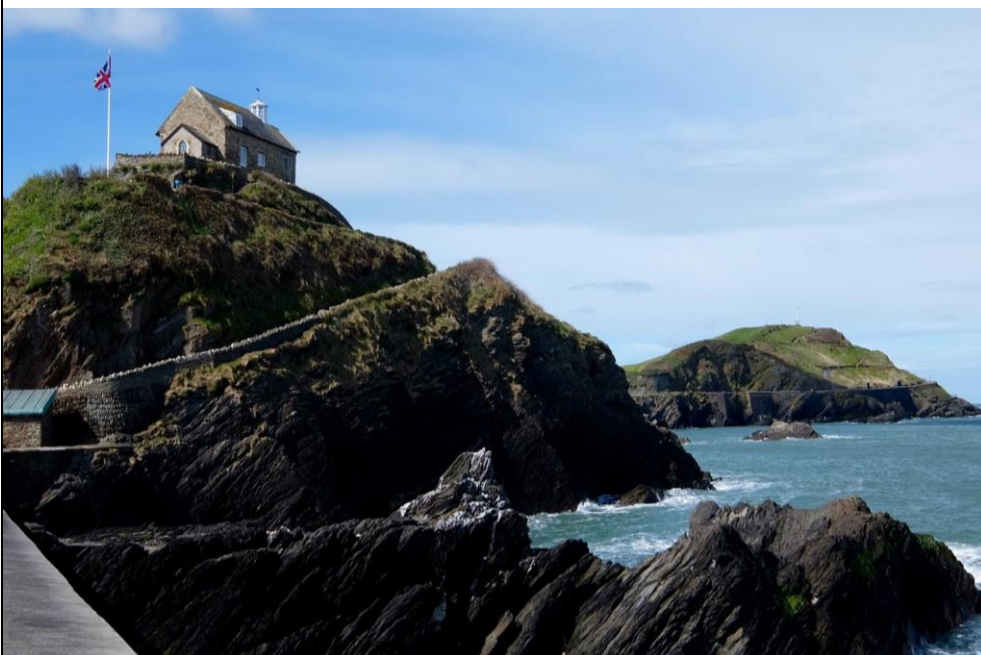
Fig. CS5.4.18. (top) & CS5.4.19. (middle) provide two further highly detailed 'geological views' of the entrance to Ilfracombe Harbour in the 1860s (a further fine watercolour of this subject is held by Ilfracombe Museum). Frederick Jones' views date from the mid-1860s and show exactly the nature and condition of the harbour arm and the Chapel (see also **Fig. CS5.4.13. & CS5.4.14.**). **Fig. CS5.4.20. (bottom)** shows the view today from the end of the harbour. The chapel on Lantern Hill has been a lighthouse since at least 1852 and was later used as a Summer Reading Room. **Fig. CS5.4.18. & CS5.4.19.** © British Culture (Bristol Museum & Art Gallery).

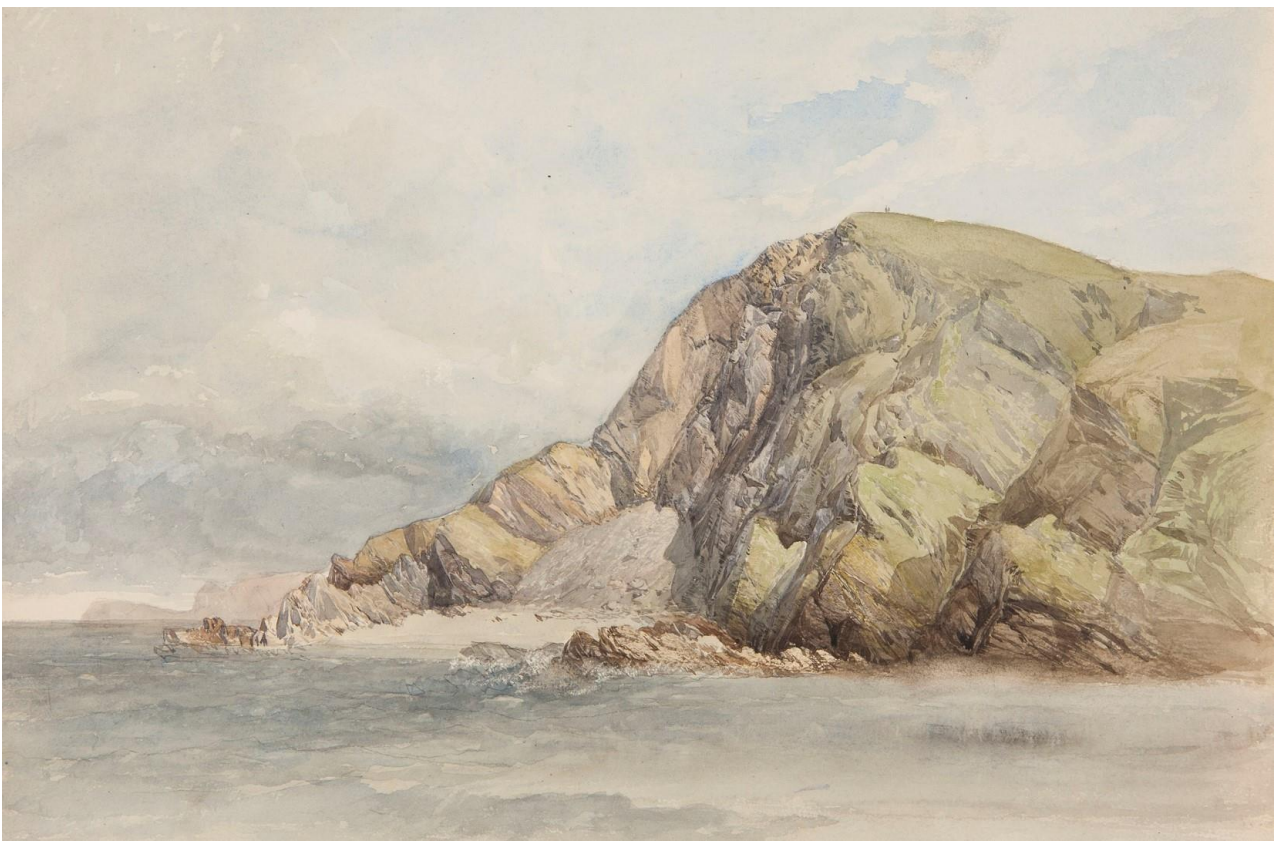
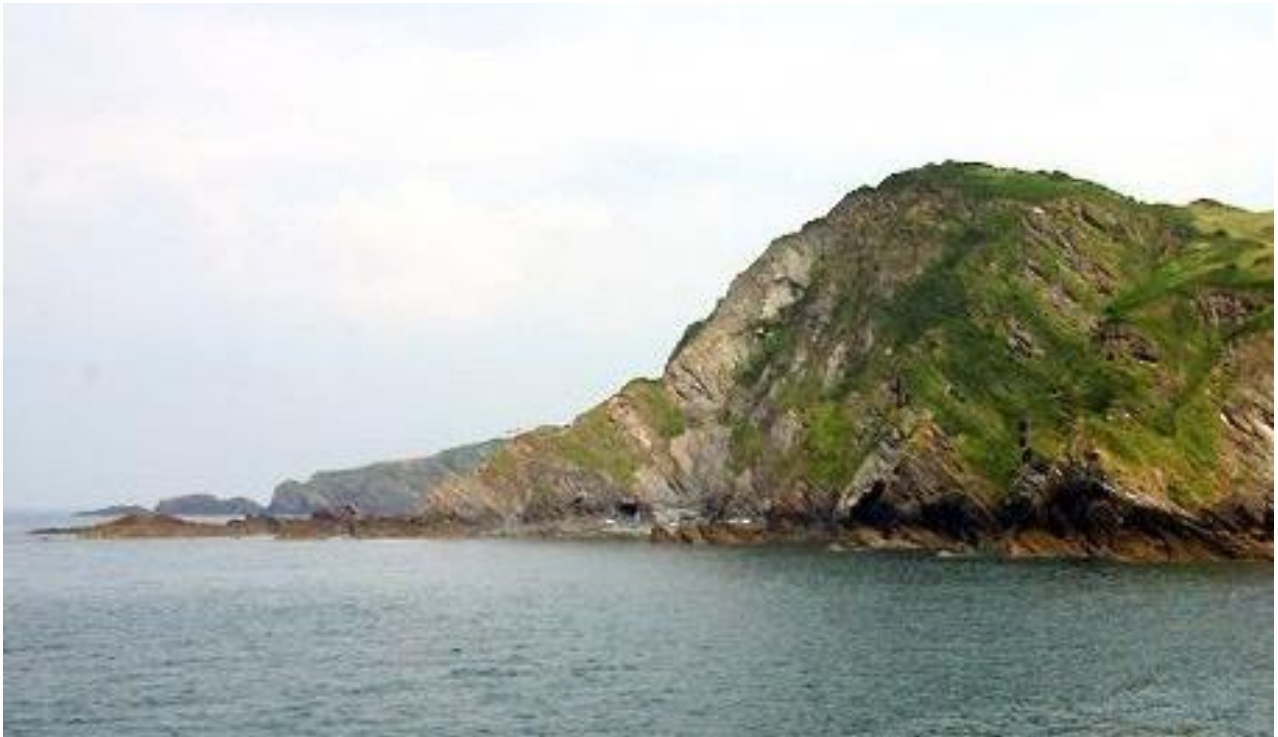
Fig. CS5.4.27. (above): This pair of views illustrate the photographic accuracy that could be achieved by some of the best nineteenth century artists such as Frederick Jones (fl.1860s). Such detailed portrayals of cliff faces allow not just qualitative but also quantitative assessments to be made of cliff and coastline change. These views show Hillsborough, which includes a promontory fort on its summit (MDV2210).
