Case Study 6 – North-West England

Case Study 6.1 – Heysham to Grange-over-Sands, Cumbria

Case Study 6.2 – Whitehaven to Maryport, Cumbria

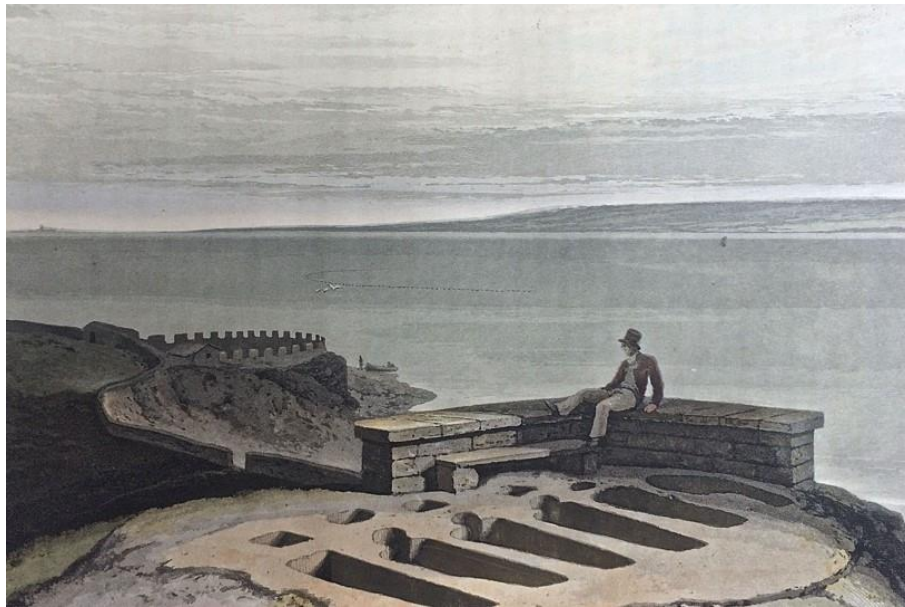
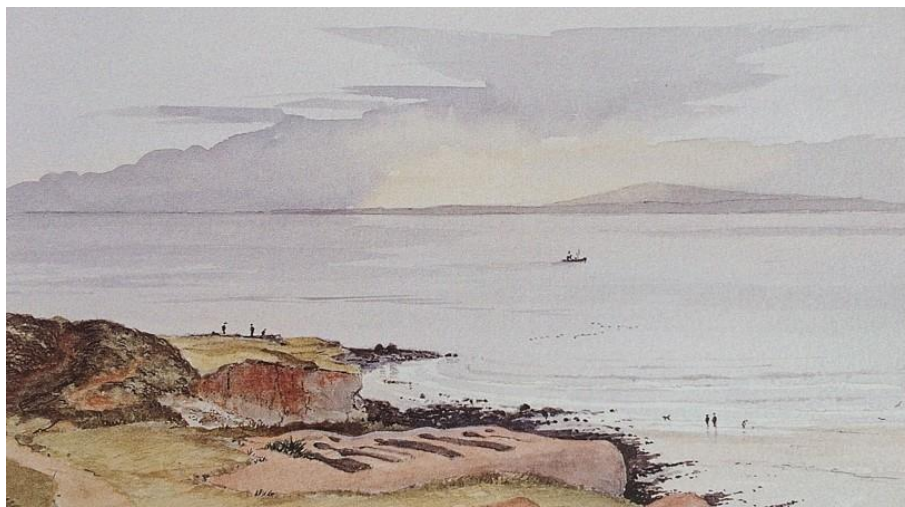
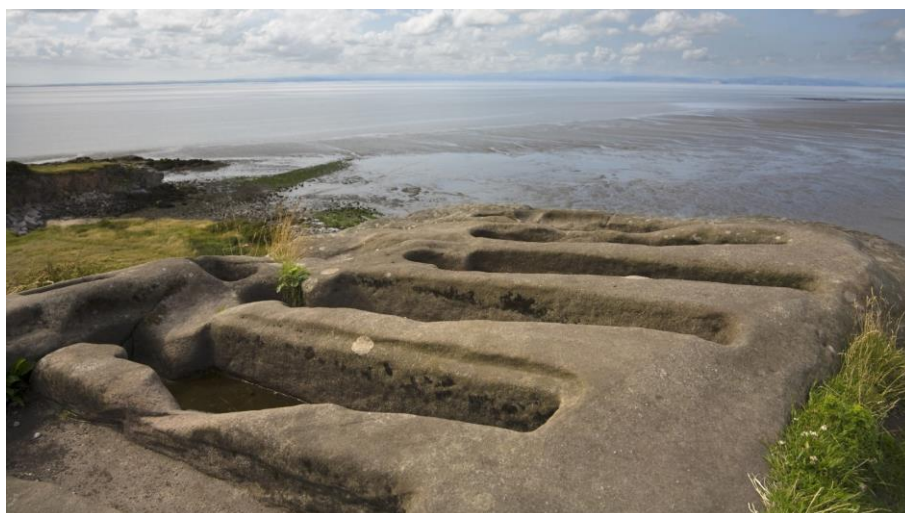
Fig. CS6.1.2.-6.1.4. This sequence of images shows the historic site adjacent to the coast near the eighth century St Patrick's Chapel (Grade 1) at Heysham. William Daniell RA visited the site whilst travelling north up the coast in 1815. In his view the graves are clearly defined in the sandstone platform with its boundary wall and seat overlooking across Morecambe Bay. A wall extends round to a crenelated feature on the headland below. In David Addey's watercolour of 1994 (**CS6.1.3. middle**) the graves have become weathered and all the structures seaward that are shown in Daniell's view have been lost through coastal erosion, as also illustrated in the present day photograph (**CS6.1.4. bottom**). Whilst the rate of cliff retreat may be gradual or episodic, loss of coastal heritage sites is a significant issue in terms of shoreline management and heritage bodies play a key role in formulating long-term coastal policies.

At Lower Heysham, Daniell's view shows the coastline near St Patrick's Chapel and the series of grave stones cut into the sandstone at the top of the low cliff. There is evidence of coastal erosion here with a number of walls and other historic structures lost over time. At Morecambe artworks by A. R. Quinton show the nature of the developing town in the early twentieth century, with new coast protection works being illustrated, as well as some key tourism-related public structures, such as the central pier and clock tower. Some of the elegant properties lining the seafront and illustrated in Quinton's views are visible in the present day photographs.

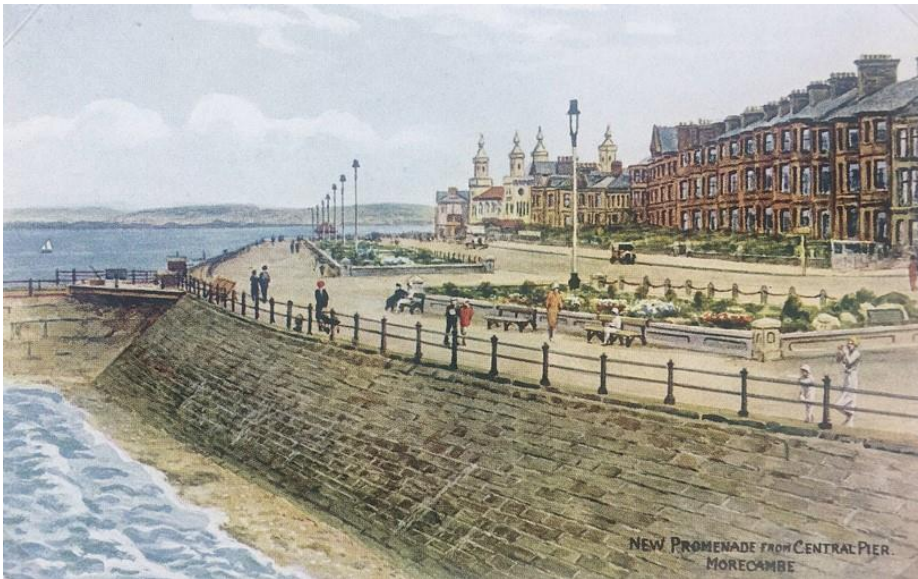
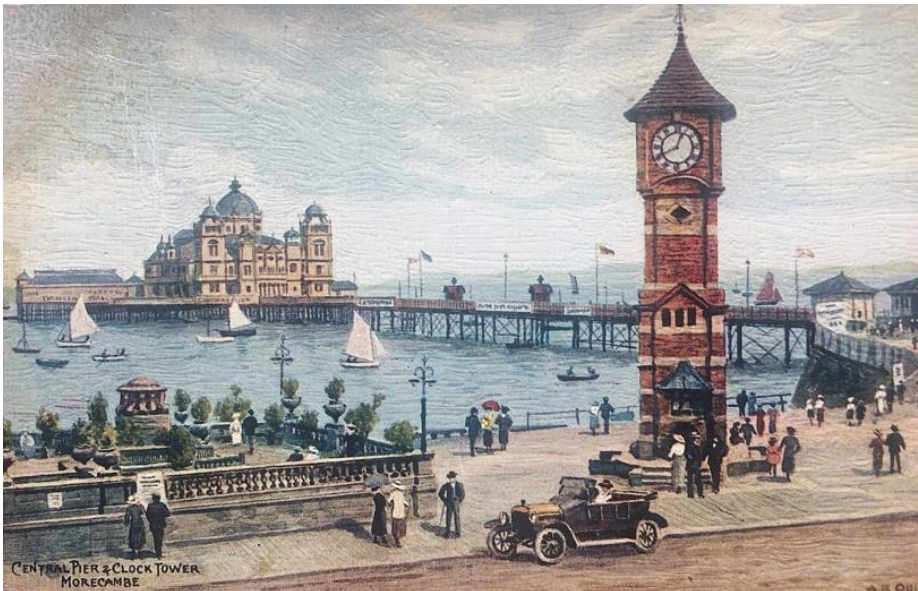
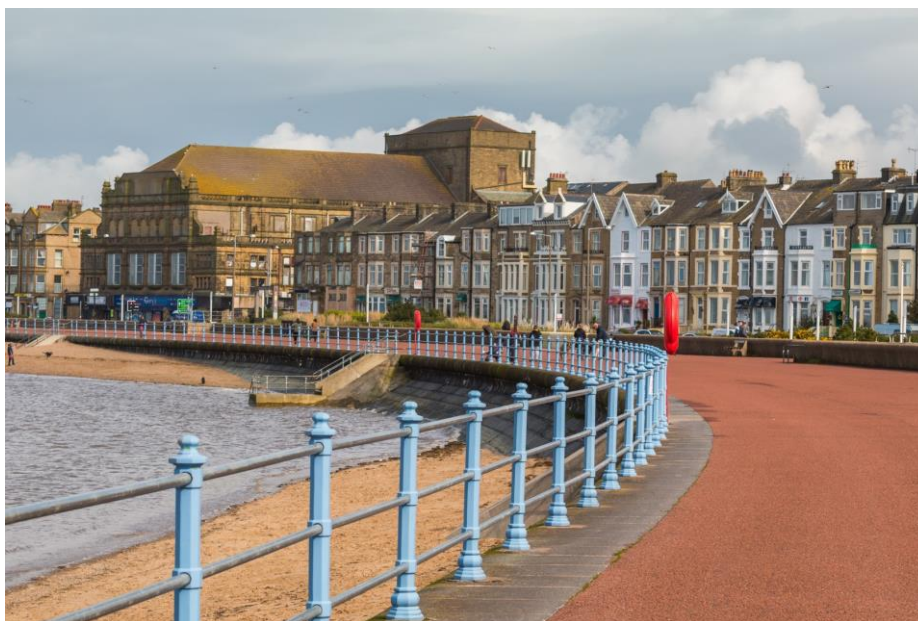
Fig. CS6.1.5.-6.1.7. The very detailed watercolours (**CS6.1.5. top** and **CS6.1.6. middle**) were painted c.1920s by Alfred Robert Quinton and show the fashionable resort of Morecambe. The view left shows the new seawall taken from the town's central pier and illustrates the nature of its construction. The watercolour (middle) shows the pier itself, which opened in 1869 and which was seriously damaged by fire in 1991; it was demolished in 1992. Standing in front of the pier entrance is the grand Clock Tower (Grade II), which was constructed in bands of brick and red sandstone. Many seaside piers have been lost over the last fifty years in particular. Such watercolours can often provide the only record of their original design and construction and are, therefore, valuable records recording heritage through the medium of watercolour art.

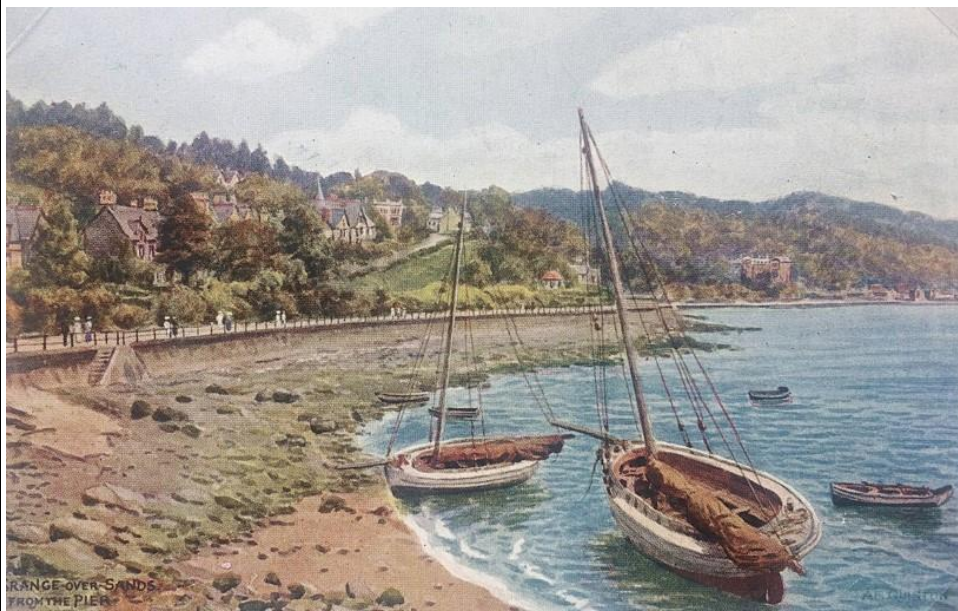
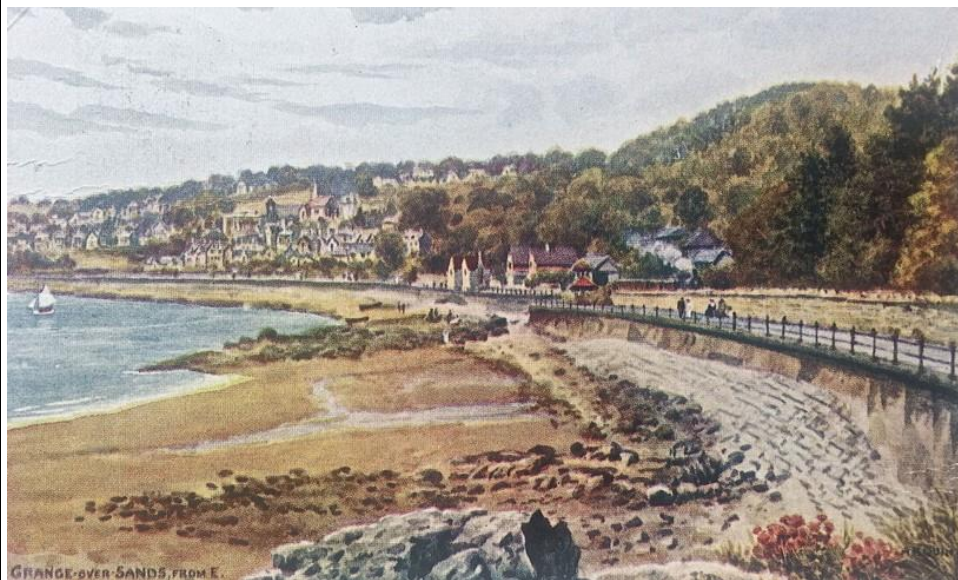
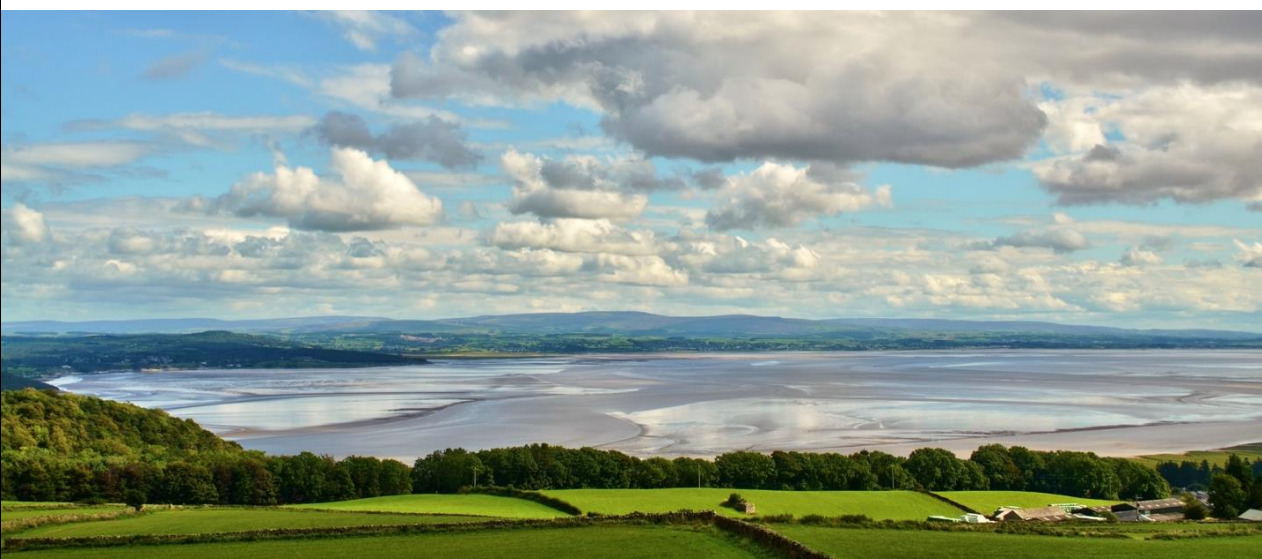
Fig. CS6.1.8.-CS6.1.10. show views of the elegant seaside resort of Grange-over-Sands, overlooking Morecambe Bay.

The artist, A. R. Quinton, painted these two views of the coastline (**CS6.1.8. top** and **CS6.1.9. middle**) which show the nature of the beach, seawall and promenade with the coastal railway link behind.

The present day photograph (**CS6.1.10. bottom**) shows the nature of the Bay at Low Water, which appears to show significant accretion since Quinton's views were painted. This illustrates a continuing trend for accretion of sand here, which will assist in protecting the frontage in a natural way in future decades.

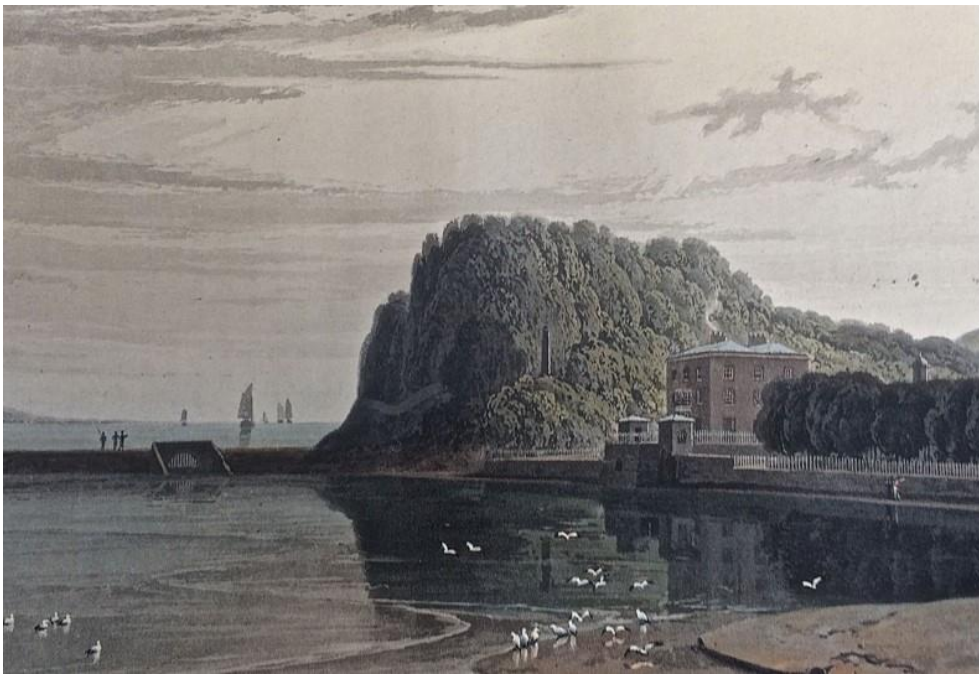
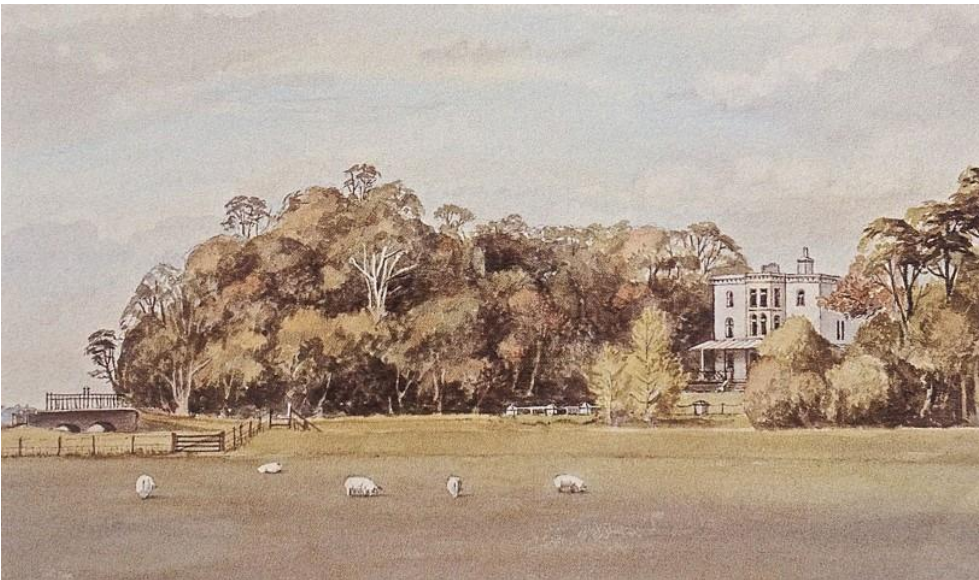
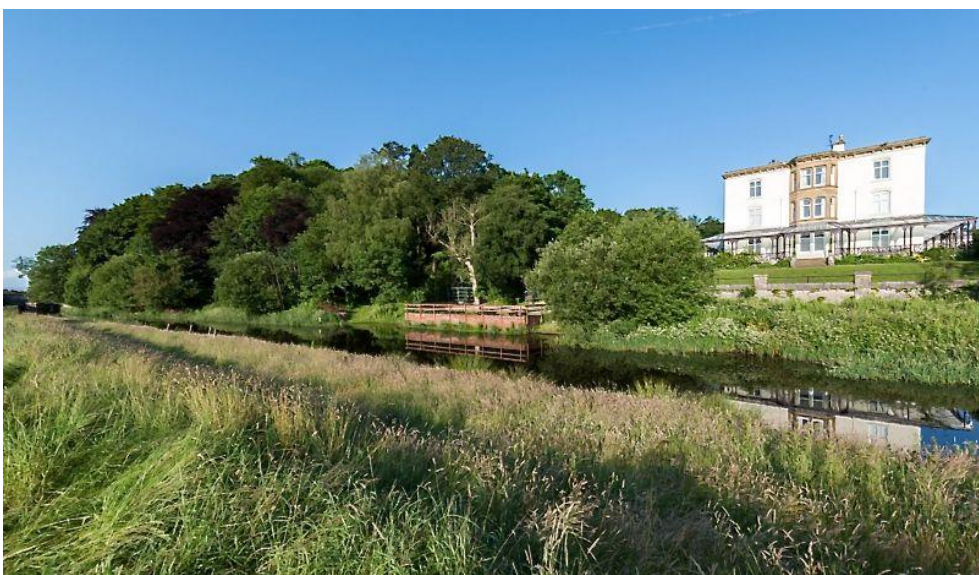
Fig. CS6.1.11.-CS6.1.13. provide views of 'Castle Head', a mansion near Grange-over-Sands. It was built a century before Grange-over-Sands started to develop, hence this property was illustrated by William Daniell RA on his '*Voyage Round Great Britain*' (Daniell & Ayton, 1814-1825).

The breakwater on the left was built in 1778/79 and much later the land was reclaimed, as can be seen in David Addey's watercolour painted in 1994 (**CS6.1.12. middle**) and in the present day view.

The cast iron monument to the owner of Castle Head, John Wilkinson, can be seen on the crag in Daniell's view but was later moved to nearby Lindale Village.

At the time of Daniell's visit, there was little development around the northern coast of Morecambe Bay, but he did select a view of *Castle Head*, a mansion near Grange-over-Sands, which is now a field studies centre. Here there has been reclamation in front of the property, although the property itself remains relatively unchanged. At Grange-over-Sands, there are early twentieth century watercolours depicting the coastline with its seawalls and rocks exposed on the upper foreshore. There has been extensive accretion over time, and it is likely that the location will have an increasing degree of natural defences with the development of sandflats and saltmarsh. Clearly, the impacts of sea level rise provide uncertainty in the medium to longer term.

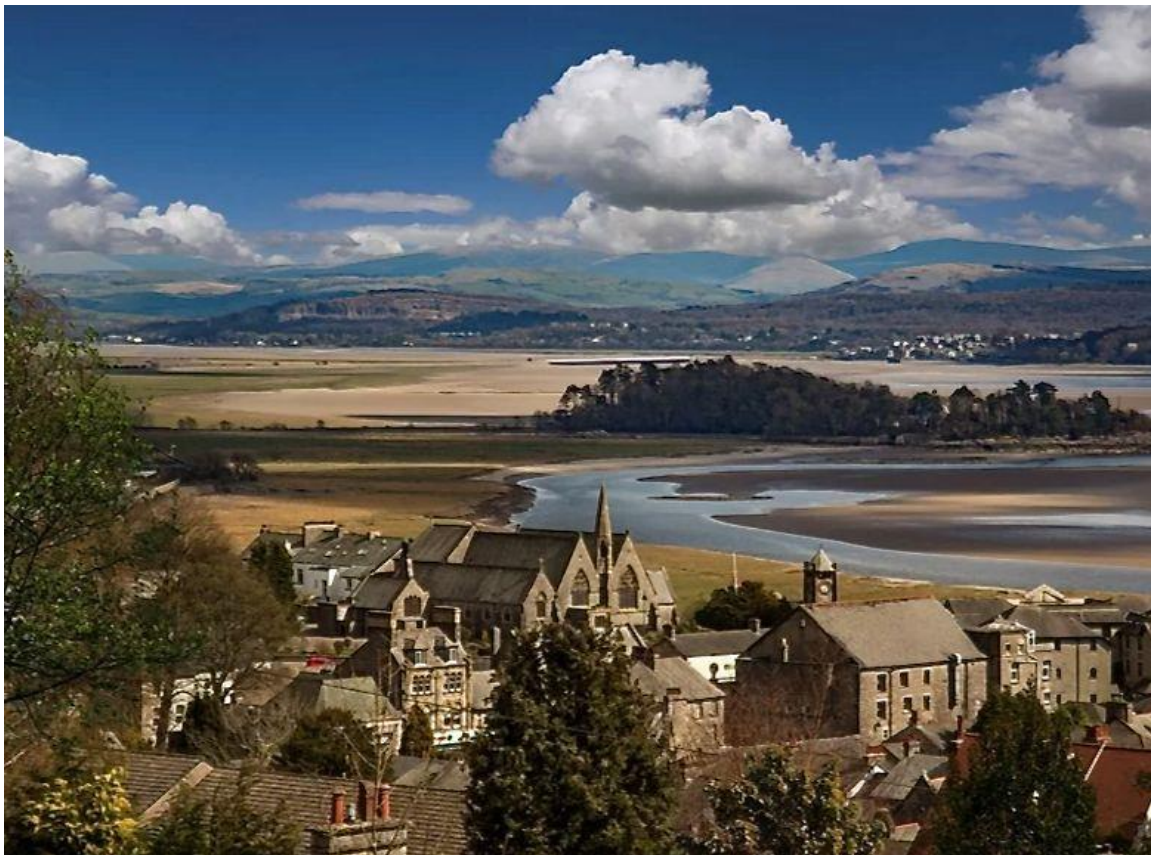
Fig. CS6.1.15. shows a view over the rooftops of the town and across Morecambe Bay at Low Water; the extensive and accreting sand and mudflats are clearly shown.

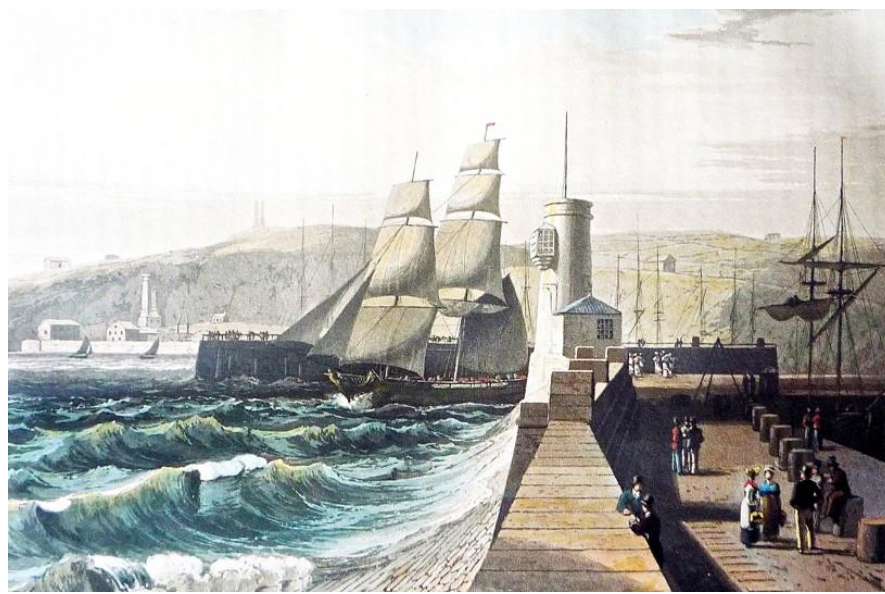
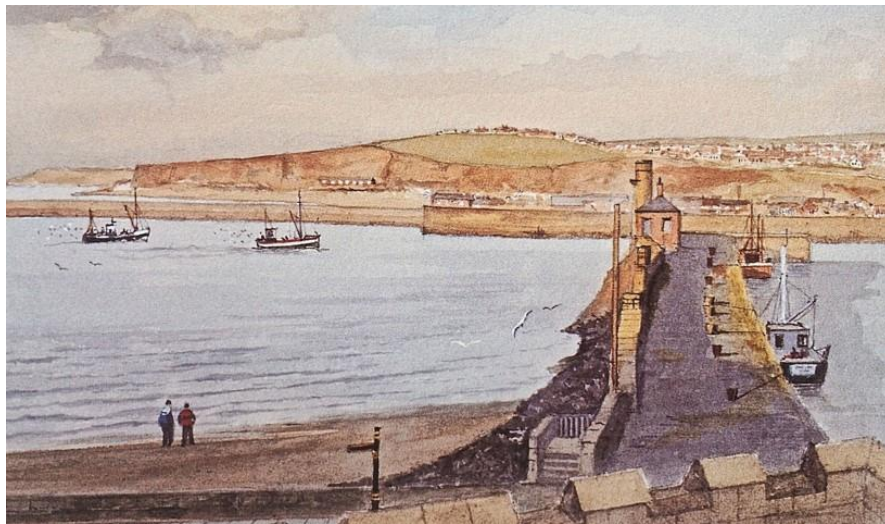
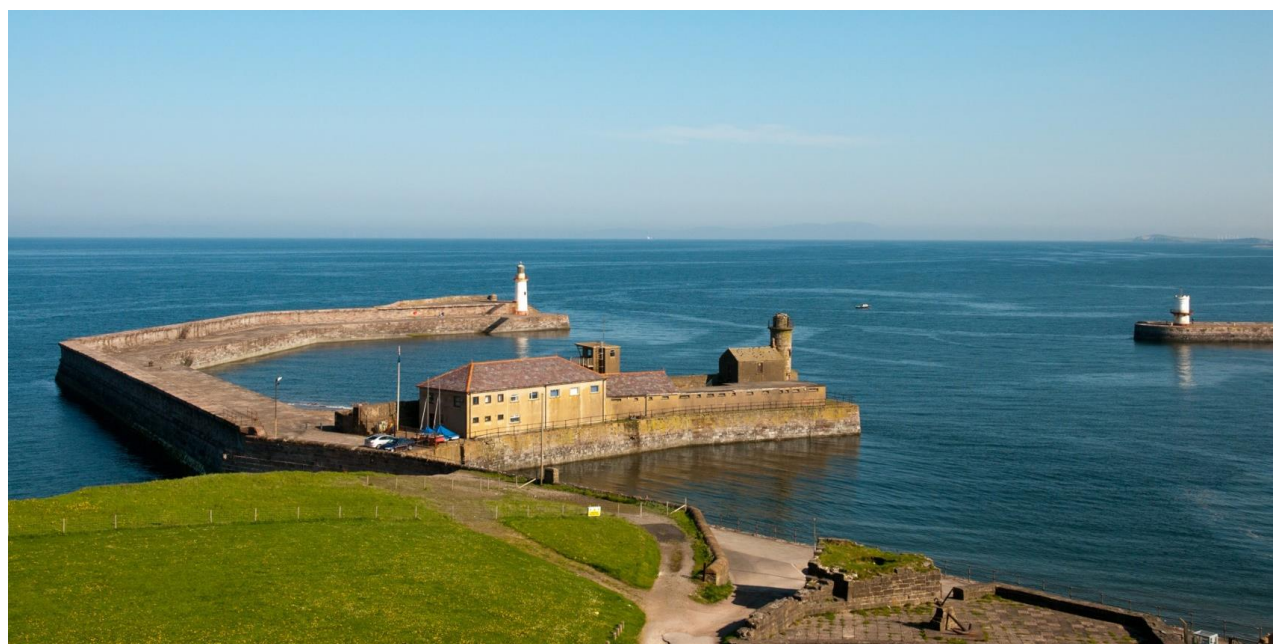
Fig. CS6.2.1.-CS6.2.3. show views of the harbour of Whitehaven between 1815 and the present day. The aquatint engraving by William Daniell RA (top) shows the flourishing port that was founded by the Lowther family following discovery of the coal and iron ore that stimulated its development.

The architect and watercolour artist, David Addey, retraced Daniell's footsteps painting from as closely as possible to Daniell's vantage points in the 1990s. The view (middle) shows that the pier with its tower still exists, although the commercial activity of the port is much reduced. The above ground workings of the William Pitt coal mine (visible left in Daniell's view) have now gone, as have the two chimneys 'the Tobacco Pipes' which were used for the destruction of contraband tobacco; these were demolished in 1923 (Addey, 1997).

The present day view shows the well-preserved harbour. Such historical images are of particular interest to those wishing to discover the architectural and social history of such locations and the changes that have been necessitated largely for economic reasons over the last two centuries.

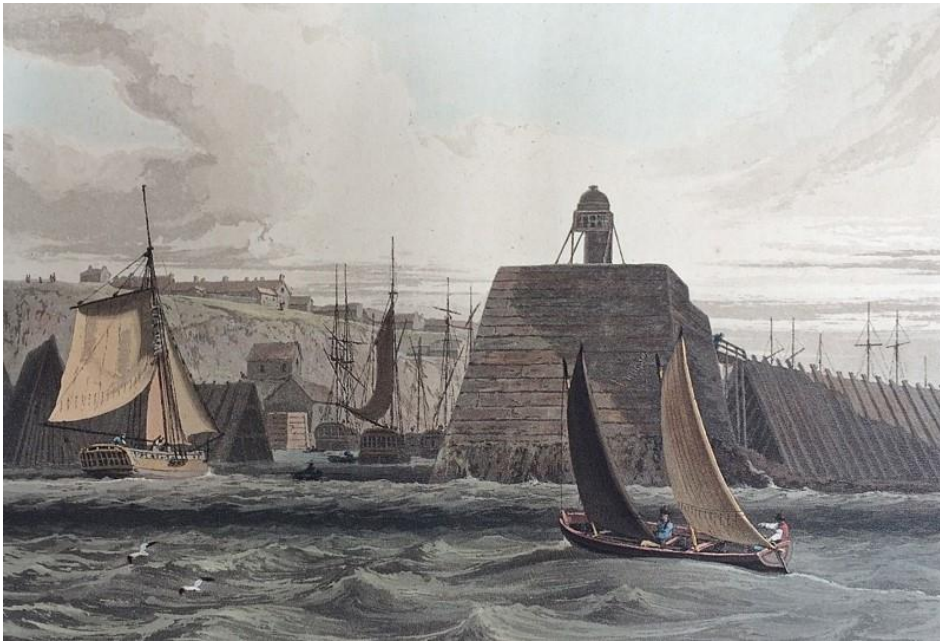
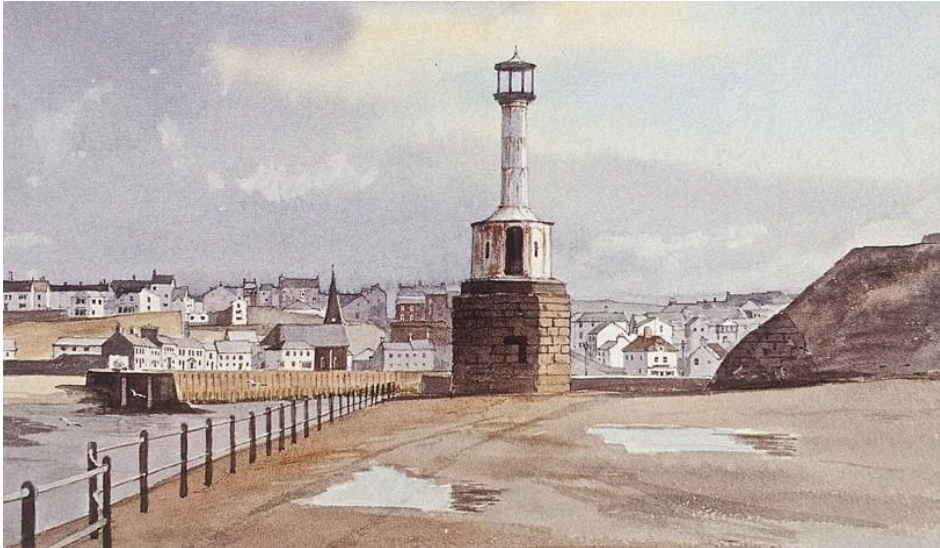
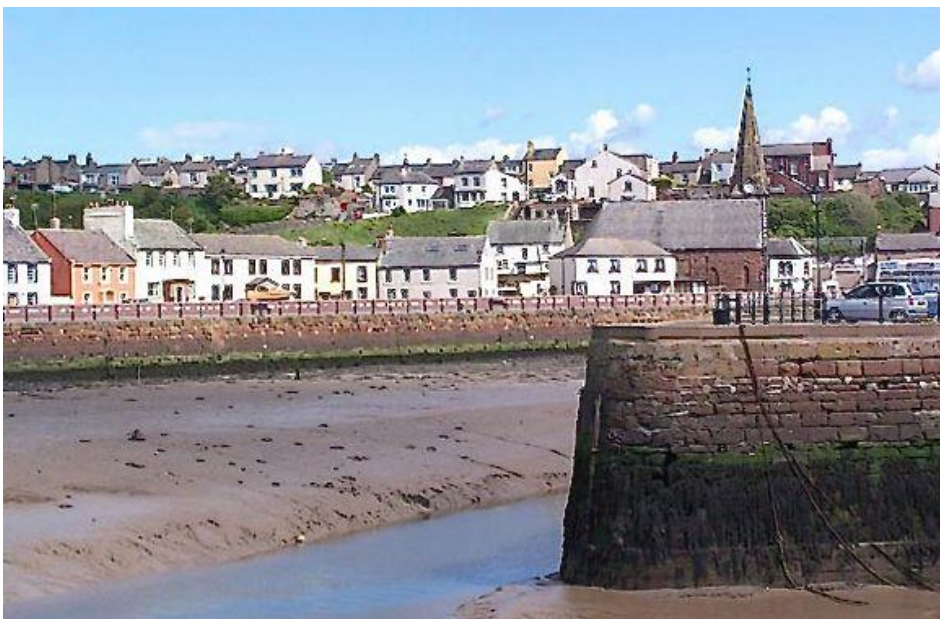
Fig. CS6.2.4.-CS6.2.6. like the previous views of Whitehaven, these reflect the changes to the port of Maryport since 1815. Daniell's view (top) shows the substantial timber and masonry harbour breakwaters, which were already starting to break up at the time of his visit; these were later rebuilt in stone.

The view by David Addey (middle) shows the harbour from a similar vantage point to that chosen by Daniell. The former docks and waterfronts are now being developed as part of a regeneration scheme for the town.

Such historical imagery can inform records of heritage changes and losses, Conservation Area planning and management and issues such as repair or reconstruction of harbour walls and coastal defences where there may be uncertainty of the nature of the original civil engineering construction.
